Review on the Major Failure Cases of Unlined Pressure Shafts/Tunnels of Norwegian Hydropower Projects

Dr. Krishna Kantha Panthi and Er. Chhatra Bahadur Basnet

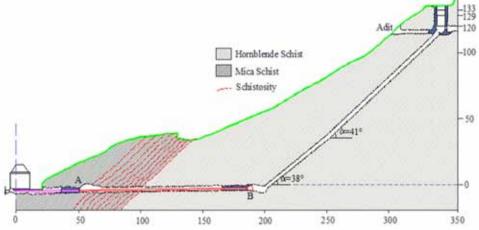
Figure 3: The Herlandsfoss hydroelectric project, in operation since 1919 (Redrawn from Voqt, 1922)

As indicated in Figure 3, the main rock types in the project were registered as hornblende schist and mica schist. The schist had foliation strike NW-SE with dip of about 500 SW (Vogt, 1922). The unlined

Initially, the steel penstock pipe was installed to cover only the first 50 m long section from the turbine. A concrete plug was installed at the cone section as shown in Figure 3. Vogt (1922) reported that water inflow was observed from chainage 92 m to 94 m during construction. Concrete lining was used as mitigation measure at this tunnel stretch and rest of the 150m horizontal pressure tunnel was kept unlined all the way up to the bottom of the shaft (Figure 3). A minor leakage was observed at the outer part of pressure tunnel during first water filling with a static water head reaching 123 m. After five hours of full hydrostatic pressure, considerable amount of water leaked from the upstream of the cone area

and leakage channel reached all the way to the surface over the 50 m chainage. The waterway system was drained and inspection was carried out. It was observed that considerable amount inflow of was coming back at chainage 98 m. This demonstrated on the extent of hydraulic splitting occurred in the tunnel after water filling. This splitting led to extend existing joints in the rock mass and also new fractures were developed along the spring line of unlined pressure tunnel over afrom Vogt, 1922)

lining between chainage 70 m to 79 m covering both tunnel walls near the spring line. Selmer-Olsen (1969) interpreted this incident in such a way that the rock mass over the tunnel had been lifted during first cracking and then deformed downward after water way was drained. Finally, decision was made to extend penstock all the way up to the bottom of the inclined pressure

shaft up to the point B as indicated in Figure 3. The third water filling was a complete success with no significant water leakage registered and this project become the first unlined pressure shaft of Norway.

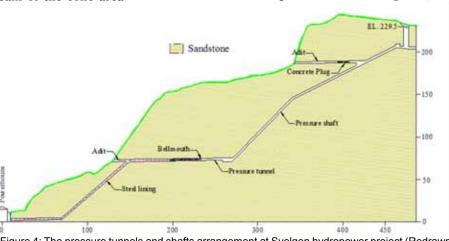
Figure 4: The pressure tunnels and shafts arrangement at Svelgen hydropower project (Redrawn afrom Vogt, 1922)

Since the fine grained sandstone has in general low degree of porosity, the leakage risk was always through the joint system; from both gently dipping bedding joints and steeply dipping cross-joints. During excavation, very little inflow in both tunnels and shafts was registered. Test water filling was carried out until the elevation of 223 masl. The pressure tunnels and shafts were filled in four hours period and rest of the headrace tunnel was filled in 5 days period. To check the leakage through the unlined

waterway system, inlet gate was closed for two days and water level was sinked to 160 masl from the maximum elevation of 223 masl (Vogt, 1922). Water loss from the waterway system was calculated to about 70 l/s. A short part of the pressure tunnel was concrete lined and cement grouted. After then the waterway system functioned normal and no as such failure reported.

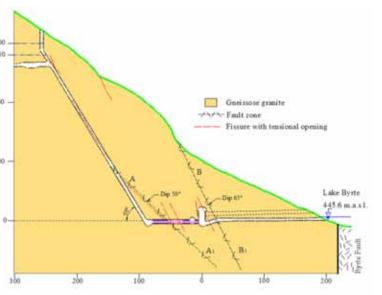
Figure 5: The unlined shaft and underground powerhouse arrangement at Byrte hydropower project (Redrawn from Selmer-Olsen, 1969)

According to Selmer-Olsen (1969), the power plant was run for below 280 m water head for the initial period of two months. During this period, insignificant leakage was registered. However, once the static head was elevated, it was observed that the leakage was increasing slowly but steadily. Once the operation crew by mistake increased the static head to 300 m, hydraulic splitting occurred in the rock mass

and the leakage increased very rapidly. Many cracks were observed in the rock mass both in the shaft and powerhouse cavern. It was necessary to pump out the leaked water from the power station. In addition to the leakage at the underground powerhouse cavern, several springs were also appeared at the surface topography indicating considerable leakage through the rock mass. The overall leakage from this unlined pressure shaft was estimated to more than 1 m3/s

According to Selmer-Olsen (1969) the clay filled fault zone AA1 (Figure 5) consisting weak rock mass did not managed to sustain the hydrostatic head acting on it and hydraulic splitting occurred along this zone. Ultimately, opening of the fault followed hydraulic splitting in the pre-existing joints in the rock mass leading to the leakage at the underground power station as well as leakage along the surface topography following fault zone BB1. Finally, the whole shaft was steel lined (Buen, 1984) as permanent solution.

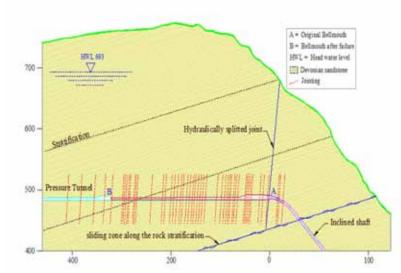
Figure 6: Section through pressure tunnel of Åskåra power plant (Redrawn from Bergh-Christensen, 1975)

In the first stage of project construction at about 173 m chainage (Figure 6), considerable water inflow into the tunnel was registered and it was sealed with cement grouting. This inflow indicated possibility of leakage from the pressure tunnel during operation. Initially the pressure tunnel was kept unlined up to the point A in Figure 6. The first water filling was carried out in the waterway system achieving full hydrostatic head of 690 m. The filling process was gradual until the unlined pressure tunnel reached to a hydrostatic pressure of 194 m and filling of remaining part was fairly quick. Leakage was observed at the western valley slope of the mountain topography immediately after the water filling was completed. The next day, large leakage of about 1.0 m³/sec was registered on the same place indicating complete failure at the downstream end of the unlined pressure tunnel. The waterway system was drained and inspection was carried out. During inspection it was observed that the cross joints were opened by about 3-4cm between the tunnel section A and B (Figure 6). The opening in the joints clearly demonstrated the occurrence of hydraulic splitting. Finally, steel lining was extended up to point B. After this modification, the power plant is being
