Architectural and Structural Analysis of the Tamang Houses in Haku, Rasuwa

Jonas Raphael Häberle, Jagat Kumar Shrestha

Department of Civil Engineering, Pulchowk Campus, Institute of Engineering, TU, Nepal

Abstract: This paper provides a summary of an architectural and structural analysis of traditional Tamang houses in Haku, Rasuwa and the best methods for integrating seismic resistant features and cultural preservation in the recovery after the 2015 Nepal earthquakes.

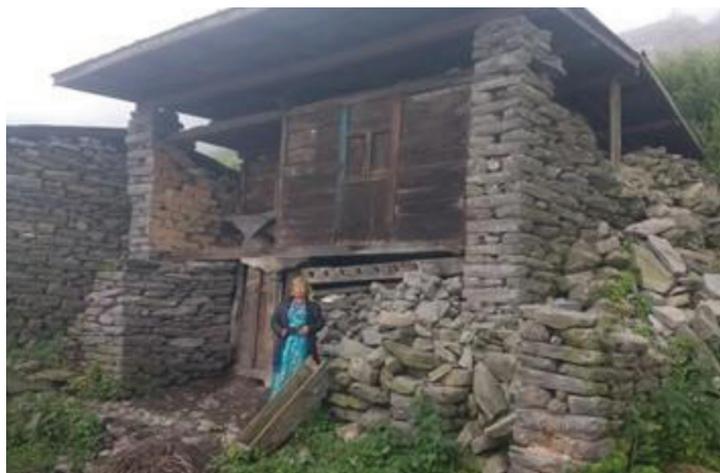
Fig. 1: A Tamang woman from Haku standing in front of her broken house in Tulo Haku, Rasuwa

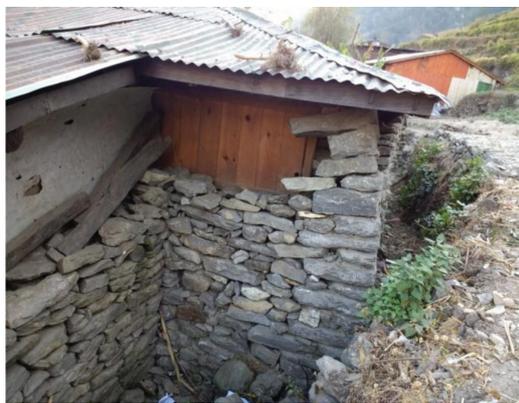
A further structural weakness is the lack of elements that tie the walls together both horizontally and vertically. The horizontal timber beams of the front wall and at the openings have been found to be the only elements that tie the structure together. In many houses, it was observed that the wall corners lost their structural integrity and started bending outwards or that the long walls collapsed

Fig. 2: Corners of wall collapsed due to lacking mortar and horizontal banding

The author recommends that horizontal bandings should be added as a structural element to the traditional house structures. According to the DUDBC, the following five bandings are required: plinth band, sill band, lintel band, stitch and roof band. The bandings are recommended as reinforced concrete bands for stone masonry and cement mortar structures (SMC). However, this structural requirement of specific types of bandings conflicts with the traditional architecture. Therefore, the new houses should focus on minimizing the amount of concrete needed in the reinforced concrete bands while still maintaining the structure's strength as much as possible.

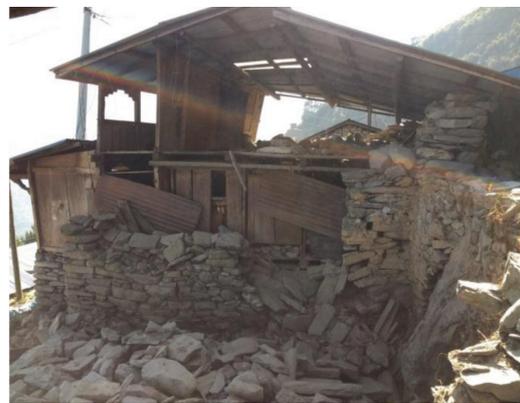
The houses have timber walls on the front side of the house. Structurally, those timber walls showed great resistance to the horizontal forces during the 2015 earthquake. Timber from pine trees as found in Haku have a tensile strength of approx. 20 – 40 N/mm² [5]. This tensile strength keeps the structure flexible and resistant to collapsing during horizontal forces in seismic movement. In the picture below, it is shown how the timber front wall and the timber structure of a house kept the roof from collapsing while the dry masonry walls on its sides collapsed entirely. Since those timber front walls add a very unique architectural feature and proved to strengthen the structure during seismic movement, the community is strongly advised to continue implementing this feature in the rebuilding of their houses.

Fig. 3: A house in Haku which kept the roof from collapsing due to its wooden structure of the front wall, floors and buried back wall

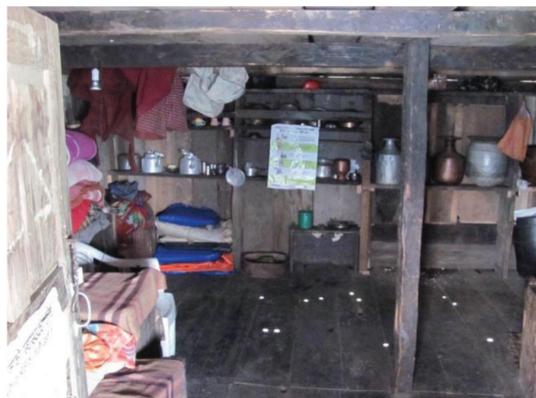
The floor between the ground and upper floor is constructed with local timber. The given dimensions of the timber beams used for the floor have a proper thickness of 100mm - 150mm and are spaced evenly at about 1000mm center to center. The boards have a thickness of 25mm - 35mm. The timber floors strengthen the structure of the house. Due to its tensile strength and flexibility, they act as a horizontal binding on the top of the ground floor walls. It is important to ensure proper connection between the timber floor construction and the stone walls. Another interesting structural element in the house's interior is traditional heavy-duty timber furniture. Along the inside of the stone walls, racks and cabinets to store kitchenware and clothes cover much of the inside walls. Some houses even have a complete wooden cover on the inside of the masonry wall. This provides an insulation layer that keeps the inside of the house warm. Additionally, this wooden cover also proved to add a strengthening structural element during the earthquakes in 2015. The furniture is made from 25-35mm thick timber boards. In many cases, the wooden interior furniture and wall cover helped to keep the roof from collapsing while the stone wall on the outside collapsed. The wooden cover on the inside also protected the people inside the house from injury since the outside stones could only fall outwards and not inwards.

Fig. 4: Interior of a traditional house in Haku with timber furniture and timber floor

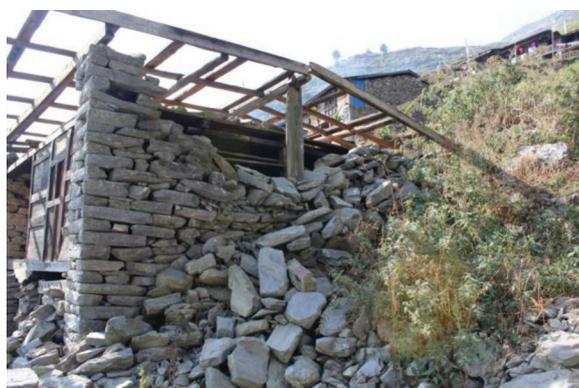
The gables of the traditional Tamang houses are made from dry stone masonry. Together with the side walls, they form one large structural element. Yet, the gables are listed here as a separate structural element, because they were identified as the greatest structural weakness during the seismic movement. In most cases, the dry-stone masonry gables collapsed in the 2015 earthquakes. Therefore, it is recommended to find ways to strengthen the gables as a structural element in future houses. One of those ways would be to exchange the stones with timber boards to construct the gables of the house.

Fig. 5: A picture of a house in Haku where the dry-stone gable collapsed

The author recommends building the gable from timber and using local wooden planks of 25mm thickness to cover the gable areas. To protect the gable areas from rain, there needs to be a sufficient overhang from the roof over the wall of at least 600mm. Additionally, the timber should be treated with "coal tar or any other preservative to prevent timber from being decayed and attacked by insects" (2).

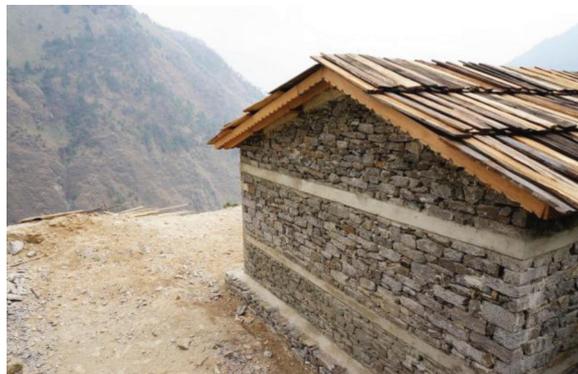
Fig. 6: New house built in Gatlang village with horizontal RCC banding and cement mortar

It still includes a traditional clean stone look on the outside of the wall and a traditional roof covered with wooden shingles [1].

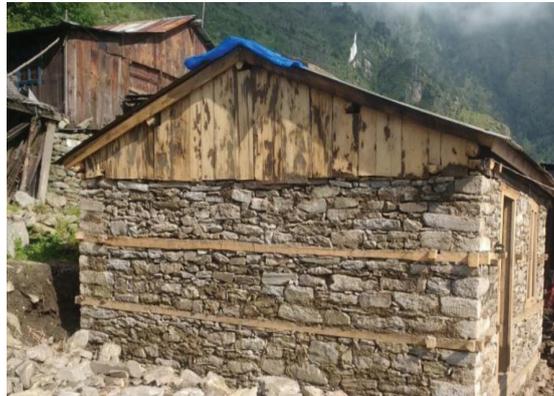
Fig. 7: Newly constructed house in Haku with timber gables and timber bandings
