Nepal Earthquake 25 April 2015: Hydro projects damaged, risks and lessons learned for design considerations

Subas Chandra Sunuwar

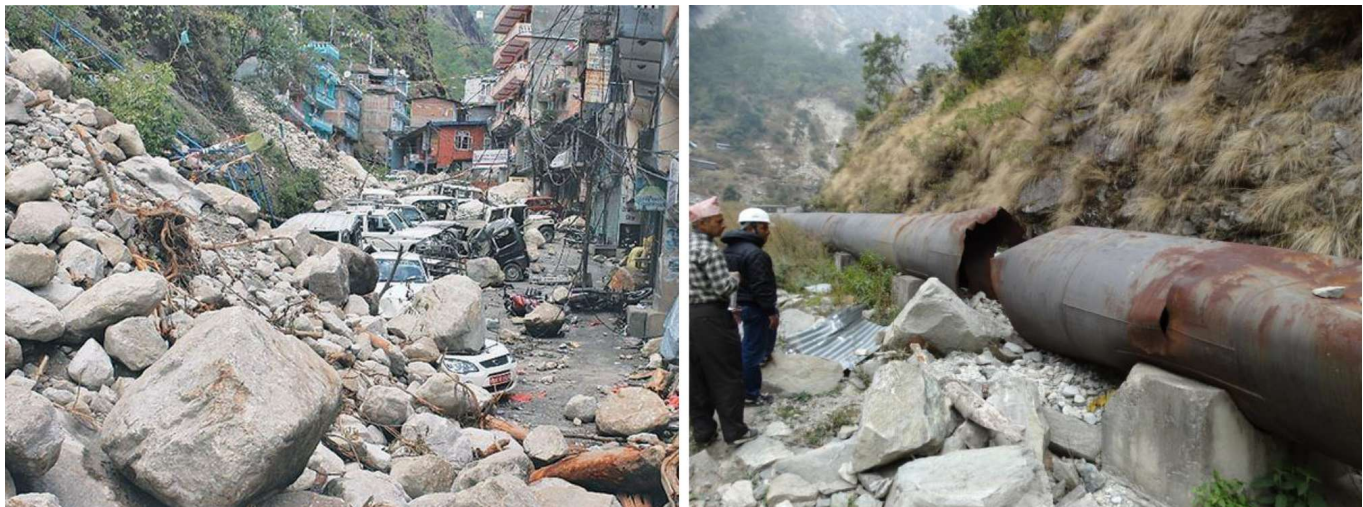
damaged by slides and rock falls (Fig. 2). Likewise, diversion weir, settling basin and penstock pipe of the Mailung Hydropower Project in Rasuwa, located at the base of steep rock cliff were severely damaged by rock falls and slides (Fig. 2).

Fig. 2: Severely damaged Tatopani village (Photo: Kantipur) and ruptured penstock pipe by landslides and rock falls of the Mailung project

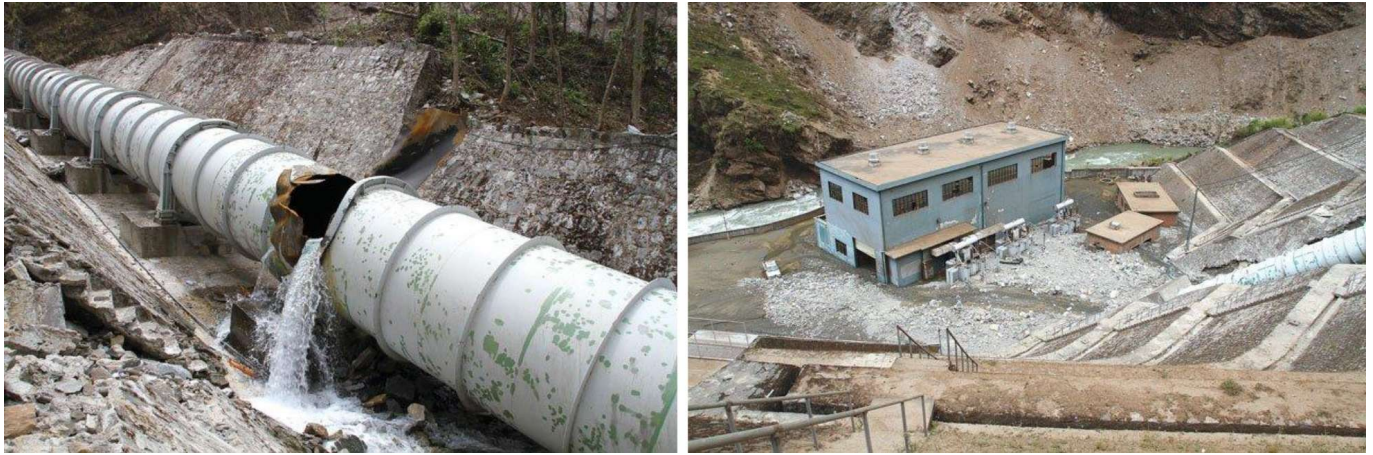
Fig. 4: Ruptured penstock pipe by rock falls and flooded powerhouse immediately downstream (Photo: Kantipur Daily)

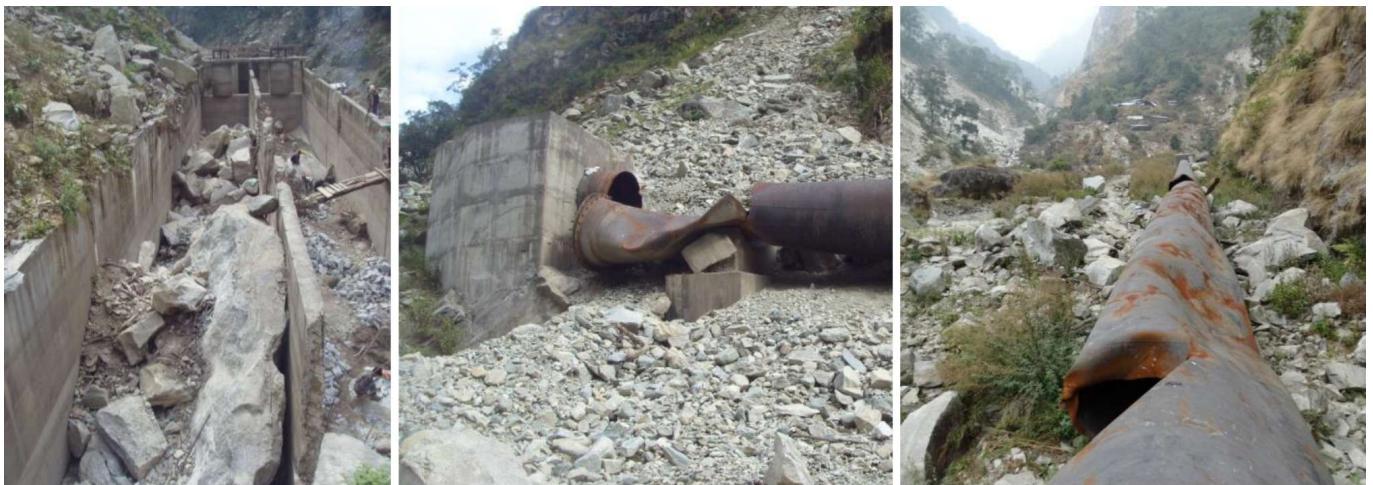
Fig. 5: Damaged settling basin and ruptured penstock pipes

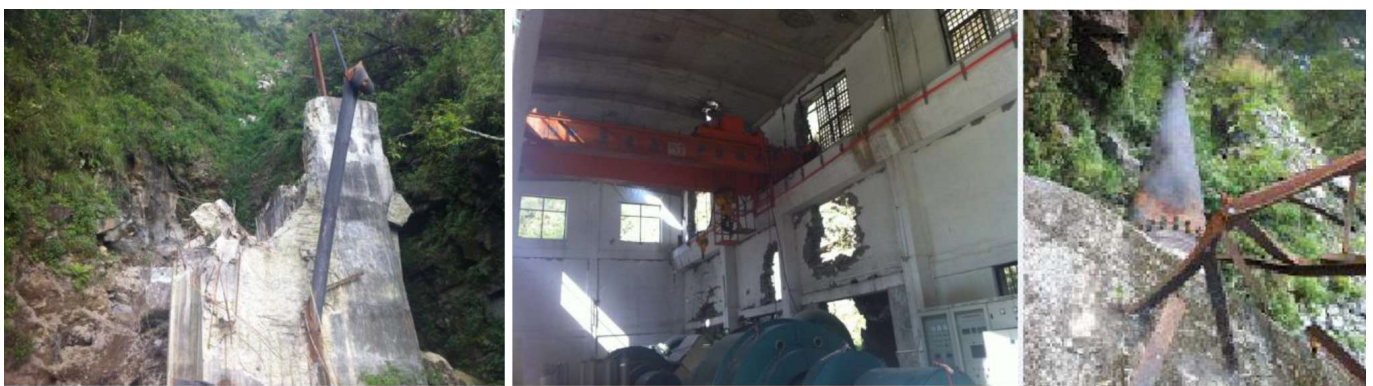
(Fig. 6). Similarly, 165 m length (21%) of surface penstock pipe were ruptured and squeezed by rock falls. Rock falls made several holes in wall on slope side and roof of powerhouse like bullet s.

Fig. 6: Destroyed Forebay, punched powerhouse walls/roof and squeezed penstock pipe (Photo: Soyuz Gautam)

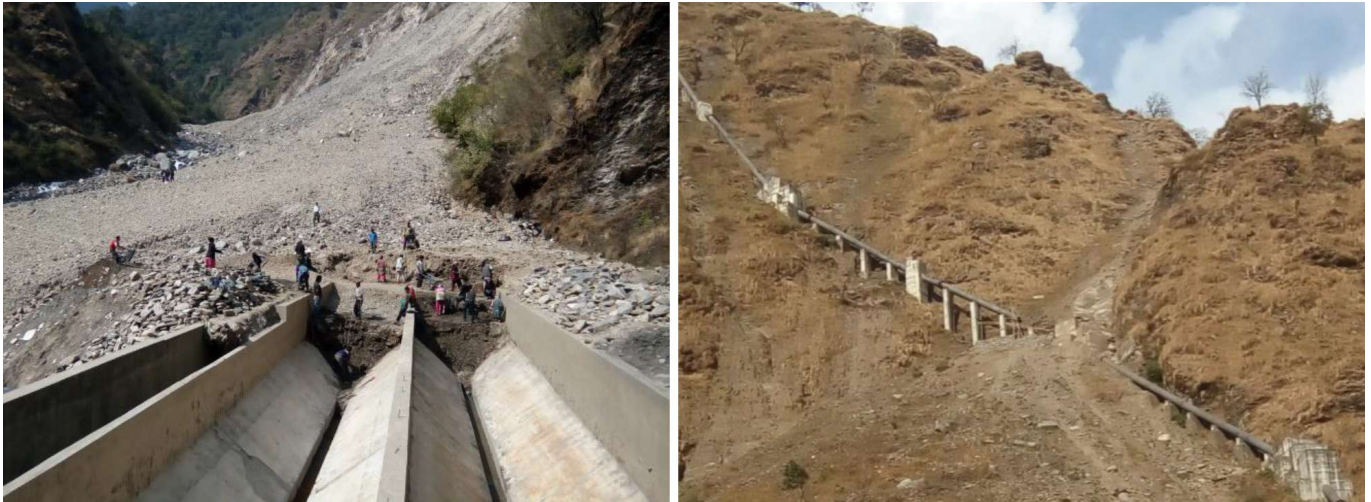
east of Kathmandu, Nepal. Major components are diversion weir, surface settling basin, 695 m long headrace tunnel (2.2 m wide and 2.5 m high), surge shaft, 250 m long surface penstock and surface powerhouse. Diversion weir built downstream of old landslide was completely buried by landslide (Fig. 7).

Shotcrete in the headrace tunnel was cracked in few places. Penstock pipe built along steep hill was also ruptured at one place by the landslide (Fig. 7) and punched at few places by rock falls. Powerhouse located at the base of hill was punched by rock falls whereas the switchyard was damaged by landslides.

Fig. 7: Buried weir, re-excavated settling basins (Photo: Bishwo Vijaya Shrestha) and ruptured penstock pipe
