## **Streambank erodibility and lateral instability hazard in the Manahara River, Kathmandu basin, Nepal**

**\*Pramila Shrestha and Naresh Kazi Tamrakar**

*Central Department of Geology, Tribhuvan University, Kathmandu, Nepal*

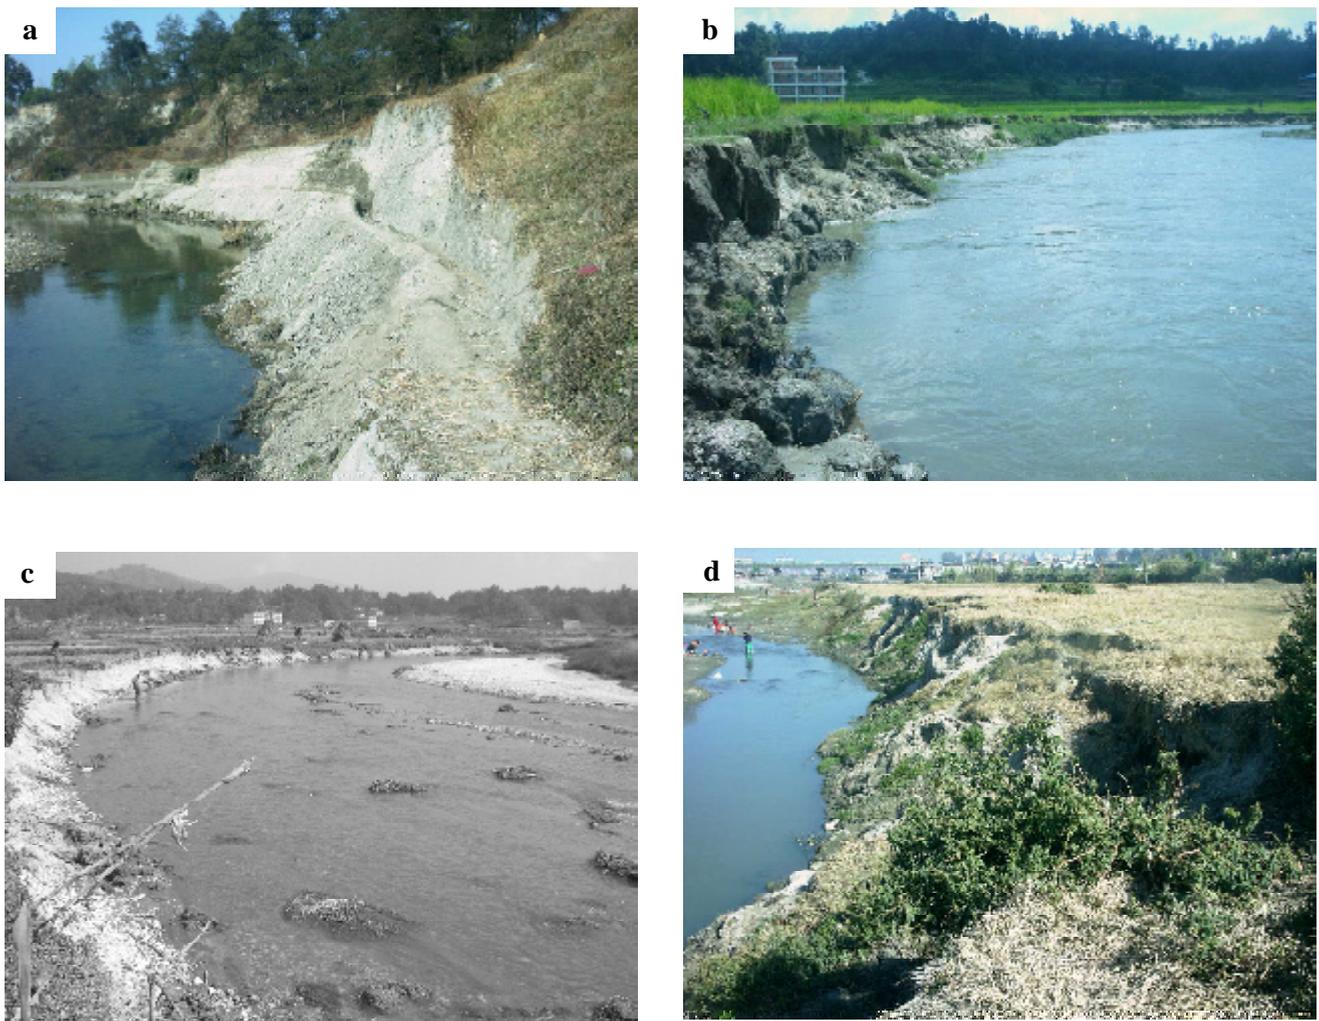
riverbanks exhibit erosional scars (Fig. 2d). The riverbed and bar materials comprise pebbly sand. Floodplains are widely developed in the fifth-order stream, and are composed of silt, sand, and gravel.

**Fig. 2: Photographs showing (a) bank height and material at Salambutar, (b) bank material and its erosion at Mulpani, (c) concave bend of Manahara River at Somathali, and (d) bank failure at Sano Thimi**

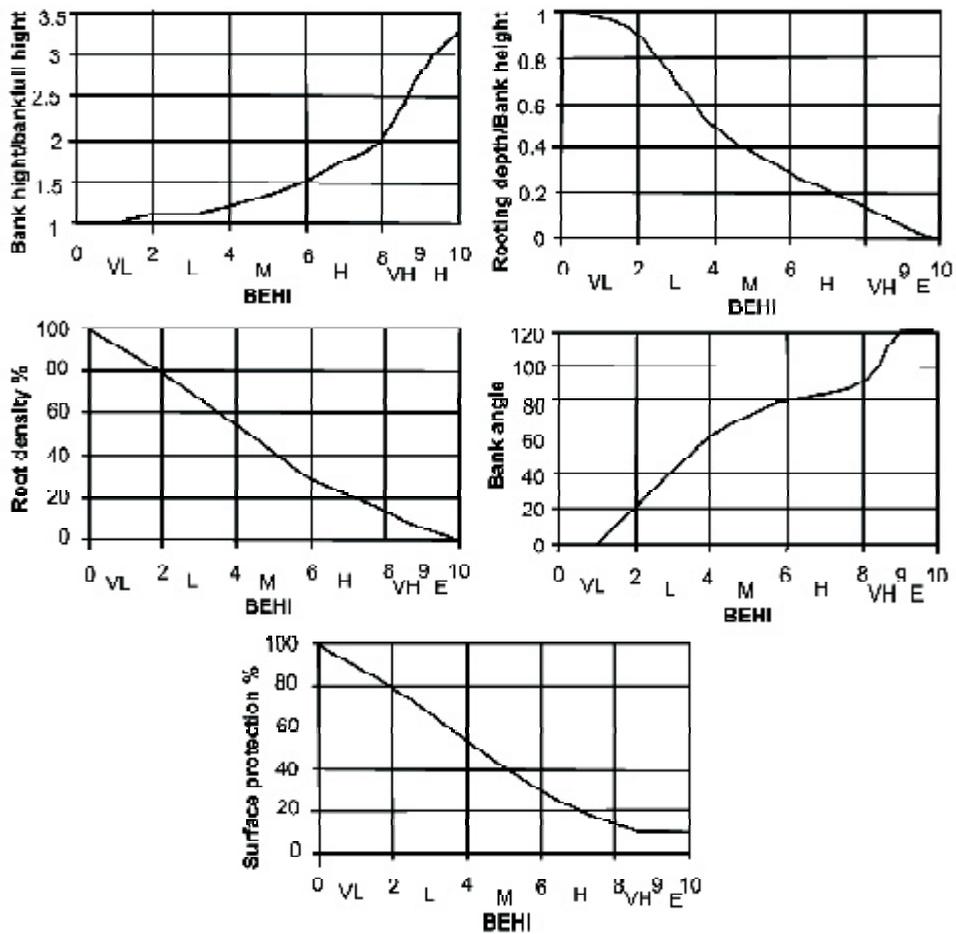
Generally, a higher BHR indicates a higher susceptibility to erosion. The slope of streambank is an indicator of its erosion rate. Vertical slopes or cantilever banks generally exhibit high erosion rates. In the Manahara River, streambanks are steep (Fig. 7) at all the locations and fall on a high to very high category of hazard levels (Table 2).

Fig. 3: BEHI attributes plotted against hazard ratings: VL = very low, L = low, M = moderate, H = high, VH = very high, and E = extreme hazards (after Rosgen 1996)

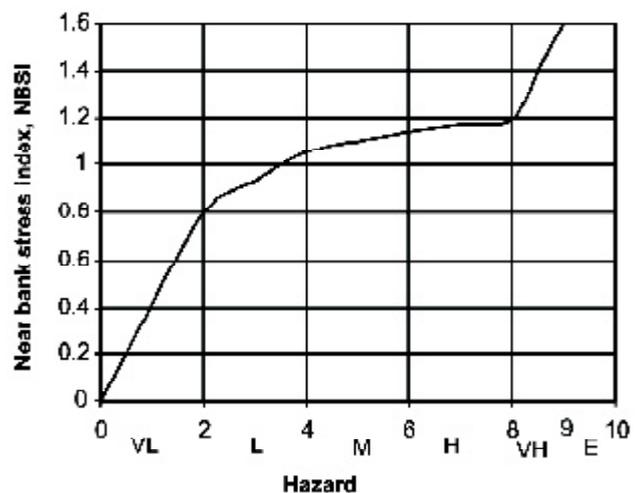
Fig. 4: NBSI attributes plotted against hazard ratings: VL = very low, L = low, M = moderate, H = high, VH = very high, and E = extreme hazards

Then, NBSI (ratio of  $\tau_{nb}$  to  $\tau$ ) was calculated. The values of NBSI were then converted to a hazard rating system (Fig. 4, Table 1). If the near-bank shear stress is greater than the tractive shear stress, the flowing river water is capable of eroding the banks.

results show that the banks of the Manahara River are subject to very high near-bank stresses. At the locations where NBSI is very high to extreme (e.g. Kurthali, Mulpani, Sano Thimi), the lateral erosion is also remarkable (Shrestha 2007).

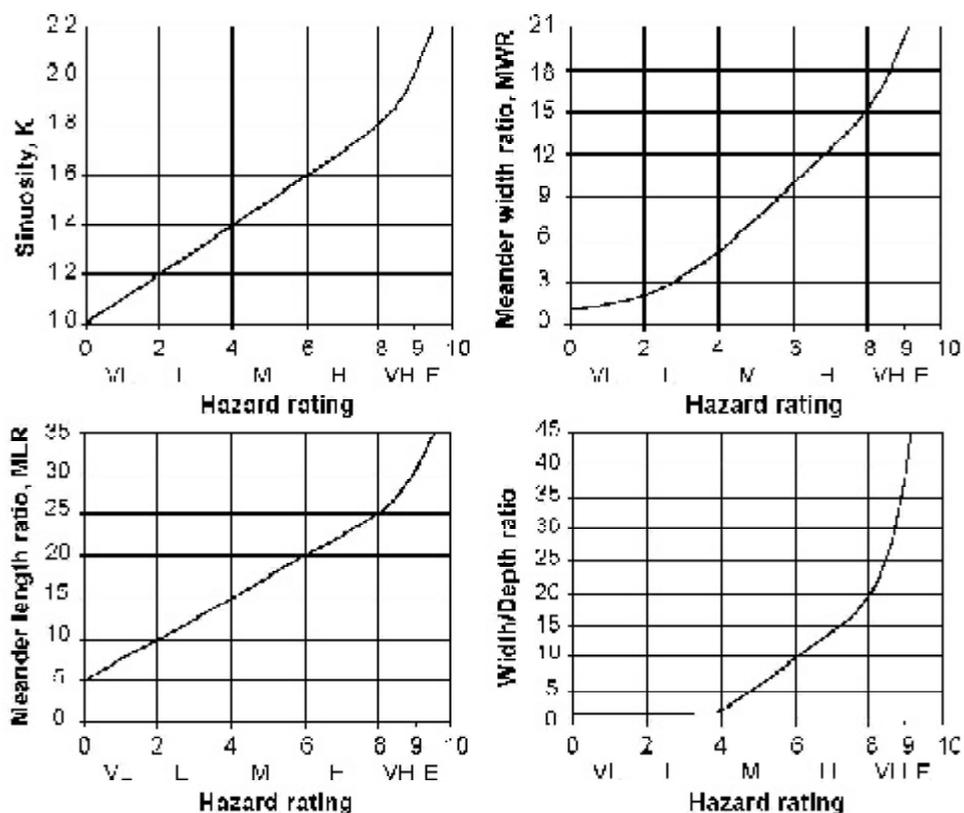
Fig. 5: LIHI attributes plotted against hazard ratings: VL = very low, L = low, M = moderate, H = high, VH = very high, and E = extreme hazards

The results of lateral instability hazard are indicated in Table 4. Except for one location (V13), LIHI ranges from moderate to high. Very high LIHI is due to high values of almost all the planiform parameters. MWR and K largely influence the hazard rating, as increased MWR and K increase LIHI.

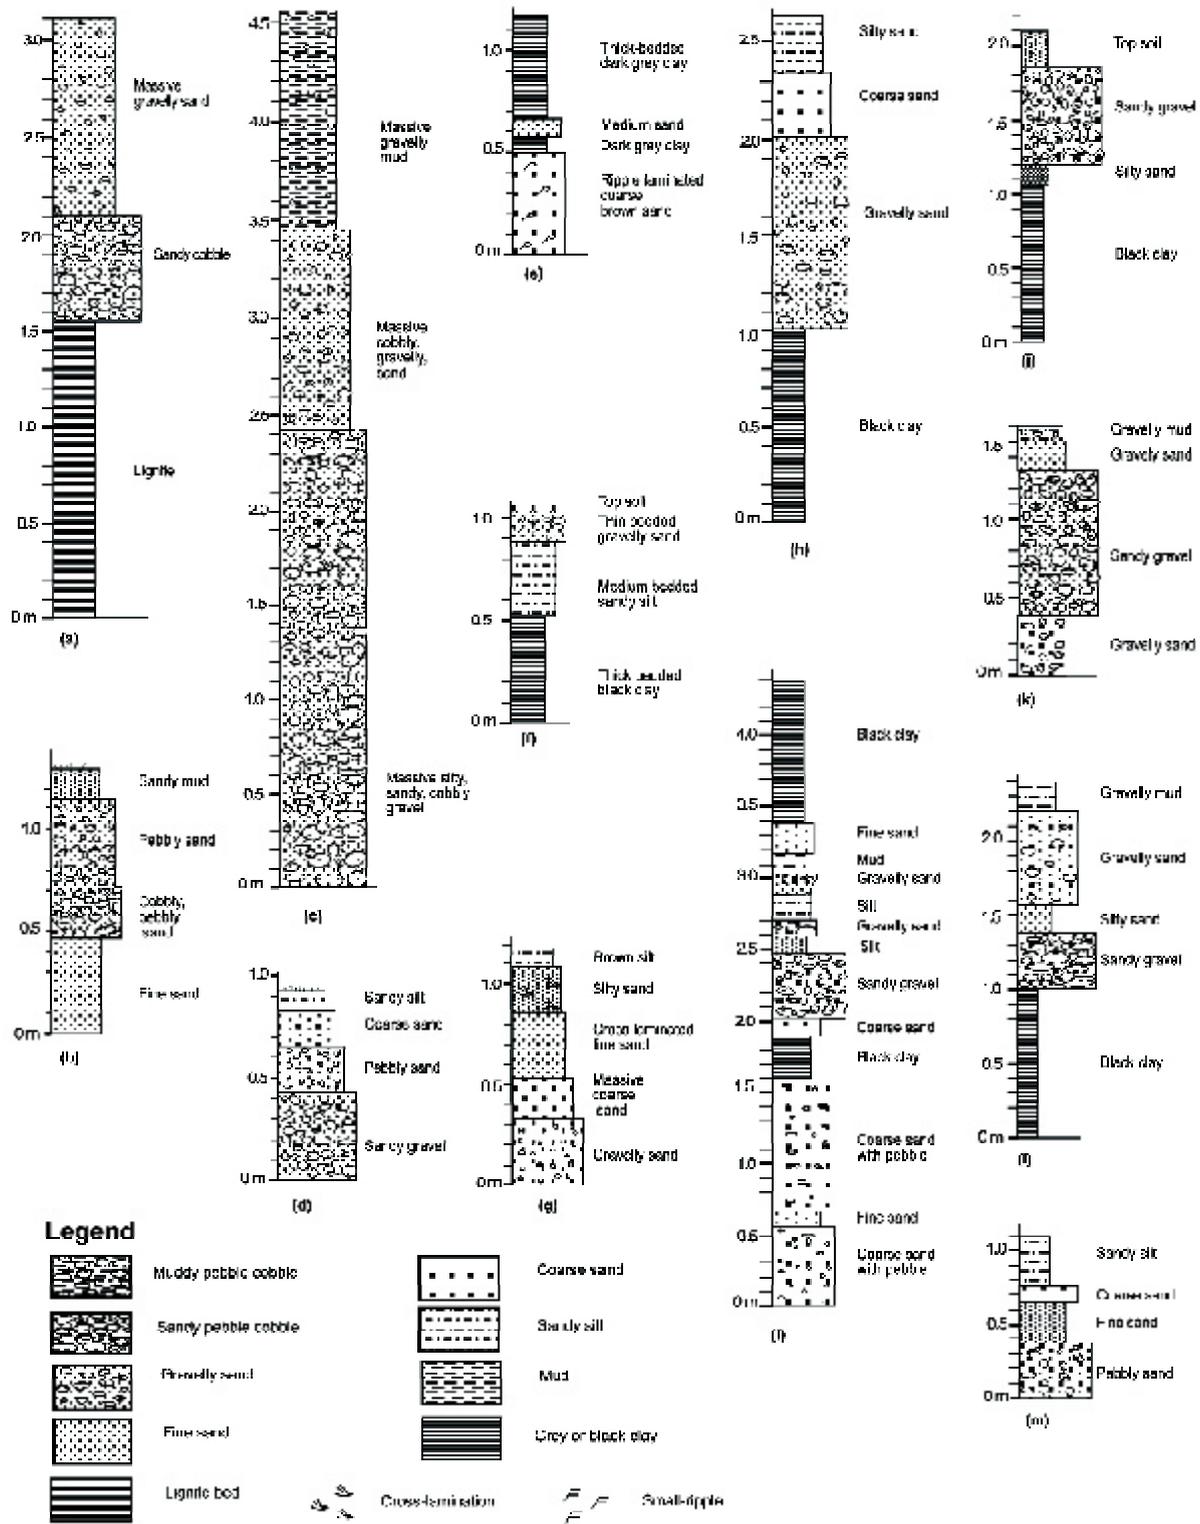
pebbles, sand, silt, and clay of the basin-fill sediments (Figs. 6b, 6c, 7). In the downstream stretches, black clay or silt and clay beds underlie sand and gravel. In the Sano Thimi area, silt and sand lamina are dipping at an angle of 40 degrees and on top of them are horizontal sand and gravel beds (Fig. 6d). Except at some locations where bedrock and black cohesive clay are exposed, most of the bank materials are made up of cohesionless sediments (Fig. 7).

Fig. 6: Lithologs of bank materials in the Manahara River at (a) V2 (see Fig. 1 for location), near Sankhu; (b) V3, near Salambutar; (c) V5, near Salambutar; (d) V7, near Kurthali; (e) V11, near Mulpani; (f) V12, near Mulpani; (g) V14, near Somathali; (h) V15, near Somathali; (i) V16, near Bodegaun; (j) V17, near Bodegaun; (k) V18, near Magargaun; (l) V19, near Magargaun; and (m) V20, near SanoThimi

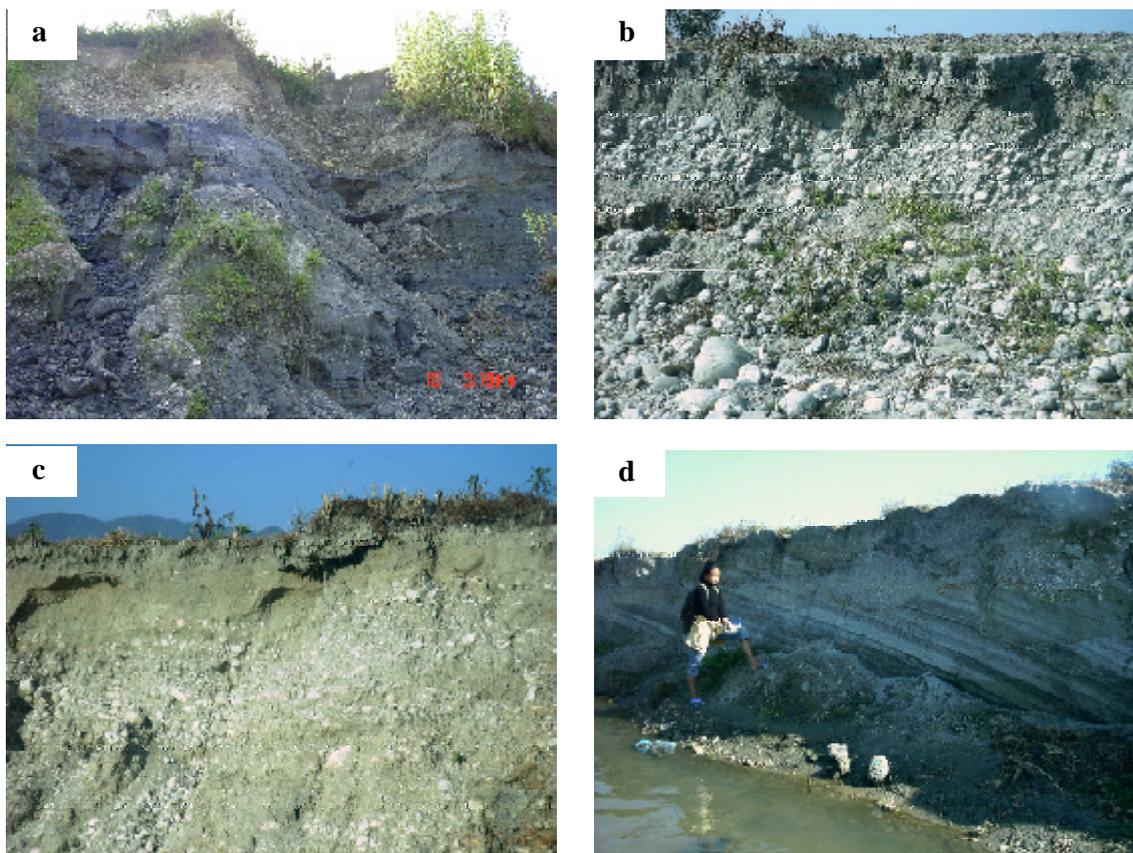
**Fig. 7: Photographs showing (a) gully erosion on sandy cobbles and gravelly sand at Sankhu, (b) riverbank at Salambutar composed of sandy cobbles and thin vegetation cover at Salambutar, (c) sandy gravel and gravelly sand in the riverbank at Kurthali, and (d) Inclined strata of clay and silt (i.e. Thimi Formation) at Sano Thimi overlain by sandy gravel of the Manahara River**

Unconsolidated and cohesionless bank material distributed in most of the places of the river offer low resistance to shearing force of stream. Poor riparian vegetation seems to be one of the influencing factors aggravating bank erodibility hazard in the river. Low root depth ratio and low root density greatly increase BEHI. The canopy cover (overstorey and understorey) distributed in the fourth-order stretches is good in terms of bank material protection from the erosion as the root depth of these vegetation exceeds 1 m and the root network also supports sediment. Because understorey and ground cover mostly represent the riparian vegetation of the fifth-order main stem, the roots hardly exceeds 1 m in length and their network supports only the upper few centimetres of soil. Therefore such vegetation is not strong enough to protect the banks. However, the vegetation helps to prevent sheet erosion and raindrop impact.

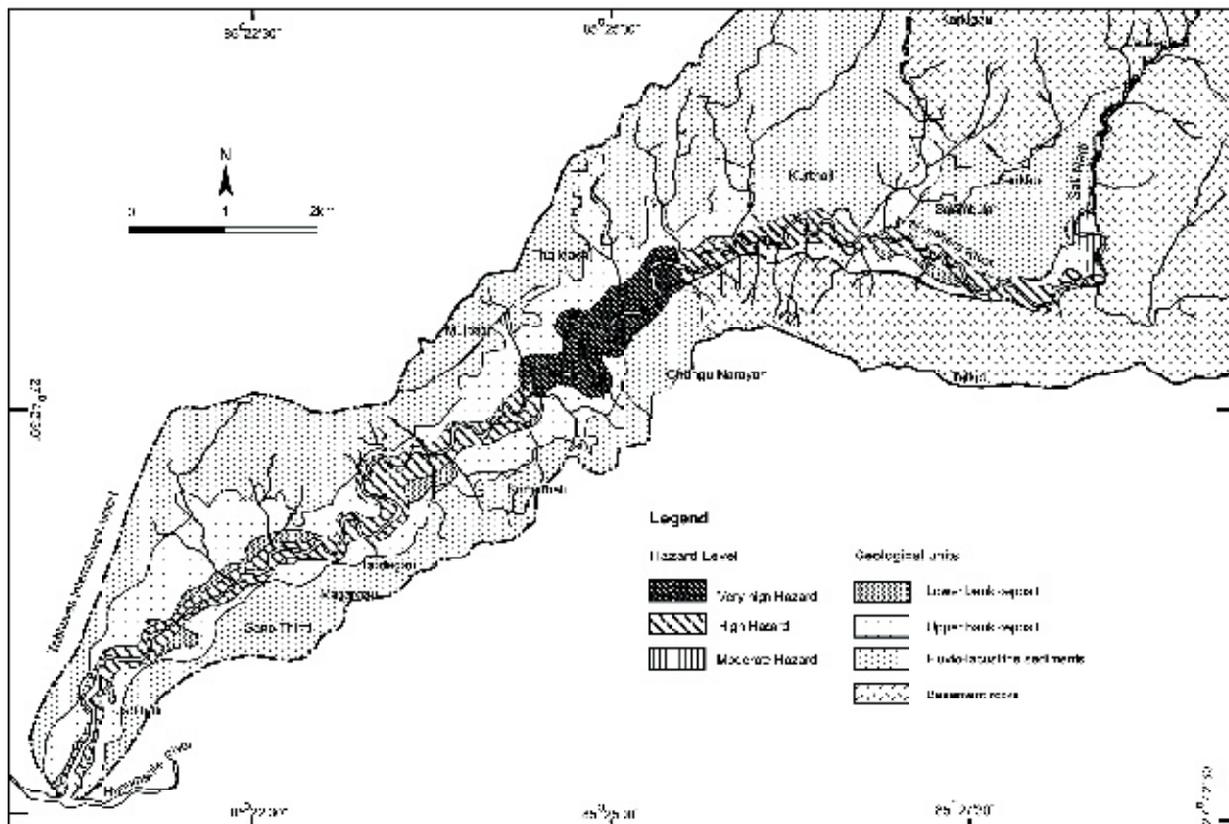
**Fig. 8: Map of the Manahara River indicating BELI hazard levels**

The results obtained from the above four major parameters (i.e. BEHI, NBSI, LIHI, and AD) were combined to obtain a final BELI hazard map (Fig. 8, Table 5). It shows that the riverbanks having moderate hazard (V1 and V2) are located upstream from the confluence of the Sali Nadi and the Ghatte Khola. The riverbanks with very high hazard (V11, V12 and V13) are observed in the Mulpani area. The riverbanks from Salambutar to Kurthali and Somathali to Jadibuti are characterised by high bank erodibility and lateral instability hazards (Fig. 8).

The major causes of accelerated bank erosion in the study area are human encroachment, lack of riparian buffer zone, and loose sediments constituting the banks. Besides, neotectonics and river meander length or belt migration are the regional causes responsible for the bank erodibility and lateral instability hazard in the river.

gravel excavation from riverbeds, effluent discharge into river, and bank encroachments) is a way to minimise the hazard level, but it is not enough. One of the most effective ways to reduce the hazard is to establish riparian vegetation buffer zones with diverse plant species that produce a strong root network.
