# Landslide hazard evaluation in and around the Ilam Hydropower Project, Eastern Nepal Himalaya

# \*Deepak Chamlagain and Vishnu Dangol

#### **ABSTRACT**

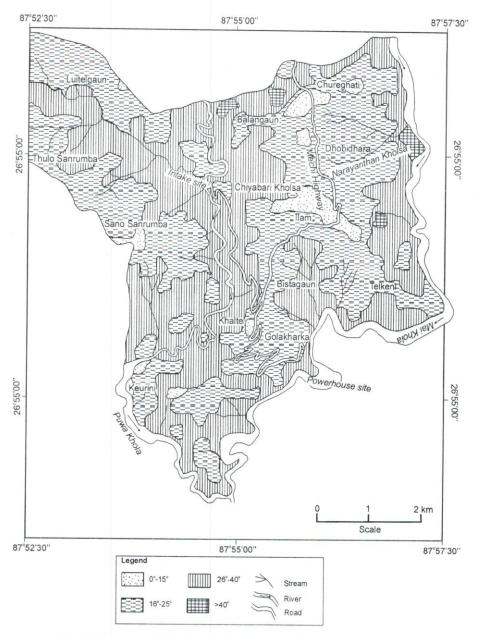
Fig. 3: Slope map of the Ilam hydropower project and adjacent area.

The area is characterised by the varied topography. The slope angles of the area are divided into the following four categories: 0°-15°, 16°-25°, 26°-40° and >40° (Fig. 3). The landform is controlled mainly by tectonic processes and subordinately by mass wasting. The erosional landforms predominate over depositional ones. Rugged hills, numerous deep gorges along the Puwa Khola, steep slopes, quartzite cliffs and active gullies, e.g. the Narayanthan Kholsa and Chiyabari Kholsa, represent the erosional landforms. River terraces, alluvial fans along the Puwa Khola and Mai Khola, talus cones of various landslides are the main depositional landforms. The Mai Khola is the trunk river and its major tributaries are the Puwa Khola and Ghatte Khola. The Mai

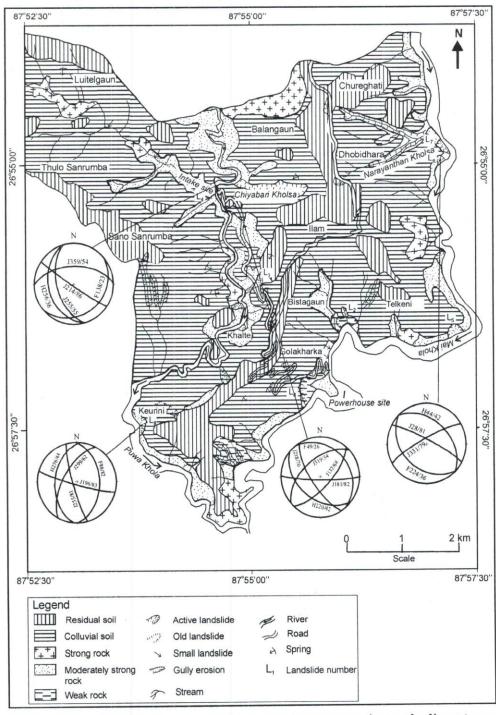
Fig. 4: Engineering geological map of the Ilam hydropower project and adjacent area.

of quartzite varies from rough to stepped in small and large scale respectively. On the basis of above parameters, rock mass of the study area was classified as high, medium and low rock mass strength (Fig. 4).

Geometry of rock mass and natural hill slope govern the stability of rock slope. Statistical analysis of fourteen rock slopes carried out by using lower hemispherical projection (Fig. 4). In the intake site and south of Chiyabari Kholsa, central and lateral wedges are prominently developed but

are not daylighted indicating stable rock slopes. Similarly, the discontinuities at  $L_1$  form central wedge, which is not daylighted. Typical plane failure was observed at the location  $L_2$ . Toppling failure observed in location  $L_6$  where foliation plane (224°/36°) dips at gentler than natural hill slopes (044°/42°) in opposite direction. The type and mode of failure are important to assess rock slope hazard. Thus the modes of failures were rated individually during the preparation of rock slope hazard map.

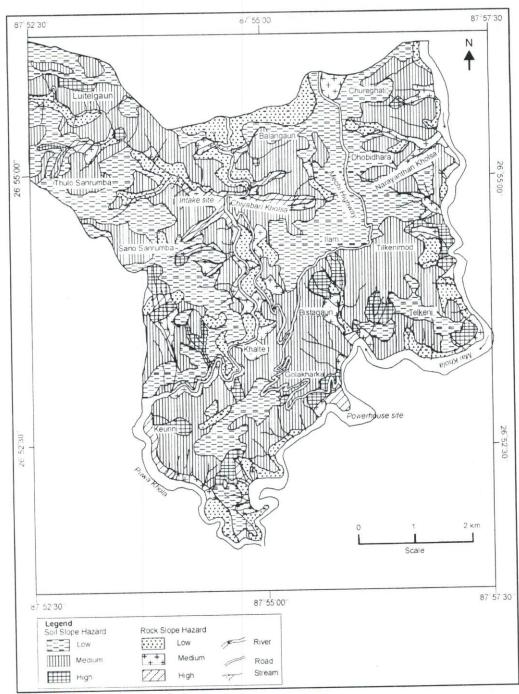
Fig. 9: Hazard map of the Ilam hydropower project and adjacent area.

Various levels of hazard and their location are shown in Fig. 9. The most hazardous zones in the study area lie along the Puwa Khola, Mai Khola and in the active gullies. The main causative factors for landslide hazard in the study area are steep slope, rock discontinuity, land use pattern, soil depth and hydro-geological condition. High hazard zones

are confined near Sanrumba, Luitelgaun, Keurini, Golakharka, Powerhouse site and Mahabhir north of Dhobidhara etc. Medium hazard zones are confined around Luitelgaun, Tilkenimod, Bistagaon. The remaining parts of the study area lie in low rock and soil hazard.

normally no natural disaster occurs. The medium hazard region can be made safe and stable with mitigating measures. But high hazard zones are difficult to stabilise and sometimes impossible too. It is better to avoid for the construction of large infrastructure, settlement and cultivation.
