Quality control test of fixed x-ray units at Bir hospital and National trauma center

K. P. Adhikari*, K. S. Nyaichyai*, B. B. Chand**, H. Khadka***, S. Sharma***, T. Khanal****

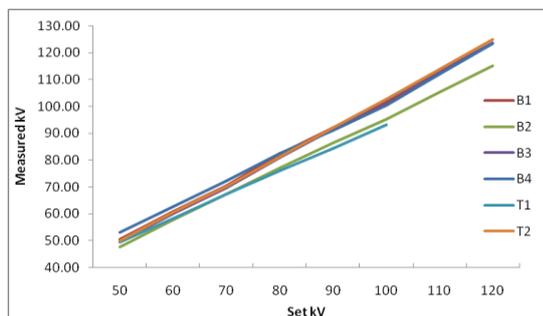
Figure 1: Relationship between applied and observed voltage

At a fixed value of current and time, exposures were done for various tube voltages of different machines. Test was performed from 50 kV_p up to 120 kV_p tube voltages, at fixed tube current 200 mA and an exposure time of 0.1s. The obtained graph is shown in Figure 1.

For a fixed applied tube current average of observed voltage was calculated. Percentage deviation between applied and observed voltage is calculated and found to have fairly good kV accuracy. However, inconsistent kV_p accuracy was found in two X-ray units with highest deviation at -6.9% greater than 5% tolerance limit. This meant that these

machines need calibration and to be adjusted to be within 5% kV_p accuracy. Besides that, in one equipment all the measured kV were less than the set kV.

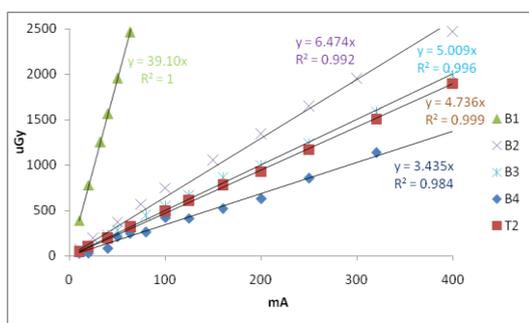
Figure 2: mA linearity

mA linearity test was done for both small focal spot and big focal spot sizes. The linearity tests were done with kV value fixed at 80 kV and time set at 0.1 sec while applying variable mA values from 10 to 400 mA where applicable. However with higher mA values errors were introduced hampering the data acquisition.

In the graph above, lesser data acquisition, up to 71 mA only, was done for the equipment B1. The linearity graph shows that all of the equipment has excellent linearity close

to one R² values except for the equipment B4 which has the least R² value. The probable reason for this mediocre performance might be that this machine has not been used routinely for a long period of time of around 4 years in its life time of about eight years.

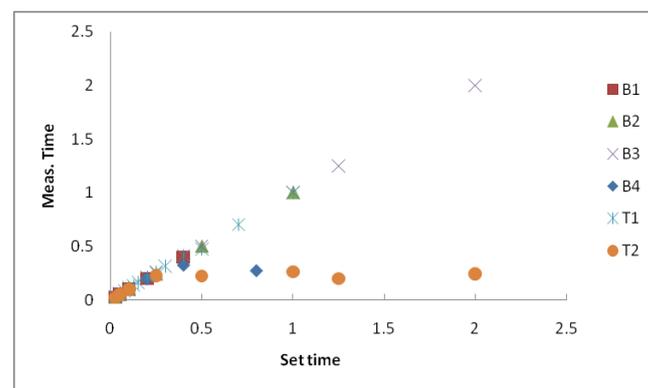
Figure 3: Relationship between applied and measured time

At fixed voltage and current, measurements were carried out for varying time. The observed graph of different applied values of mAs is shown in Figure 3.

It was observed that at three X-ray unit, the deviation of the measured time and set time were within the tolerance limit of 5% whereas for other equipment the deviation was as high as -65.9% for one unit and respectively 30.3% and -87.8% for other two X-ray equipment. Similarly, it is also observed that three X-ray equipment have consistent $\mu\text{Gy}/\text{mAs}$ with coefficient of linearity less than the tolerance value of 0.1 while the other machines with large deviating timer value, the coefficient of linearity were greater than the tolerance value.

It is also observed that equipment B4 has irregular response for the measured and applied time, the probable reason being it an old machine without any maintenance and was also not used for a long period.

Meanwhile the response for the T2 machine is troublesome as it is being used routinely and excessively. Proper maintenance of that machine is recommended promptly.
