Evaluating the Effectiveness of Sinkhole Mitigation and Its Impact on the Local Community: A Case Study of the Armala Sinkhole, Pokhara, Nepal

Mahendra Bhattarai, Sanjay Baral*, Badri Adhikari

School of Engineering, Faculty of Science and Technology, Pokhara University, Nepal

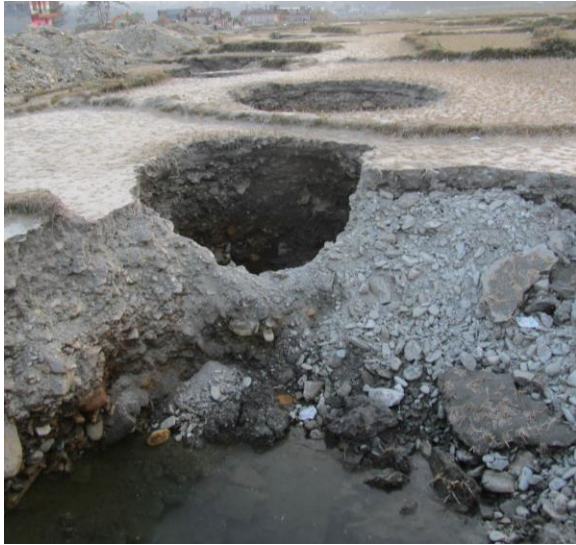
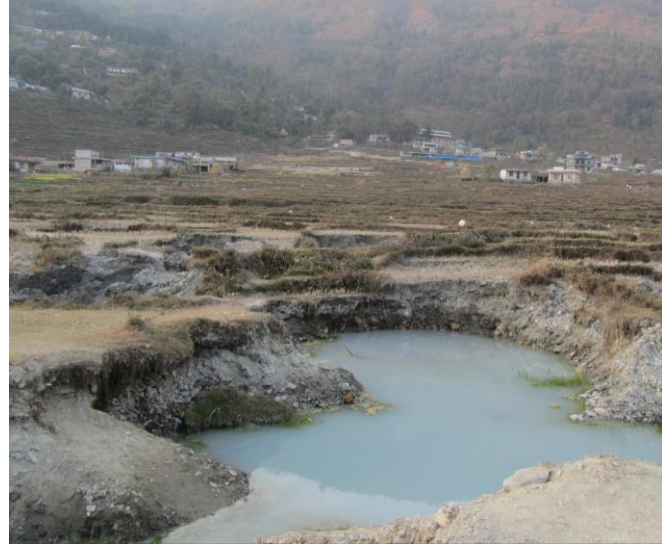
The field visit was performed in February 2014 and January 2023. Series of sinkholes was observed during 2014 (figure 4(a)). Muddy, silty water observed at the sinkhole (Figure 4(b)) serves as proof of underground erosion and cavity formation in the impacted area. Local people reported seeing muddy water flowing from the riverbank of Kali Khola, just below where Duhuni Khola joins it. Figure 4(c) shows signs of a subsurface water flow at the base of a

(a) Series of sinkhole formation and accumulation of spring and precipitated water

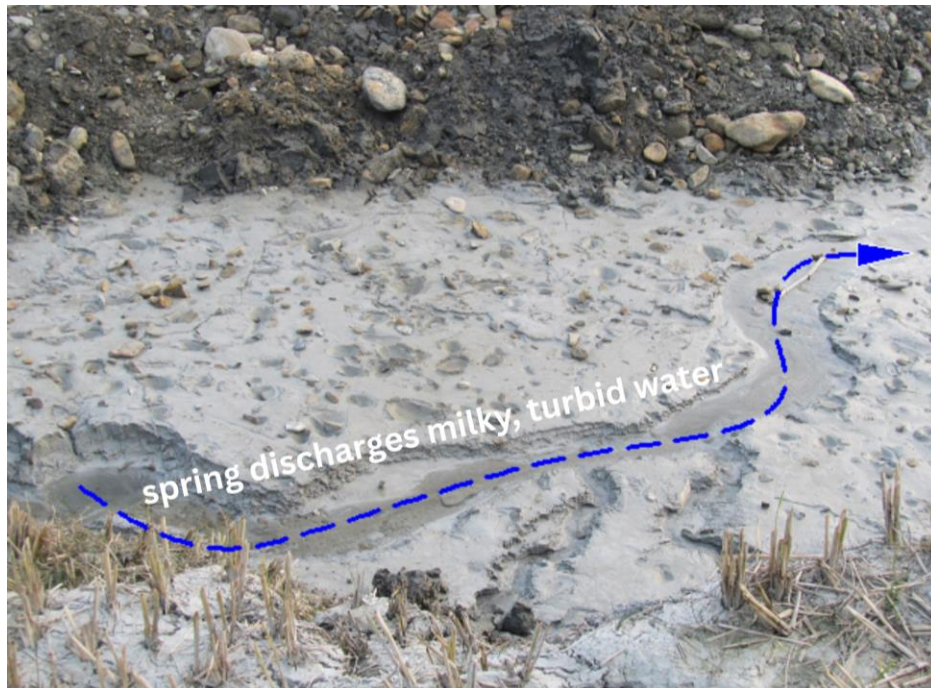
(b) A sinkhole showing the formation of milky water spring

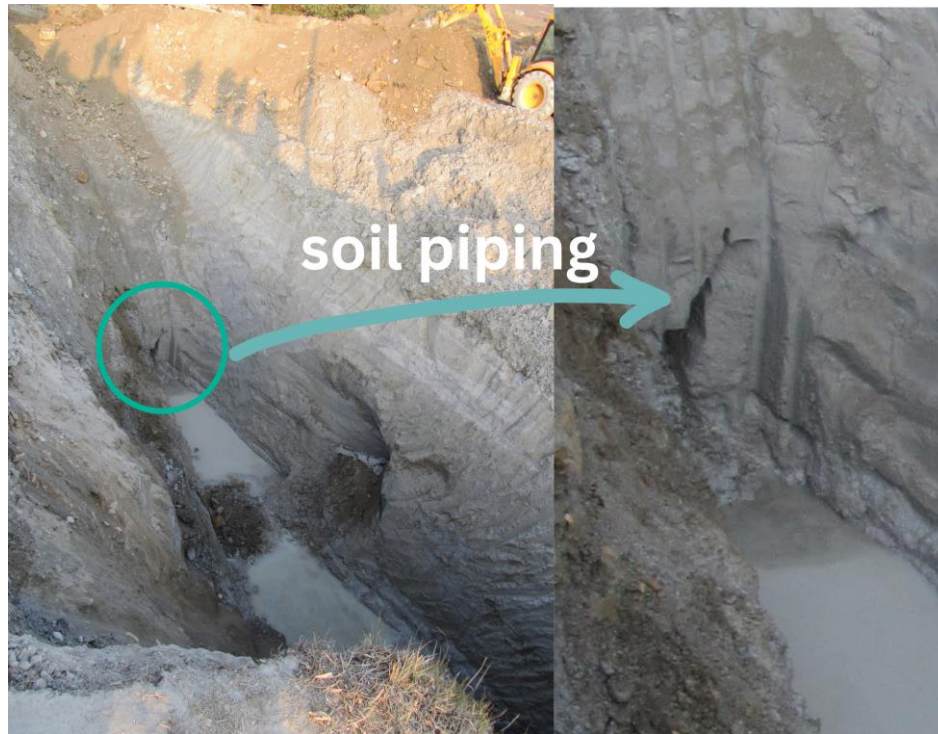
sinkhole. Soil pipe had formed within a white silty clay layer and was surrounded by milky, turbid water.

(c) One of the sinkholes revealed the presence of a soil piping

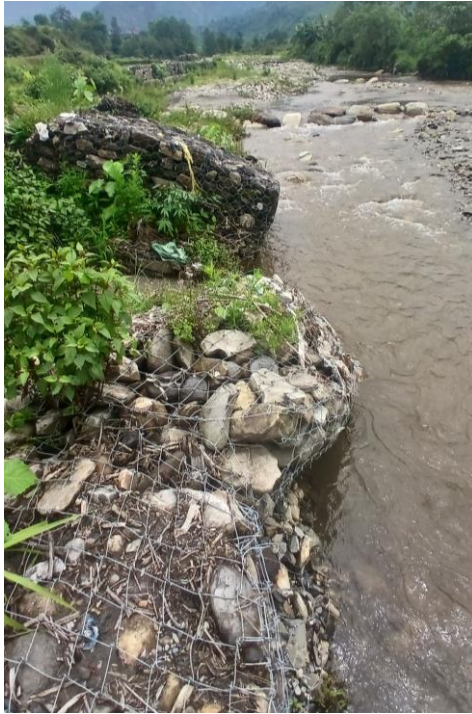
a) Gabion wall in the verge of failure at the right bank of Kali Khola

Many of them are either partially or completely damaged, and no significant efforts have been made by the responsible authorities to repair or reconstruct them. The materials used in construction were also found to be of poor quality, as concrete layers have been eroded by water. Additionally, the Bio-Engineering and Geo-Textile measures were poorly constructed and inadequately implemented. By comparing the field inspection results with public perceptions collected during the survey, it is evident that the authorities have failed to provide adequate attention, maintenance, and reconstruction of the existing structures. Moreover, minor sinkhole formations have been reported recently in certain parts of Armala (Figure 6).

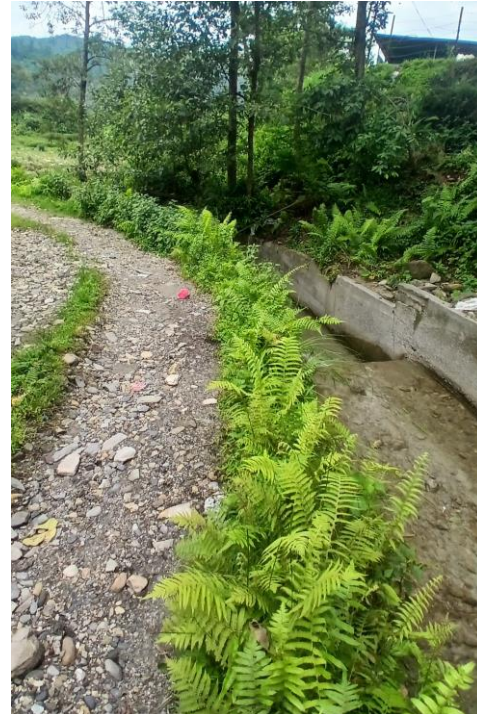
b) Concrete channel to convey Duhuni Khola

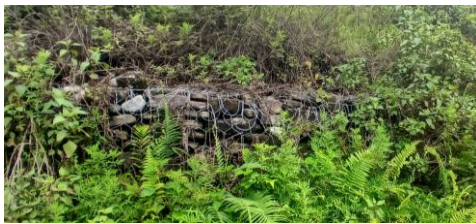
c) Bulging gabion wall

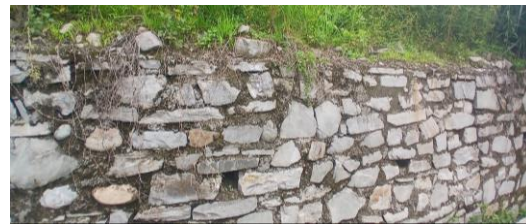
d) Dry masonry retaining wall

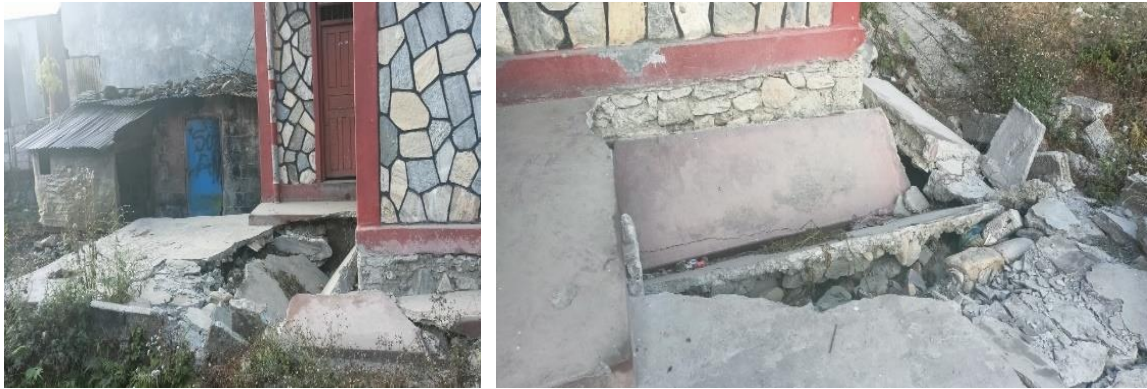
Figure 6: Picture of Sinkhole Affected Building

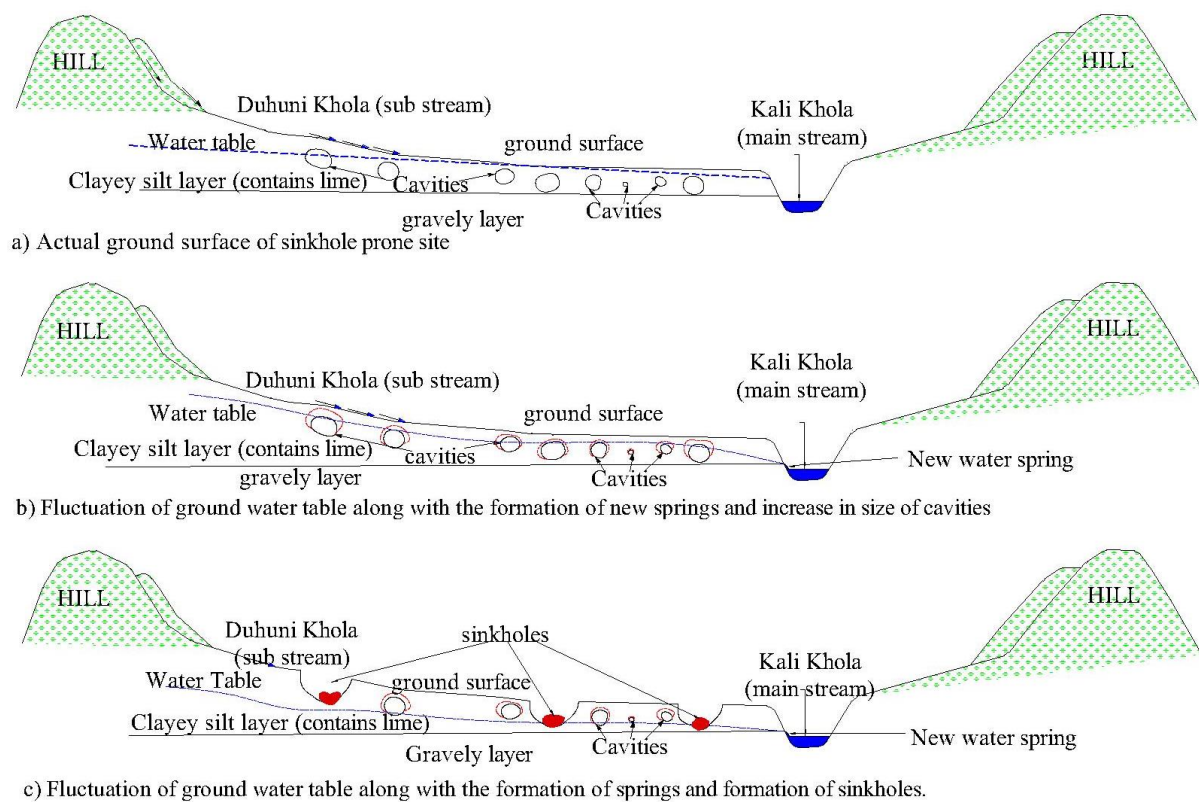
Figure 7: Possible cause of sinkhole formation in Armala regions, of Pokhara Metropolitan City

The possible cause of sinkhole formation in Armala is primarily due to groundwater dynamics and internal erosion of soil. In the long run, groundwater flow gradually dissolved the soluble calcareous materials [10, 26] in the subsurface soil, creating underground cavities which were stable before 2013. However, after November 2013 new sinkholes were developed in Armala area [26]. This all was attributed by formation of new water spring, sudden fluctuation of groundwater table, particularly during rainy season. Also the seepage from Duhuni Khola and lowering of water level of Kali Khola further increase the hydraulic gradient, accelerating

groundwater velocity. As a result, the dissolution and washing away of subsurface calcareous soils, resulted collapsed of overlying loses and unconsolidated soils into the voids. These all activities resulted in the sudden and unstable formation of sinkholes (Figure 7).
