An Intersection under Stress: Diagnosing Layout and Control Issues - A Case Study at Srijana Chowk, Pokhara

Saroj Dhungana^{1*}

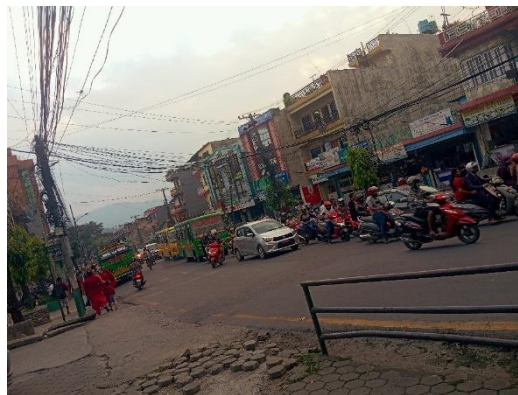
The southern leg, Rastra Bank Road, experienced the longest queue buildup, with a maximum queue length of 70 meters during the morning peak hour and an average of 35 meters throughout the day. This is attributed to its relatively narrow width (9 m), the presence of a curbside bus-stop only 40 meters from the intersection, and turning conflicts caused by blocked left-turn movements. The northern leg (Ganeshman Singh Road) showed a maximum queue of 40 meters, with a daily average of 25 meters. The eastern approach, though wide, observed a maximum queue of 35 meters, likely due to signal timing issues and right-turn movement delays, averaging 20 meters over the day. The western approach recorded a maximum of 45 meters, averaging 25 meters, likely influenced by combined through and right-turn movement delays near the signal cycle's end.

Figure 5. Long Queue Length in Southern Leg

- The northern approach should be widened by 3 meters over a stretch of 40 meters.
- The southern approach should be widened by 3.5 meters over a length of 50 meters.

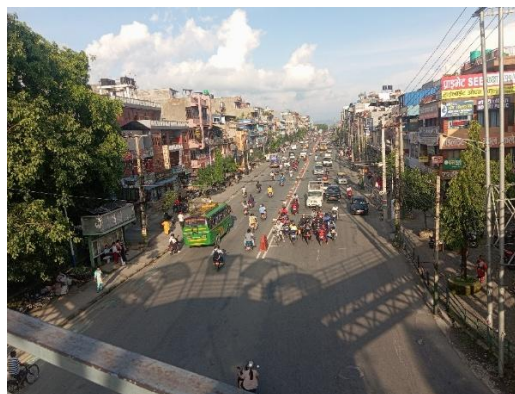
Figure 6. Short Queue Length in East Leg

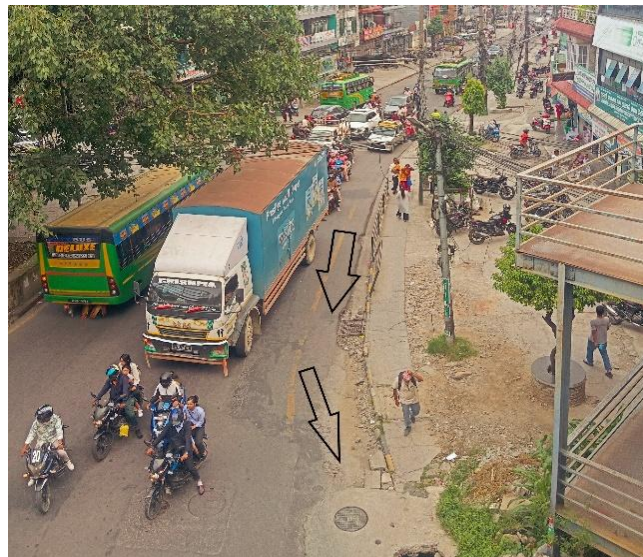
Drivers and traffic police were unanimous in stating that the southern approach (Rastra Bank Road) is significantly under-designed for the current volume of traffic. According to their perception, this stretch ought to function as a four-lane road rather than its existing two-lane configuration. Residents echoed this view, noting that frequent congestion causes discomfort and confusion, and in some cases, forces motorcycles onto footpaths. While the eastern and western legs were generally regarded as adequately dimensioned, the northern leg was considered somewhat congested, though manageable due to lower traffic volume. All three groups agreed that if widening interventions are to be made, they should ideally target both the north and south approaches for balanced flow. Traffic police specifically pointed out that managing lane discipline under such constrained geometry remains challenging, with even minor widening—on one side alone—potentially offering meaningful operational relief.

Figure 7. Left Turn Blocked in Southern Leg

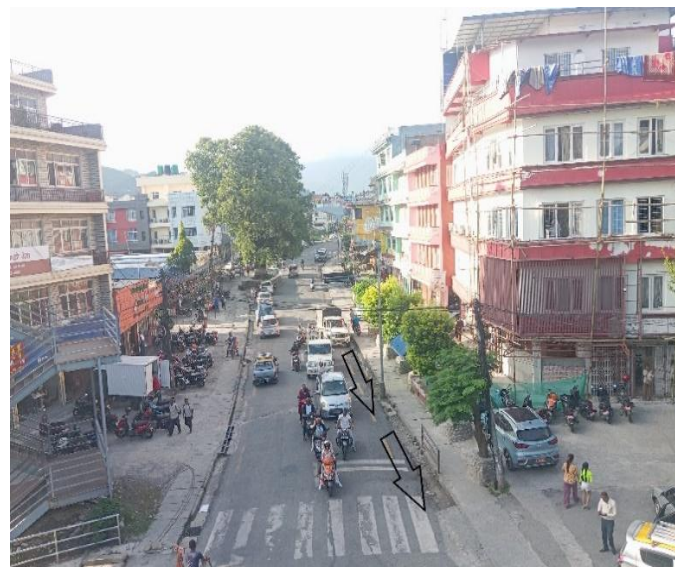
Figure 8. Left Turn Blocked in Northern Leg

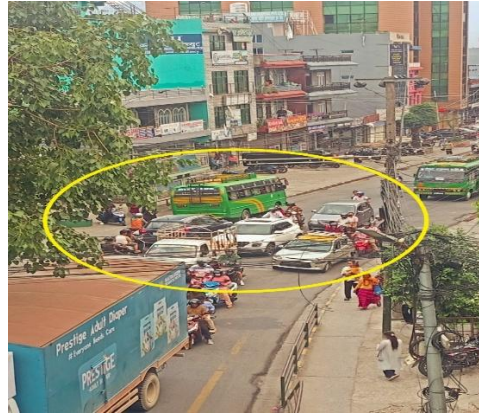
The bus stop located on the southern leg, serving southbound buses, was widely perceived as a major contributor to traffic disruption. Drivers and traffic police reported that public vehicles from at least six different routes converge at this location, leading to one of the two lanes being consistently blocked. Residents highlighted the same issue, noting that buses often stop beyond designated areas and for extended periods, compounding congestion during peak hours. All groups strongly recommended relocating the stop farther downstream and converting it into a recessed bus bay or pocket to separate waiting vehicles from the moving traffic stream. The consensus was that the current arrangement is incompatible with the intersection's operational demands.

Figure 9. Bus-Stop Causing Blockage

The bus stop on the southern approach significantly interferes with lane usage and turning movement. It lacks a proper setback and creates unpredictable stopping patterns that interrupt flow.

- The bus stop be relocated approximately 100 meters downstream from the intersection.
- It be converted into a recessed bus bay, preventing blockage of active lanes.

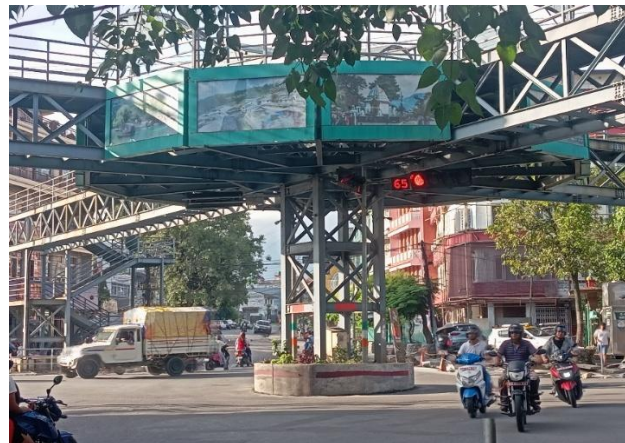
A prominent geometric constraint is introduced by the centrally located pillar of the overhead pedestrian skywalk, which is a circular steel truss structure with a diameter of 4.5 meters. This pillar not only occupies valuable space at the heart of the intersection but also restricts sightlines for drivers, particularly those in smaller vehicles. Additionally, each corner of the intersection is occupied by staircases providing access to the skywalk. These stair structures each measure approximately 4.5 meters by 6.3 meters and further encroach into the intersection's operational envelope, particularly during turning movements. The combined effect of the central pillar and corner staircases results in reduced effective turning radii, tighter merging space, and increased interaction conflicts—contributing to operational inefficiencies and driver confusion during signal transitions.

Perception of the overhead skywalk was largely unfavorable. Drivers expressed concern that the central steel pillar obstructs visibility—especially for microvans and motorcycles—while also creating confusion during turning movements. Vehicles approaching from the west and intending to turn south were particularly affected, with many unsure whether to maneuver around the pillar or initiate their turn in front of it. Residents questioned the necessity of the skywalk altogether, suggesting that appropriately marked zebra crossings would be more user-friendly. The staircases, particularly on the southwestern side, were also criticized for encroaching upon the footpath, reducing walkable space. Traffic police noted that despite the skywalk's intent, most pedestrians continued to use at-grade crossings, further questioning the functional utility of the structure.

Figure 10. Skywalk Structure at Intersection

The central pillar and staircases of the existing skywalk infrastructure significantly obstruct visibility and limit turning movements at the intersection. Therefore, the functional necessity and current design of the skywalk should be critically re-evaluated. Based on feedback from local residents, one recommended option is to remove the skywalk entirely and consider relocating it to Prithivi Chowk, where pedestrian demand and traffic complexity are higher. Alternatively, a suspended or floating skywalk structure—designed without a central pillar—should be explored to eliminate mid-intersection obstruction while still providing safe

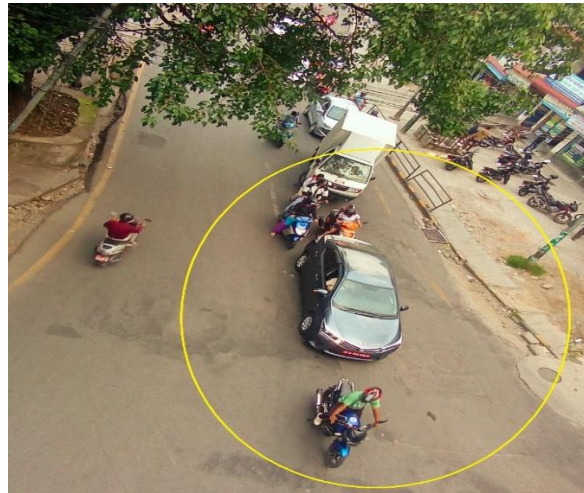
All stakeholders pointed out the poor visibility or near-complete absence of lane and stop markings at the intersection. Drivers reported confusion during signal transitions, especially on the northern and southern approaches, as they were unsure where to halt their vehicles. Residents corroborated these observations, citing erratic vehicle positioning and inconsistent turning behavior. Traffic police emphasized that while minor

violations could be penalized, widespread disregard for lane discipline—exacerbated by faded or missing markings—was difficult to control manually. The lack of clearly defined lanes contributes to turning conflicts and unpredictable movement, particularly during peak congestion.

Figure 11. Confusion due to Faded Margins

- “No Horn” signage should be installed immediately on all approaches.
- New lane markings must be applied on every leg of the intersection to clearly demarcate stop lines, turning paths, and through lanes.
- Plastic cone medians should be introduced on the west, north, and south legs to guide vehicles, similar to the existing median system on the east leg.

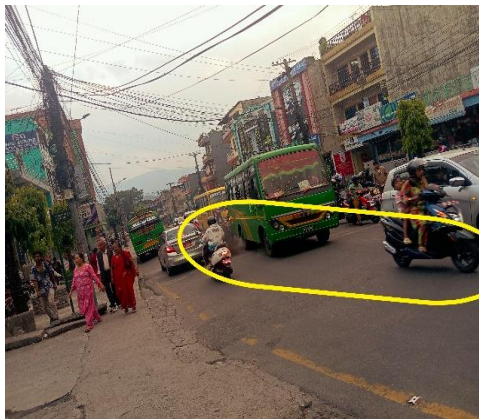
Figure 12. Lane Violations Due to Faded Margins

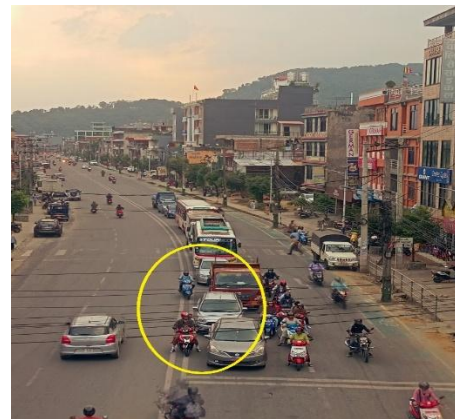
Figure 13. Lane Violations Due to Absence of Median in Western Leg

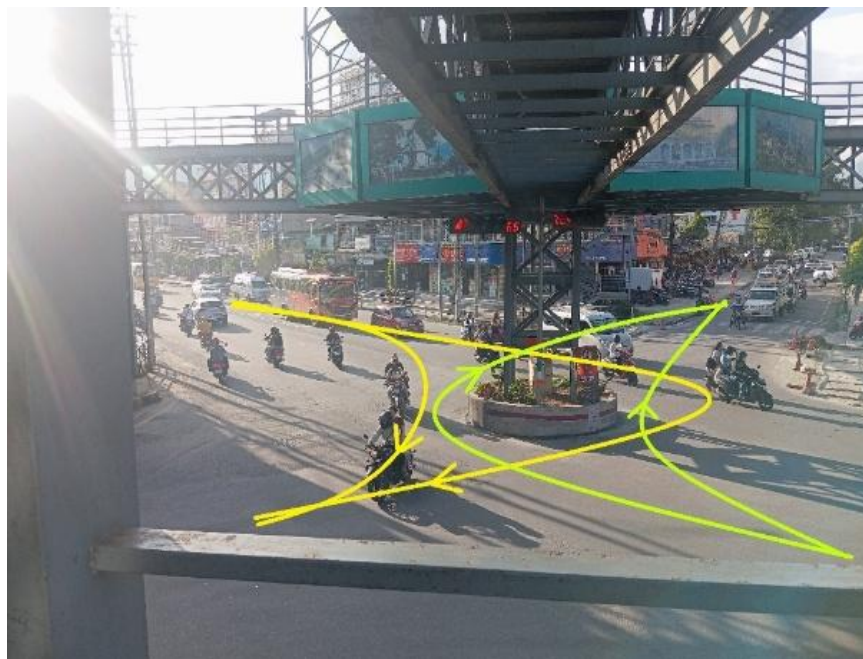
- Most lane markings are faded or fully erased.
- Drivers unsure where to stop; no visible stop lines on northern and southern legs.

Figure 14. Confusion on Turning due to Pillar and markings
