Comprehensive Safety Assessment and Improvement Strategies for the Satdobato-Budhanilkantha Corridor in Kathmandu Valley, Nepal

Abstract

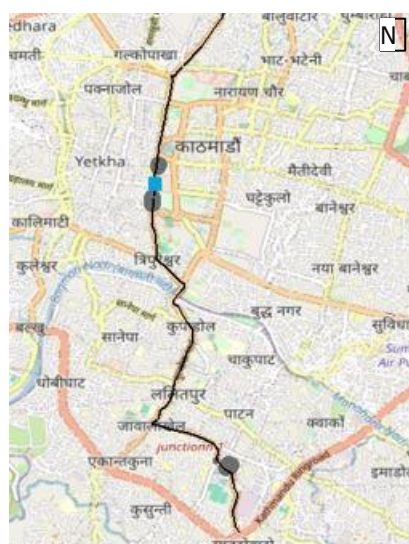
Figure 3. Map of designated parking areas along the route

Parking management was equally problematic, with just 4 designated parking areas (Lagankhel, Ratnapark, Bir Hospital vicinity, and Kumaripati) contrasted against 11 unauthorized parking zones. While most basic traffic elements were physically present, their poor maintenance and uneven distribution significantly undermine functionality, particularly regarding nighttime safety due to inconsistent street lighting spacing. These systemic

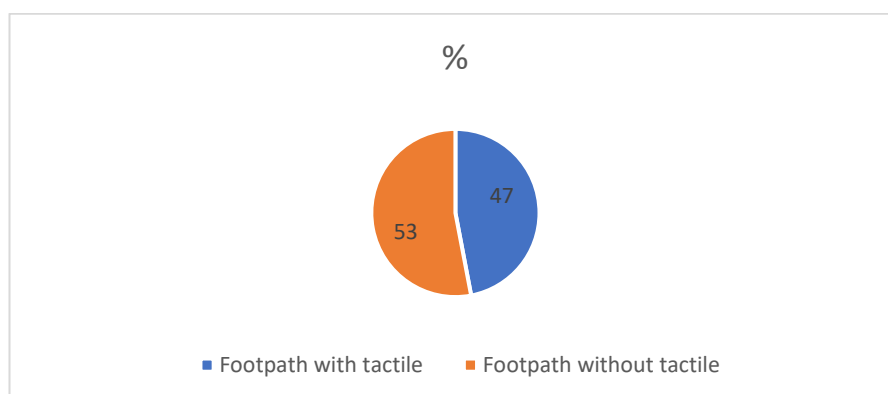
The assessment revealed significant gaps in accessible infrastructure, with tactile paving present on only 47% of footpaths, leaving 53% without this critical feature for visually impaired pedestrians.

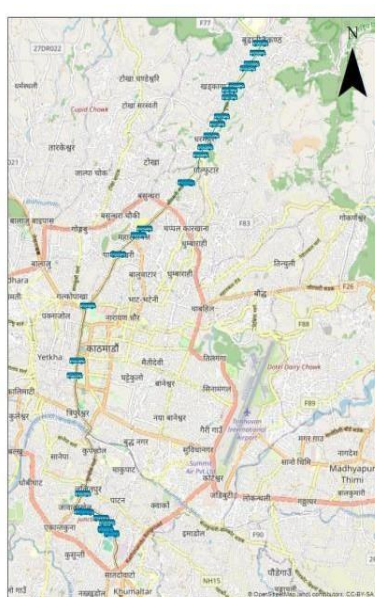
Figure 4. Bus Stops located in the study route

Intersection safety measures proved equally inadequate - among the 26 intersections along the route only Thapathali featured properly functioning pedestrian countdown signals, clearly visible crossings, and consistent traffic police presence. Field observations identified particularly dangerous pedestrian behaviors such as not using crossings and footpaths for locomotion stemming from poor infrastructure design. Numerous instances were documented of pedestrians crossing immediately in front of stopped buses after disembarking, creating blind spots where approaching vehicles in the same direction became invisible. This hazardous behavior appears directly linked to two design flaws:

- Placement of crosswalks on the far-side of bus loading zones
- Location of bus stops at the nearside of intersections

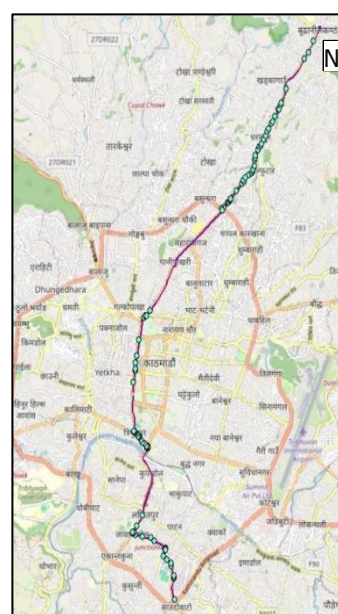
Figure 5. Traffic Signs Along the study route

The comprehensive survey of the 17.7 km Satdobato-Budhanilkantha route revealed multiple critical infrastructure deficiencies compromising road safety. Traffic control measures proved inadequate, with only 84 signs observed along the entire corridor, including a severe shortage of diversion (6) and speed limit signs, while some sections lacked even these basic requirements. Pedestrian infrastructure was particularly deficient, with poorly maintained footpaths and dangerously inadequate crossings - of 53 zebra crossings documented, only the Thapathali intersection crossing remained fully visible, while 6 were deteriorated beyond functionality. This situation creates exceptional hazards near schools and hospitals where pedestrian crossings are scarcest. Bridge crossings presented additional challenges, with average crossing times of 2.25 minutes recorded at three major bridges (Satdobato, Labim Mall, and Ratnapark) regardless of pedestrian demographics or carried loads. Public transport infrastructure showed similar shortcomings, with only 12 of 32 observed bus stops featuring proper laybys. 14 Bus stops were observed in Lalitpur district other 18 in Kathmandu district along the study route.

To enhance road safety and compliance with traffic regulations, a strategic installation of 72 standardized signs in accordance with the Traffic Sign Manual. This includes 9 regulatory signs (such as stop, yield, and priority signs), 41 warning signs (for curves, pedestrian crossings, and school zones), and 22 informational signs (providing directions and distances). These upgrades will improve clarity, enforce traffic rules, and ensure safer navigation for all road users.
