## Impact of Monsoon Rainfall on Roadside Slopes

Laxmi Adhikari<sup>1</sup>, Jayant Bhatt<sup>1</sup>, Shreejan Bikram Thapa<sup>1</sup>, Lipika Mahajan<sup>1</sup>, Kushal Dahal<sup>1</sup>, Madan Rimal<sup>1</sup>,  
Prajwal Timsina<sup>1</sup> Bhim Kumar Dahal<sup>1\*</sup>

<sup>1</sup>Department of Civil Engineering, Institute of Engineering, Pulchowk Campus, Tribhuvan University,  
Nepal

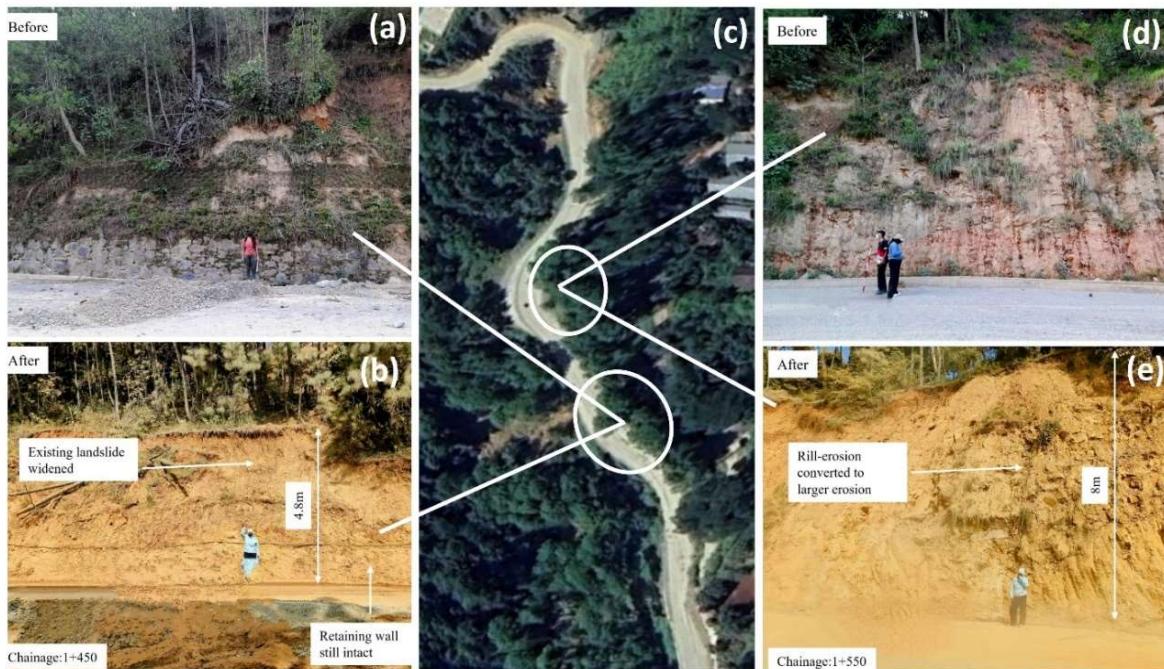
The field observations clearly demonstrated the significant impact of monsoon rainfall on slope stability. Within a relatively short 300 m stretch of the road from chainage 1+450 m to 1+778 m, three uphill slopes and one downhill slope exhibited notable failures as depicted in Figure 5. For example, at chainage 1+450 m (uphill), a shallow-seated planar failure with a crown height of approximately 4.8 m occurred, causing accumulation of landslide debris that blocked side drains and obstructed surface drainage. Similarly, at chainage 1+550 m (uphill), erosion and sliding with a crown height of 8 m were observed, intensified by pre-existing gullies and steep slopes; this erosion extended about 40 m along the road corridor, destroying vegetation and depositing material along the roadside, which reduced carriageway width and clogged drainage. Downhill at chainage 1+752 m, the slope comprising loose road-cut material with no protective measures showed significant post-monsoon damage, including erosion of almost half the road width and persistence of large gullies, indicating high vulnerability to future instability.

Figure 5: Pictorial comparison of before and after the monsoon at different chainage; (a) Before monsoon picture of chainage 1+450, (b) After monsoon picture of chainage 1+450, (c) Satellite Map of the alignment part, (d) Before monsoon picture of chainage 1+550, and (e) After monsoon picture of chainage 1+550

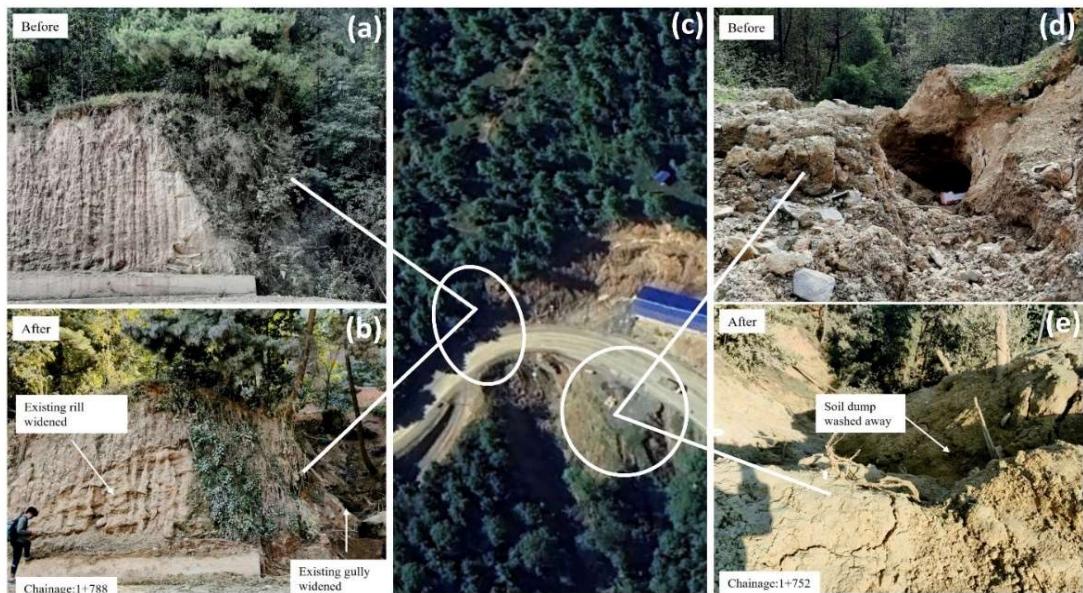
Further observations at chainages 1+777 and 1+788 m revealed that a cross-drainage structure and a natural gully, present before the monsoon, suffered badly after the monsoon as the gully widened and the drainage structure got clogged, reducing runoff discharge capacity. Unprotected soil deposited

downhill was washed away, causing partial damage to an adjacent gabion wall. At chainage 2+554 m (downhill), the absence of drainage provisions led to uncontrolled water flow forming gullies up to 0.5 m deep, transporting sediment downslope and damaging agricultural fields and a secondary access road. Additionally, at chainage 2+742 m (uphill), a vertical cut slope about 4.2 m high with small pre-monsoon gullies experienced severe erosion post-monsoon, with large gullies forming along concentrated water paths and side drains clogged by soil deposits. Lastly, at chainage 4+031 m, critical river training structures, including gabion and retaining walls protecting a culvert and road boundary, were destroyed by floodwaters, leaving the culvert foundation exposed and the adjoining roadway extensively damaged, posing serious risks to transportation safety.

Figure 6: Pictorial comparison of before and after the monsoon at different chainage: (a) Before monsoon picture of chainage 1+788, (b) After monsoon picture of chainage 1+788, (c) Satellite Map of the alignment part, (d) Before monsoon picture of chainage 1+752, and (e) After monsoon picture of chainage 1+752

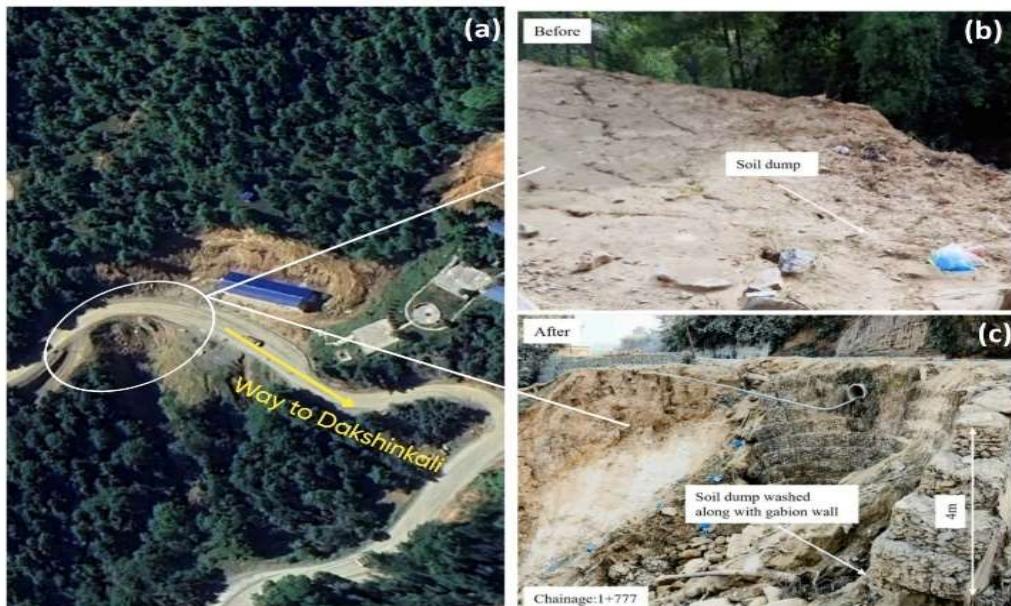
Figure 7: Pictorial comparison of before and after the monsoon at different chainage: (a) Satellite Map of the alignment part, (b) Before monsoon picture of chainage 1+777, and (c) After monsoon picture of chainage 1+777

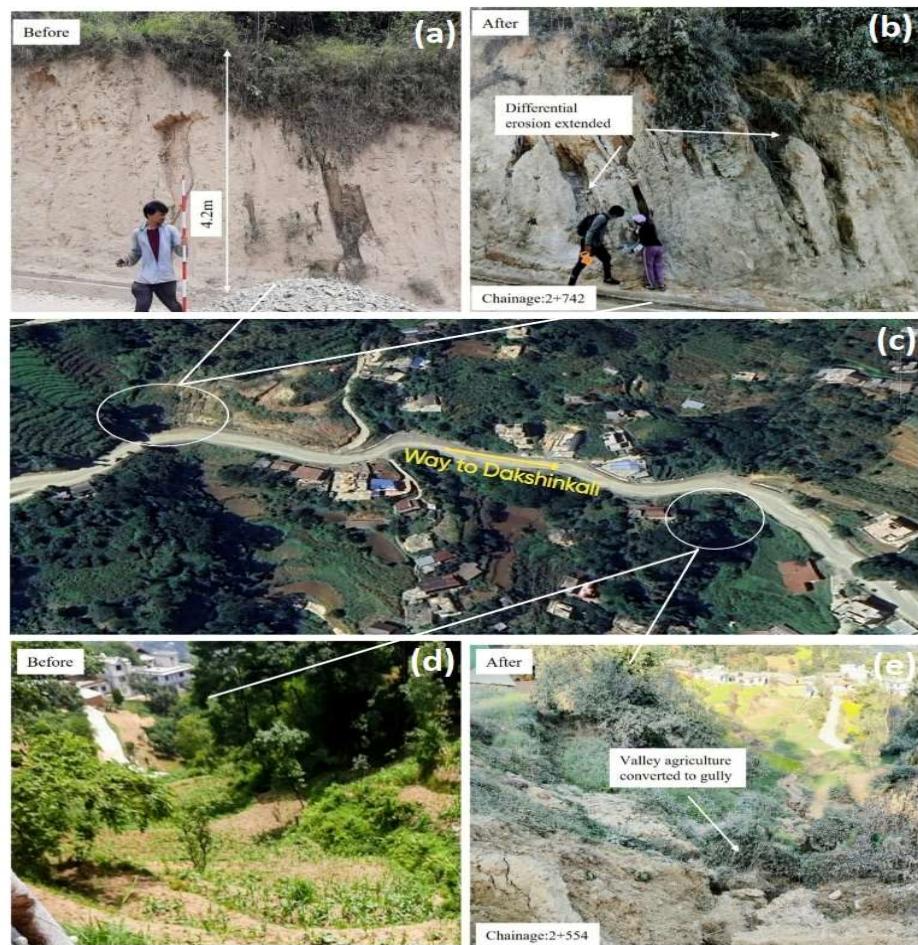
Figure 8: Pictorial comparison of before and after the monsoon at different chainage; (a) Before monsoon picture of chainage 2+742, (b) After monsoon picture of chainage 2+742, (c) Satellite Map of the alignment part, (d) Before monsoon picture of chainage 2+554, and (e) After monsoon picture of chainage 2+554

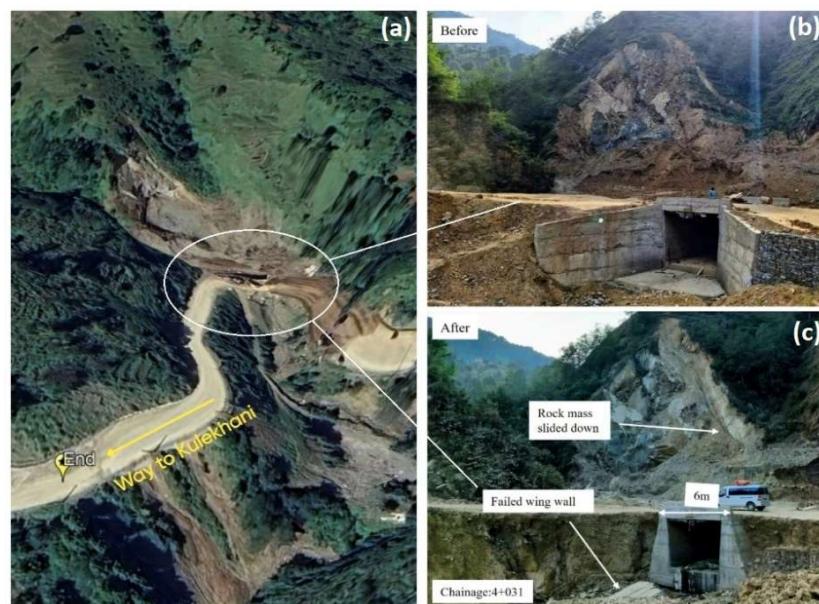
Figure 9: Pictorial comparison of before and after the monsoon at different chainage; (a) Satellite Map of the alignment part, (b) Before monsoon picture of chainage 4+031, and (c) After monsoon picture of chainage 4+031

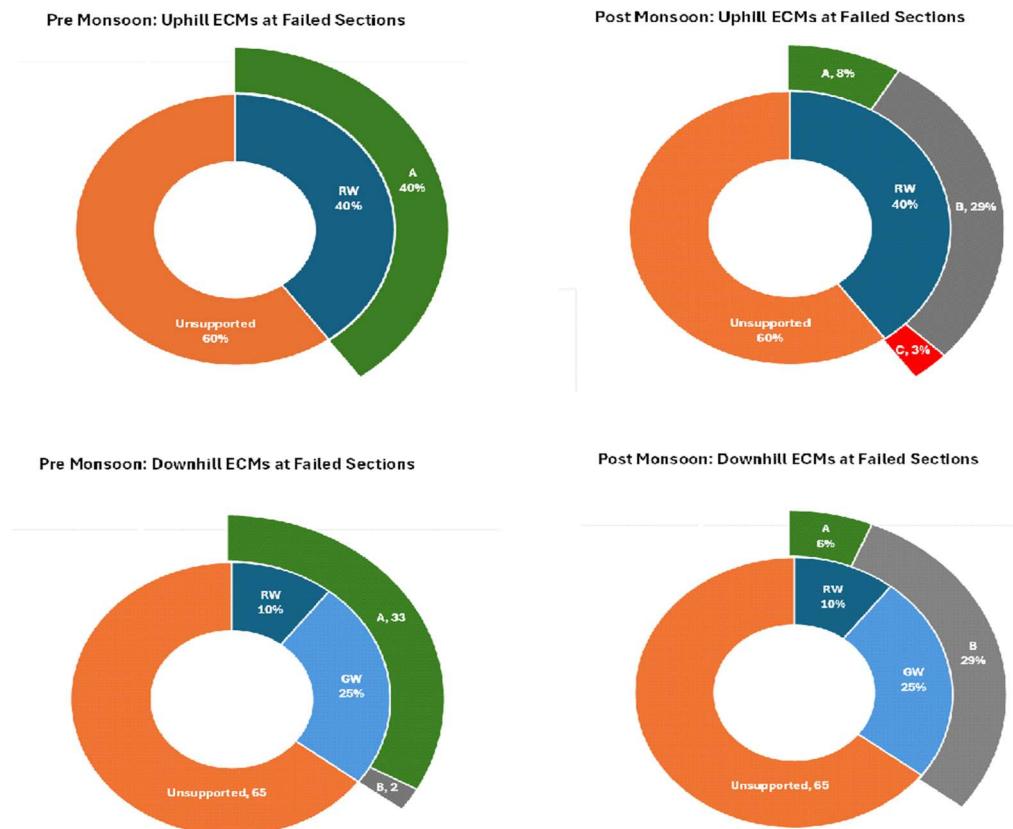
Figure 10: Pre- and Post-Monsoon Comparison of ECM at Failed Sections

Among the 188 chainages/sections studied, 62 sections encountered significant slope failures: 14 on uphill, 26 on downhill and 22 on both sides. Among the slope failure sections, the patterns observed were presented in the Figure 10, suggested that most of the failed sections did not have any erosion control measures. And those which did have ECM in place, the measures were insufficient to prevent slope failures and thus were badly collapsed or distorted post-monsoon.

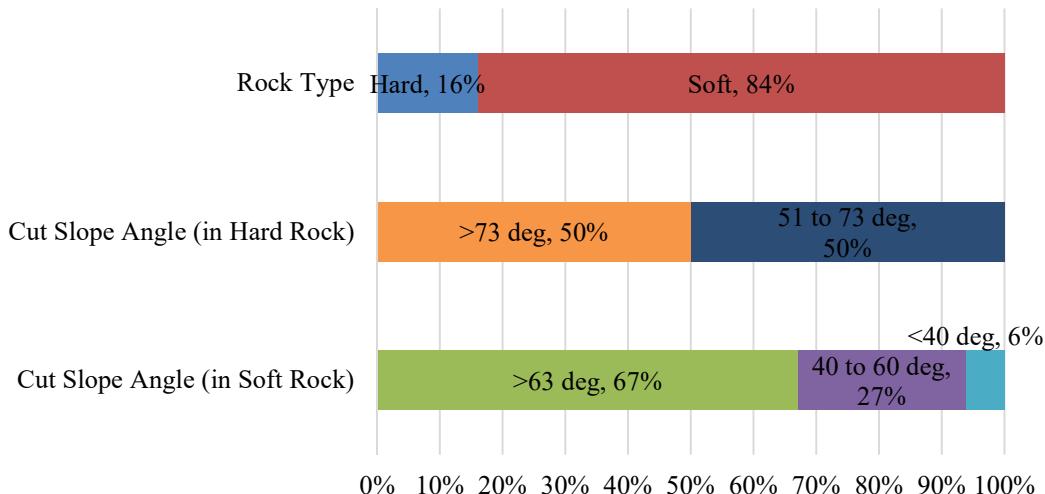
As per the DoR recommendations (DoR-GoN, 2007), for cut heights up to 15 m, the preliminary cut slope angle for road excavation should be 40 to 63° in soft rock and 51 to 73° in hard rock. But the observed cut slope angles at failed sections were:

Figure 11: Rock type and Cut slope angle composition at Failed Sections

This shows that slope failure was more common in areas with soft rocks, and that DoR guidelines were not followed properly during road excavation – excavating roadside slopes at angles greater than that recommended by DoR- and have therefore resulted in slope failures. Moreover, some slopes were indeed cut at a slope angle equal to or less than the DoR recommended angle but still endured landslides, which may also hint towards the insufficiency of the current DoR recommendations and the need for their upgrading.

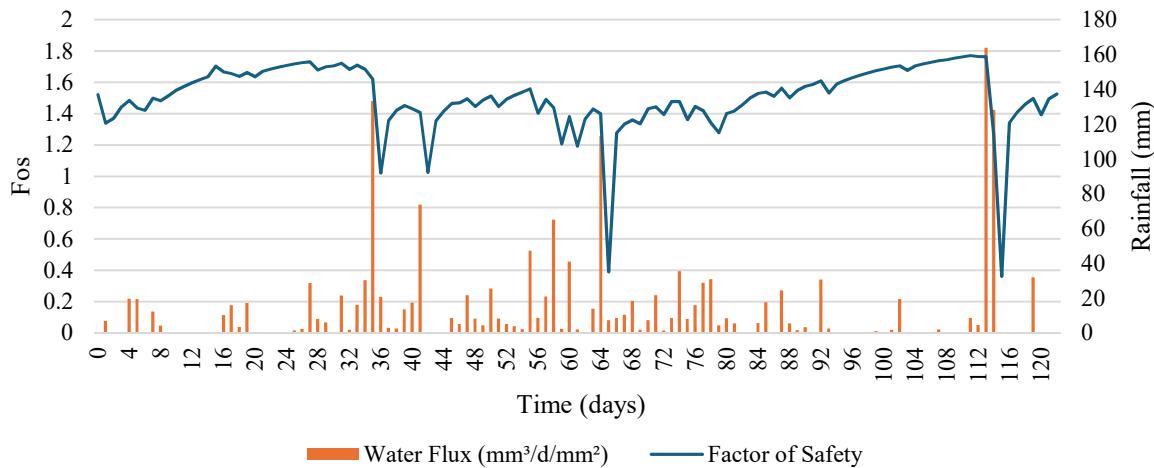
Figure 12: FOS vs Rainfall Vs Time graph for chainage 0+640m

The initial site was a sloped terrace farm uphill, with vertical cuts in the soil at certain points along the chainage and reinforced with a short retaining wall of 3m height. The initial factor of safety for the site was 1.34. Analysis suggested a plane failure, particularly at high risk on days 65 and 115, with the factor of safety dropping to as low as 0.36. Notably, the factor of safety also decreased to 1 as early as days 36 and 42. The actual site showed wedge failure with the retaining walls overtaken by debris, drains filled with soil, and the large mass movement exposed the uphill land and house to the risk of further damage. Failure is attributed to the insufficient design of the retaining wall, coupled with the geometry of the section alongside the classification of the soil on site as loamy sand, which is generally prone to waterlogging, and therefore highly sensitive to rainfall. It is possible that the initial failure originated from the section with the vertical cut, which allowed further mass movement to occur.

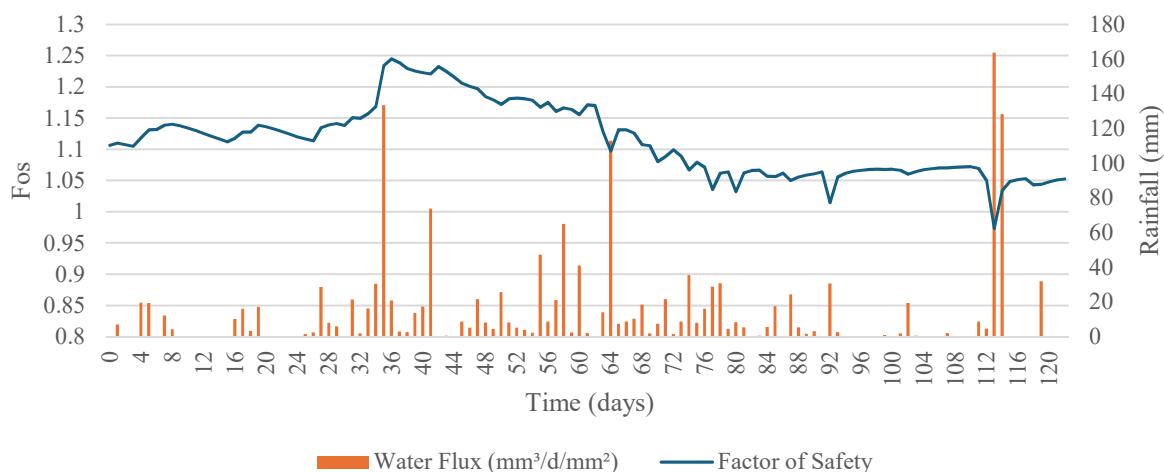
Figure 13: FOS vs Rainfall Vs Time graph for chainage 0+980m

The factor of safety (FoS) at this chainage was also greater than 1 before the monsoon. As rainfall started, FoS started to vary in reaction to the pattern of infiltration and water flux. At moderate early storms, partial saturation raised stability at some point temporarily, a phenomenon due to the increase in matric suction. But sustained infiltration decreased this stabilizing effect. The heavy rains caused pore-water pressures that continued to reduce the FoS. According to the results, limited rainfall does not instantly cause failure, which indicates that the slope could tolerate a certain level of precipitation. However, persistent and heavy rainfall quickly moves FoS downward until slope failure eventually occurs. Overall, the correlation analysis shows that the water flux due to rainfall has a strong negative dependence on slope stability. Infiltration into deeper layers of soil causes sudden decreases in FoS, and long-term seepage will not allow restoring the stability state; the slope remains in a very dangerous position. Consecutive severe storms increase the pace of this degradation process, eventually lowering FoS to life-threatening levels and slope failure.

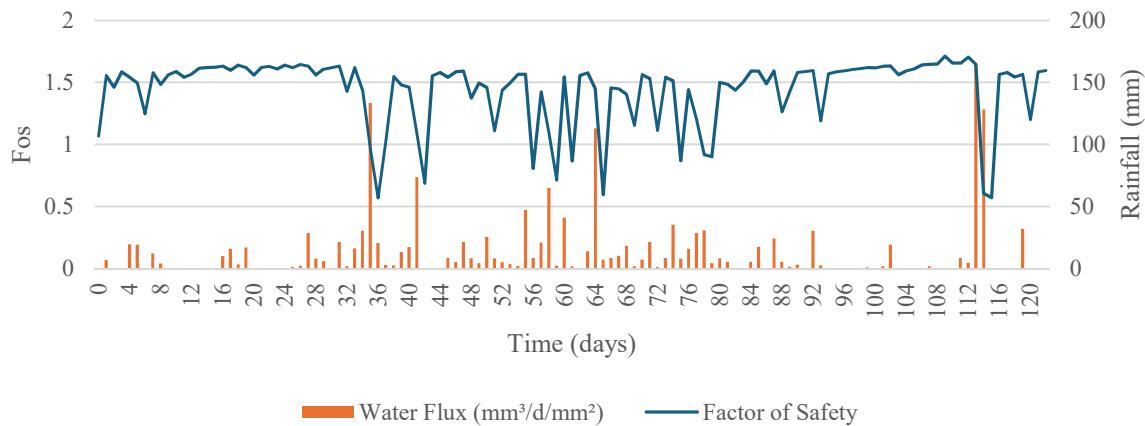
Figure 14: FOS vs Rainfall Vs Time graph for chainage 1+550m

Initially, the site had steep cuts of approximately 70 °, 10m in height uphill, with the provision of a retaining wall 4m in height. Soil from the cut slope was deposited downhill. Still, it was not relevant to the slope stability analysis as it covered the existing retaining structure, which kept the road stable. The initial factor of safety was found to be 1.06. Analysis suggested a plane failure with steep drops in factor of safety throughout the monsoon season, which shows very high sensitivity to rainfall conditions. The Factor of safety dropped to less than 1 on several instances, notably days 36, 42, 56, 59, 114, and more. The actual site showed erosion along a large span of 40m with a crown height of about 10m, which corresponds to the analysis results. Multiple large gully erosions were also observed further than 10m. The resulting erosion covered both the drainage measures and retaining walls. Failure is attributed to the heavy rainfall alongside the properties of the site soil, as the analysis suggested a high correlation with rainfall, and evidence of water erosion was clearly present during the site visit.

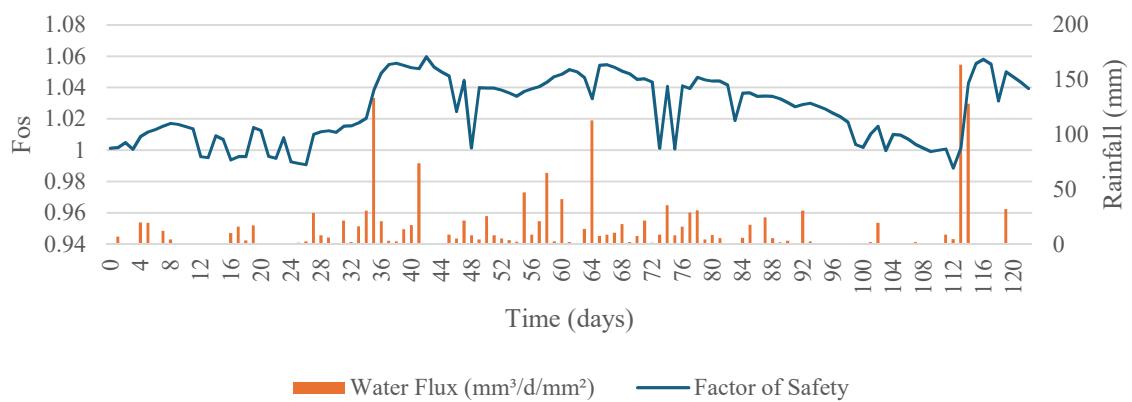
Figure 15: FOS vs Rainfall Vs Time graph for chainage 1+760m

Initially, before the onset of monsoon rainfall, the factor of safety for this chainage was satisfactory, i.e., it was above 1. As soon as the precipitation started, the factor of safety began to decrease. The factor of safety dropped enormously during intense precipitation. The graph of the factor of safety illustrates the high risk of the site as the factor of safety prominently dropped with the slightest precipitation. The analysis brought out the high peaks of infiltration during the storms and the seepage that followed, which sustained the pore-water pressure build-up and delayed the recovery of stability. These results bring attention to the extreme effect of rainfall on the slope, as it is only marginally stable and is highly impacted by aggressive storms. Overall, these results point out the likelihood of the factor of safety dropping below unity and the slope failing due to extreme rainfall events or consecutive rainfalls, in addition to bringing attention to the need for drainage and constant monitoring.

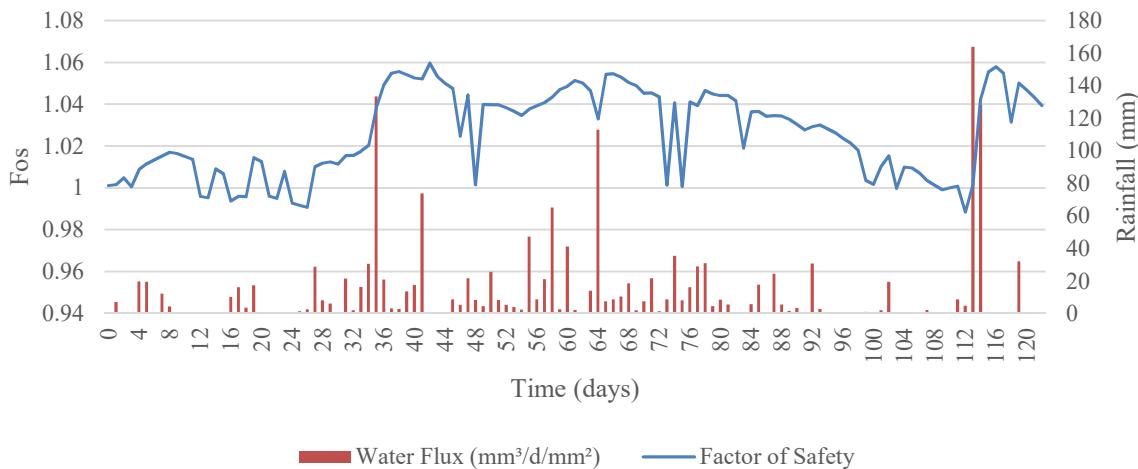
Figure 16: FOS vs Rainfall Vs Time graph for chainage 3+897

Pre-monsoon, the site was a fresh-cut soil slope of height about 7m and 70° angle with no ECMs present uphill except for the side drain. Analysis suggested a plane failure, but also that the section was initially unstable. Back analysis showed the actual properties of the slope to be much greater than the laboratory data for the slope to be initially stable, exceeding the range of values for loamy sand. Some correlation was found between the FoS and rainfall. The actual site showed large erosion on the top layer of the slope, revealing a layer of gravel underneath the soil layer. This suggested that the interlocking action of the gravel layer contributed greatly to the overall stability of the slope, and during rainfall, only the top layer of weak soil was eroded, resulting in plane failure for the soil layer only. Drains were found to be clear, likely cleaned up before the post-monsoon site visit.
