Flooding and Inundation in Nepal Terai: Issues and Concerns

Basistha Raj Adhikari

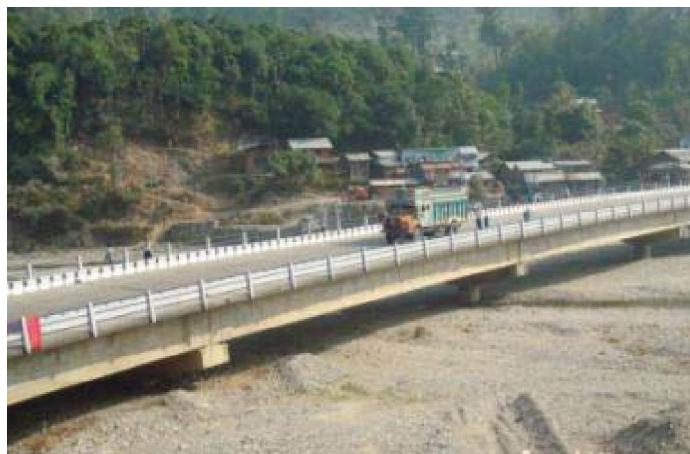
Photo 2. Sediment Accumulation under the Lothar High Bridge.

Excessive Sediment Load: The Churia range contributes maximum sediment load to the rivers originating from the southern face (Sharma 1977). According to a JICA study, the annual sediment yield of the Lakhandehi river is estimated as high as 178,000 m³ per year. In some stretches of the Churia rivers, almost two meters of sediment has been deposited in the last 45 years (Dixit 1995). Due to the higher sediment load, the bed level of several rivers are rising significantly. The case of the Lothar river in Chitwan District is typical of this phenomenon (Photo 2).

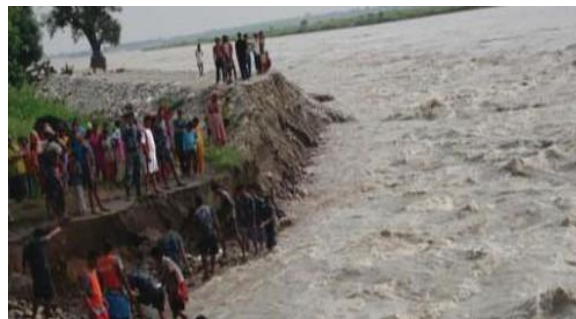
Photo 3. Flood in Mahakali River in 2009.

High Peak Floods: Runoff in Churia Rivers concentrates only in the monsoon months from June to September. Factors like short steep slope, overgrazing, deforestation, and short time of concentration produce high peak flood during the monsoon. In general, the runoff duration is less than one day and the flood hydrograph is very sharp with high peak discharge.

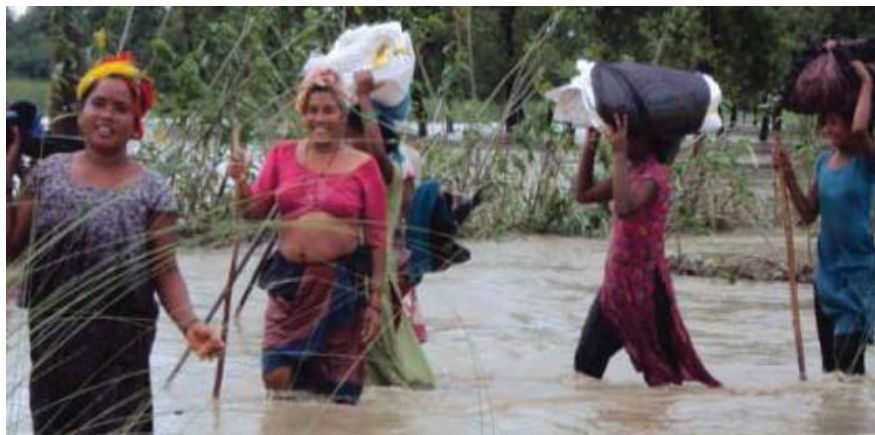
Photo 5. Forced Migration due to Flood.

Koshi Flood of 2008: The devastating Koshi flood disaster occurred on 18th August, 2008 near Kushaha village of Sunsari District due to a breach of the eastern embankment of the Koshi barrage. The barrage and embankments were constructed in the 1960s under the

Nepal-India Koshi Project Agreement. Four VDCs of West Kushaha, Haripur, Shripur and Narsingha of Sunsari district were severely affected from the flood disaster. At the time of the breach, the Koshi river had only 4,700 m³/s of water flowing through the barrage. The flood flow was minimal of August flow against the highest flood of 26,990 m³/s (Dixit 2008) recorded in 1968.

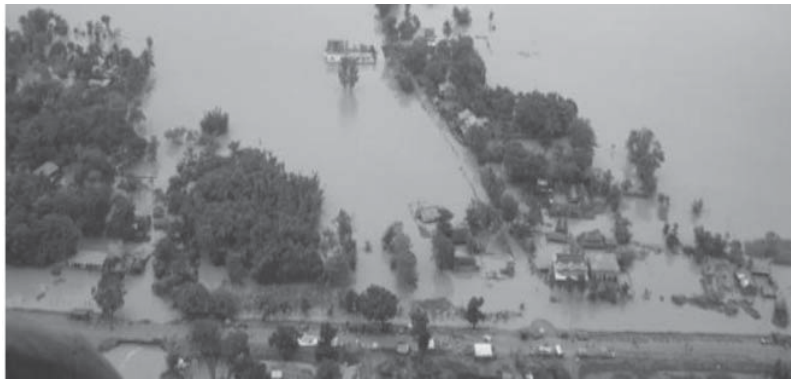
Photo 6. Koshi Flood 2008.

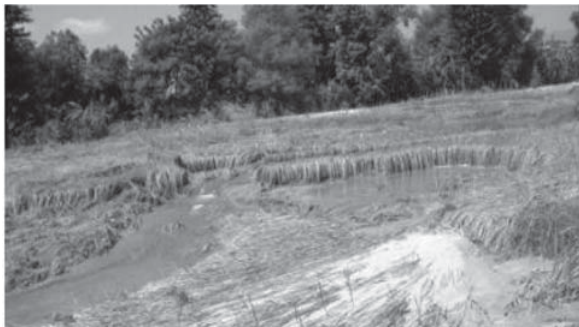
Photo 7. Damage of Crops in Far-West Flood, 2008.

Far-West Flood of 2008: One month after the devastating flood of the Koshi, downpour generated by cloudbursts occurred in the Far-western region. Most of the mountain districts were affected by a series of landslides while the Terai districts were affected by floods. All the rivers that originate from the Churia hills swelled with bankful discharges, spilled over their banks, eroded adjacent agricultural lands, deposited sands and silt on nearby houses, and inundated settlements for days. The East-West highway was eroded in two-three places in Kailali and Kanchanpur districts along with damages to irrigation projects, transmission lines, and other public and private infrastructure.

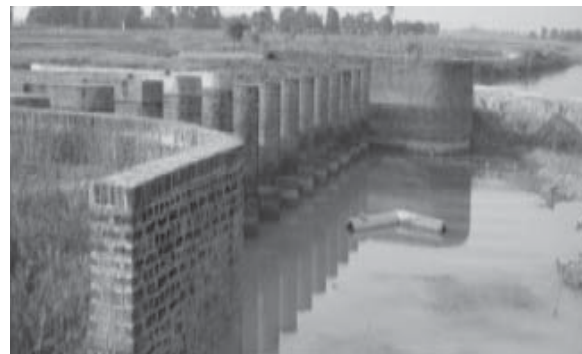
Photo 8. Mahali Sagar of Kapilvastu District.

The Sagars in Kapilvastu District are the typical examples of pond irrigation. These Sagars provide irrigation to the bordering area of India at the cost of inundation in Nepal territories. More than 60 percent of the reservoir area of these Sagars lies in Nepal at normal water level. The situation aggravates during the heavy monsoon rainfall and delay in gate operation by the Indian authority who live far away from the location of these gates.
