Rockfall Characterization and Structural Protection in the Siddhababa Section of Siddhartha Highway H10, Nepal

Department of Civil Engineering, Khwopa College of Engineering, Tribhuvan University, Nepal corresponding author: kaushal.raj.gnyawali@gmail.com

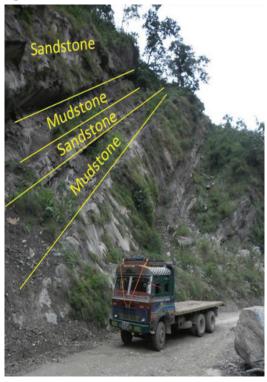
Fig. 4. The primary bedding is of sandstone and mudstone occurs at places; the mudstone bed erodes/wash out by rain then the overlying jointed rock loses support thus slips by plane failure

Large blocks (average size. 1m³ to 20 m³) splitting from the surface and falling on the road with mostly plane failure mechanism.

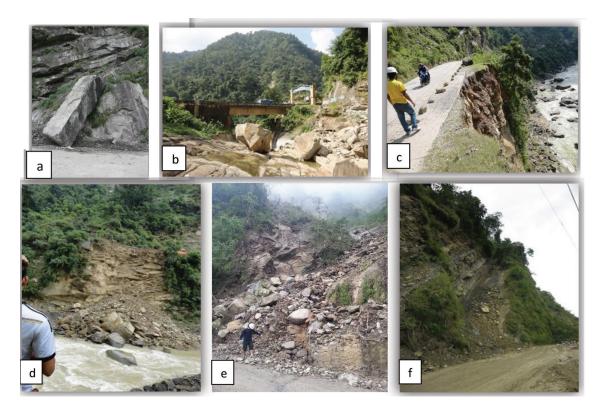
Fig. 5. Rock slope failure problem (a, b), Block failure type (c, d), Slope scar collapse and Debris flow (e & f).

A portion of the rock slope fails by shear failure causing minor scale landslide leaving scar on the slope.

Many gully channels are being formed which are activated periodically during monsoons and carry large volume of debris at high speeds towards the road.

The recent rockfall of [18] is a slope scar type fall of approximately 18-20 m³ volume and of [8] is Debris flow type fall.
