Flood Events in Gangapur Village, Banke District: An Example of Climate Change-induced Disaster in Nepal

Tara Nidhi Bhattarai

ABSTRACT

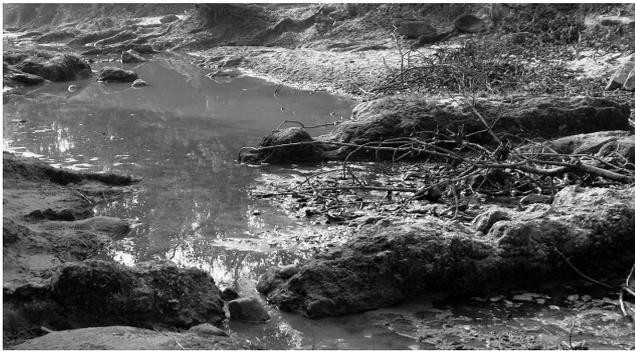
The field investigation revealed a fact that the Dhondra River bed is not a smooth surface as there are rock exposures across the river bed (Fig. 2). The bedding of the rock exposures (mainly sandstone) dips due south with an angle that varies between 25 and 45 degrees. Out of three prominent set of joints, one set dips parallel to river flow direction (south) with an amount that ranges from 30 to 55 degrees. These rock exposures have formed low-lying (less than a meter in height in average) dams or barriers at several locations across the river. These barriers have behaved like natural check dams, which catch sediments and reduce river velocity. The width of the Dhondra River is a narrow one within the Siwalik range but it is deep enough to transport all the water even during flood events. But in the Terai region, it is shallow and high discharge is often spilled out as flood water.

Fig. 2. Bed rock (mainly sandstone) behaves like natural check dams as it is exposed across the Dhondra River

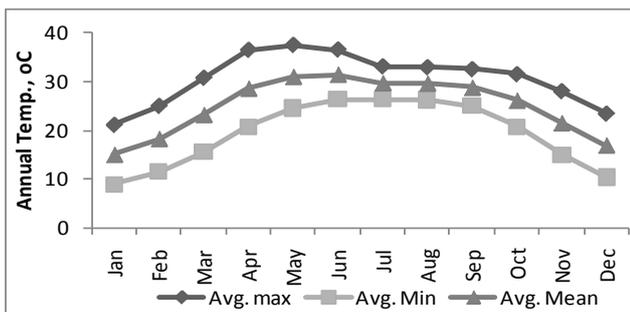
Fig. 3. Average monthly temperature trends for the period of 1976-2009

Based on the data of the 33 years (1976-2009), the highest average monthly temperature is observed during the month of May with an average value of about 38 °c, whereas the lowest temperature is observed during the month of January with a monthly average value of about 8 °c (Fig. 3). In case of annual trend, although there does not exist any significant trend, it seems that the annual maximum temperature is on a very slight decreasing trend with a decline of 0.005 °c per year and the annual minimum temperature is gradually increasing with a trend of about 0.016 °c per annum (Fig. 4).

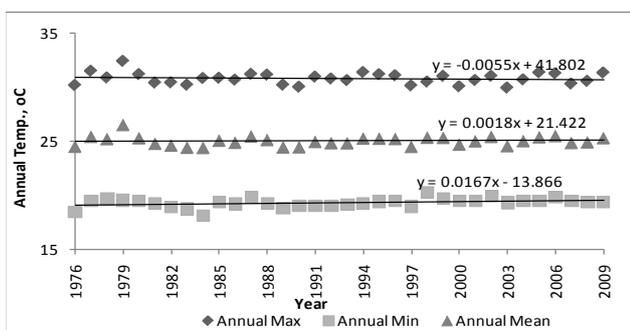
Fig. 4. Average annual trend of temperature for the period of 1976 - 2009

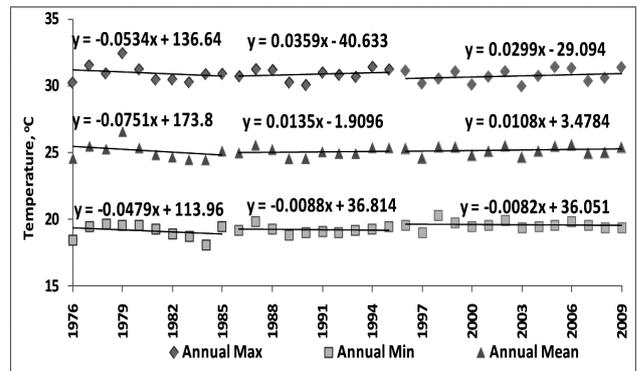
Fig. 5. Decadal trends in maximum, minimum and mean temperatures for the years 1976 - 2009

The decade wide trend analysis indicates that the maximum temperature is on a declining trend during 1976 – 1985. But after 1986 it follows an increasing trend with an average increment of 0.032 °c per year till 2009 (Fig.5). Similarly, minimum temperature follows an overall decreasing trend. However, the rate of decline is slightly less in the second and third decades. The mean temperature also follows an increasing trend, for the last two decades, with an increment of 0.011 °c per year. All of these results suggest an overall warming due to increase in maximum temperature and slight decline in the decreasing trend of minimum temperature in the recent decades.

Almost similar results are obtained from the study site. An analysis of temperature data recorded from 1976 to 2009 has suggested an overall warming due to increase in maximum temperature (0.032 °Cv per year) and slight decline in the minimum temperature (0.008 °C per year) in the later decades, starting from 1986. Since the study site belongs in the southern part of the country, the increase in temperature, though not much significant, is in line with the warming scenario as mentioned in the National Adaptation Plan of Action report (MoENV, 2010).

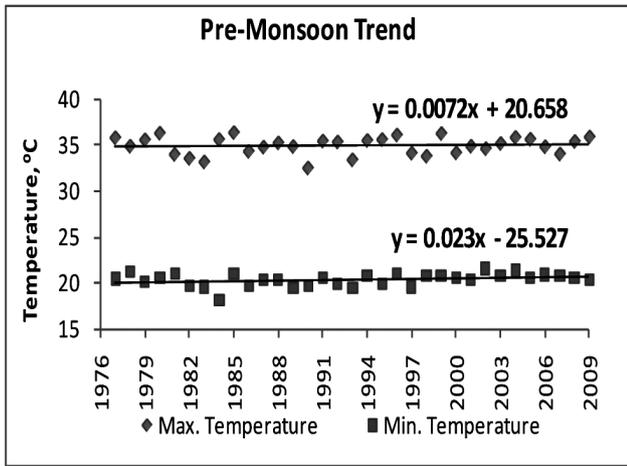
In case of seasonal trend, it is observed that both the maximum and minimum pre-monsoon temperatures are increasing by a gradient of 0.007 °c and 0.023 °c per year, respectively (Fig.6a). However, during monsoon season, the maximum temperature is on a declining trend with a gradient of 0.003 °c per year. Unlike this, the minimum temperature is increasing slightly with a gradient of 0.008 °c per year (Fig.6b). Similarly both maximum and minimum temperature trends tend to follow a decreasing trend during the post monsoon season (Fig. 6c). Finally, during the winter season, the maximum temperature

Fig. 6a. Temperature trends during pre-monsoon seasons for the years 1976 - 2009

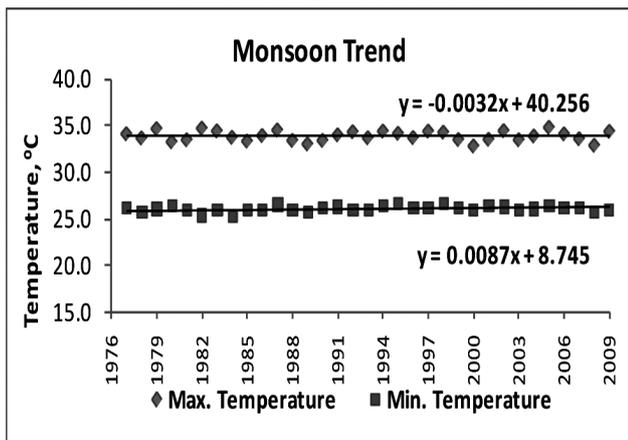
Fig. 6b. Temperature trends in monsoon seasons for the year 1976 - 2009

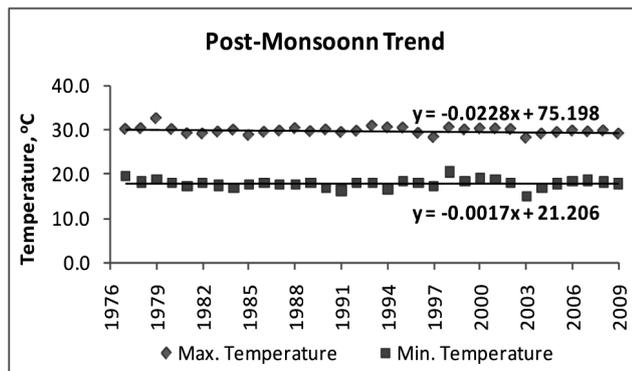
Fig. 6c. Temperature trends in post-monsoon seasons for the years 1976 – 2009

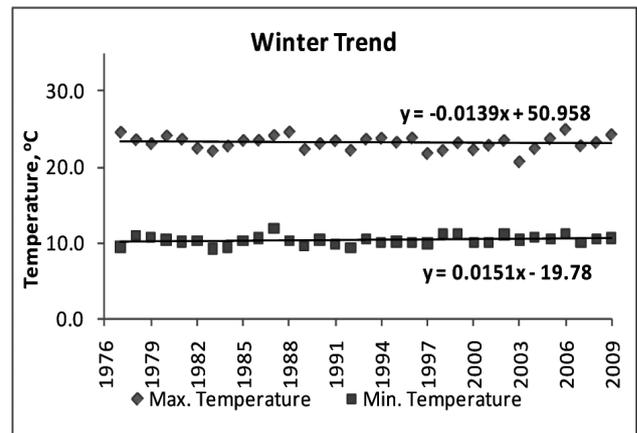
is observed to be decreasing with a gradient of 0.013 °C whereas the minimum temperature is increasing with an increment of 0.015 °C per year (Fig. 6d).

Fig. 6d. Temperature trends in winter seasons for the years 1976 - 2009

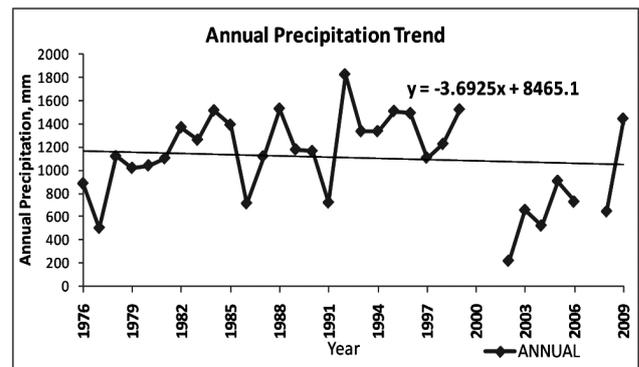
Although there is no any significant trend in each of the components (annual, monsoon and extreme events) of the precipitation, it seems, generally, that the annual precipitation as well as the monsoon precipitation is in declining trend, though not remarkable (Fig.7, 8 and 9). Similar situation is existed in the case of extreme rainfall events as well. However, a remarkable features observed in each of the three cases is that their trend is gradually increasing for the last decade (2002 - 2012), except the years 2001 and 2007 for which data are not available.

Fig. 7. Annual precipitation trends for the years 1976 - 2012 (data are not available for the years 2001 and 2007)

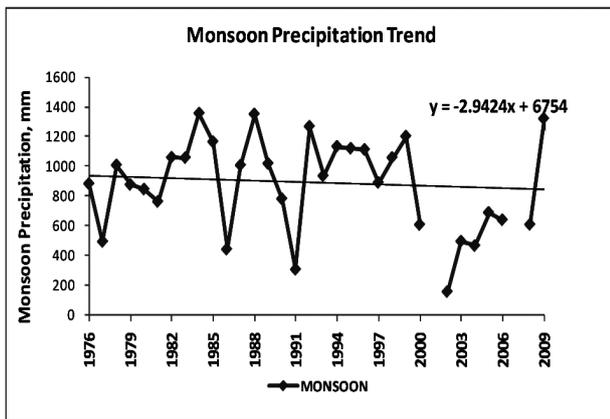
Fig. 8. Monsoon precipitation trends for the years 1976 - 2012 (data are not available for the years 2001 and 2007)

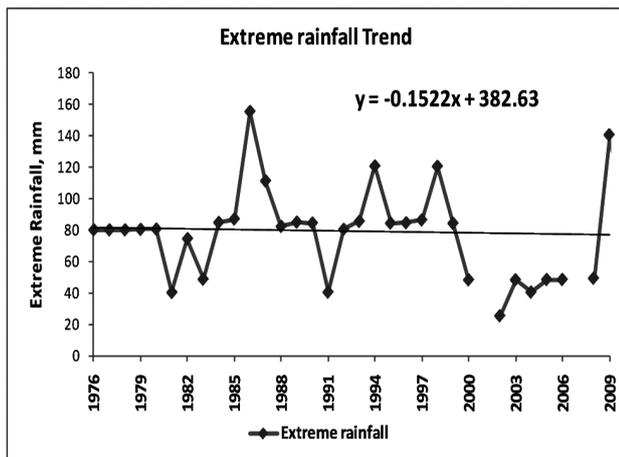
Fig. 9. Extreme rainfall trend for the years 1976 - 2012 (data are not available for the years 2001 and 2007)

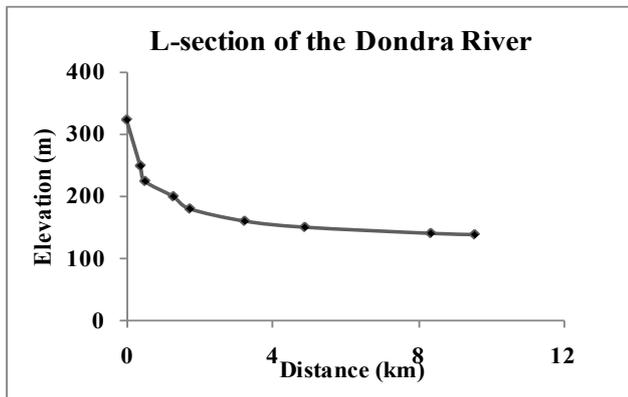
Since the High Mountains block the monsoon passing into central Asia, precipitation is highest in front of the Higher Himalayan range. Intense precipitation also occurs in the areas lying south of the High Mountain regions including Middle Mountain, Siwalik, and Terai. This results high discharge in the rivers and streams originated in these mountain ranges. The Dhondra River is one of the seasonal streams of this kind originated in the Siwalik hills. The intense precipitation events in the monsoon season give rise high discharge which flows with high velocity owing to the steep river bed gradient (Fig. 11) in the Siwalik zone. As soon as the river water emerges in the Terai plain, the velocity reduces significantly due to low river bed gradient. Consequently, coarser sediments start depositing, causing river bed rise. This situation has promoted flooding as the river depth becomes shallow and discharge spills over the banks in the Terai region. This process seems to be responsible for the shifting of the Dhondra River channel westward since 1995. After 1995, intense and localized precipitation started occurring, as an impact of climate change in that region, in its catchment almost each year resulting huge discharge in the river. It promoted even bigger flooding events than before, and shifting of the river channel westward was also accompanied faster accordingly. In the flooding event of 2000, owing to the huge sediment-loaded discharge, the river channel shifted further westward blocking the Singhya River, whose discharge was comparatively less due to almost no rainfall in its upper catchment. It means the area suffered with localized intense precipitations. After 2000, as the natural check dams created by rock exposures across the river are being excavated along with removing the big boulders scattered along the river bed by local people, river is transporting all the sediments directly to the lower reaches of the river. Deforestation and grazing also promoted soil and rill erosions increasing sediment load in the river water. This process is responsible for depositing huge amount of sands each year around the confluence point with the Singhya River.

Fig. 11. Longitudinal section of the Dhondra River
