Debris flows in the central sector of the northern slopes of the Main Caucasus Ridge: peculiarities of the current situation

E. V. Zaporozhchenko

OAO Sevkavgirovodhoz, Pyatigorsk, Russia

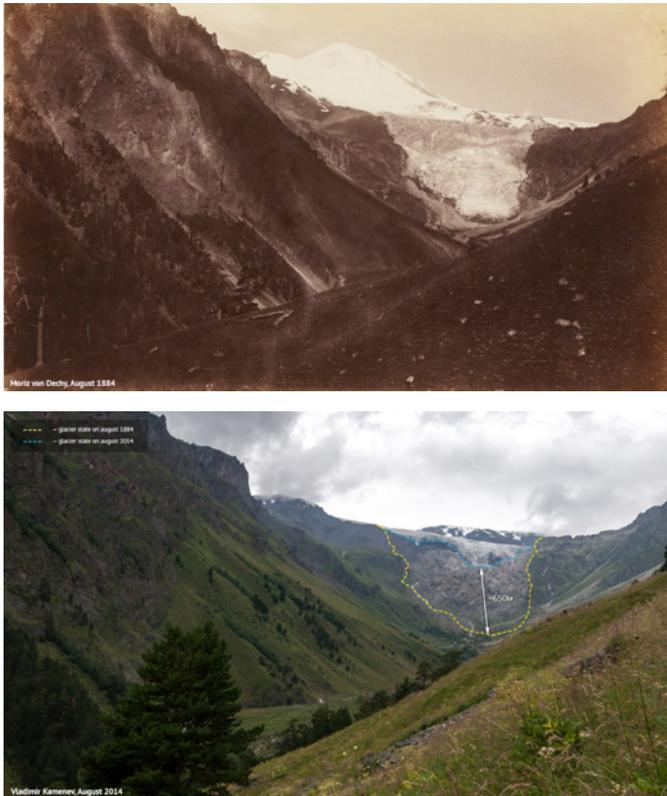
Fig 1: The Terskol glacier (Prielbrusye, Kabardino-Balkar Republic) retreated by approximately 650 m for 130 years. Pictures taken by M. von Dechy in August 1884 (top) and by V. Kamenev of OAO Sevkavgirovodhoz in August 2014 (bottom).

This can be illustrated by the example of the Terskol Glacier tongue (Prielbrusye, Kabardino-Balkar Republic). In August, 2014 a clear photograph, taken in August 1884, was found and the point from where it had been shot was located. Bushueva (2013) published another photo from Dechy's publication of 1905, where "the glacier terminus is poorly visible, so it is hard to reconstruct its location". As then the glacier floated over an almost vertical granodiorite riegel (rock-bar), whereas now it hangs over a bare wall, it is not hard to determine (Fig. 1) that for 130 years it contracted by approximately 650m (± 20 m). For glacier terminus, the reaction time to a climatic signal is on average 10-50 years (Oerlemans 2001).

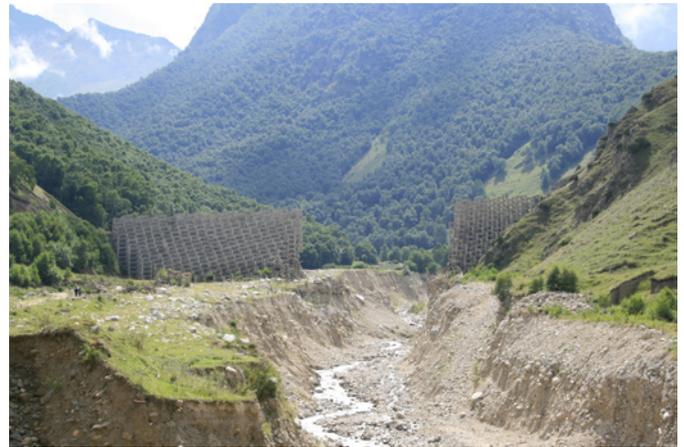
Fig. 2: A structure built for protection of the town of Tyrnyauz on the Gerkozhan-Suu River was destroyed by a debris flow in 1999.

Initially, a debris flow chute was designed, but its construction was stopped. Another design was approved and realized. The new structure built to this design was destroyed by the first debris flow 2 months after being put in commission.

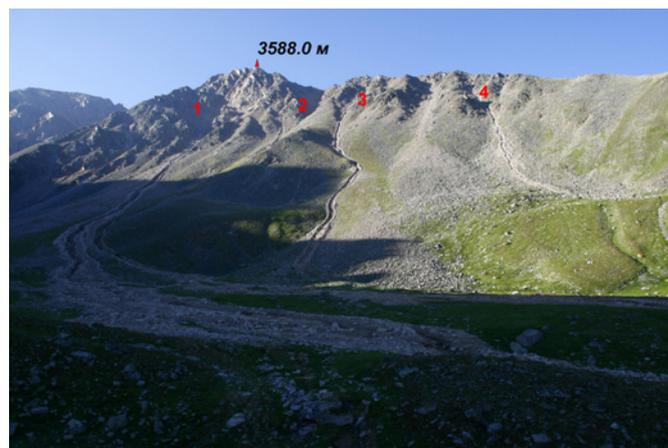
Fig. 4: The sources of the Sylyk-Suu River. 1, 2, 3, and 4 are originating sites of debris flow of July, 20, 2010.

The 2010 debris flow was caused by heavy precipitation of a storm nature in the upper reaches of the Sylyk-Suu River valley, which had by that time been almost free of snow patches. Four origin sites, located under the western Korgashinitau range branch at altitudes of about 3,500 m on the left side of the Sylyk-Suu river valley (Fig. 4), became active. Two western debris flows (3 and 4) disintegrated, not reaching the flattened part of the valley, two eastern debris flows (1 and 2), although losing part of detritus and some of their energy in the flattened zone (2,900-3,000 m), merged below and steeply entered the canyon-like river channel where again gathered speed and gained momentum, travelled 5 km via the river and covered a part of the village with debris flow material.

The debris flows had their maximum power when entering the pre-moraine flattened reach of the valley where they formed 5x3 m grooves and debris flow levees 2-2.5 m high. It was here where the bulk of suspended sediments and bedloads were deposited. Further down the valley the debris flow continued to deposit the solid component, transported from the upper reaches, including just before the village itself, while also getting slightly enriched with loose, more silt, detritus as it moved. Rains and sequential sudden warming activated the thawing of buried ice and remnants of avalanche snow, situated above the upper reaches of the Sylyk-Suu River valley. An additional concentrated seepage discharge started in

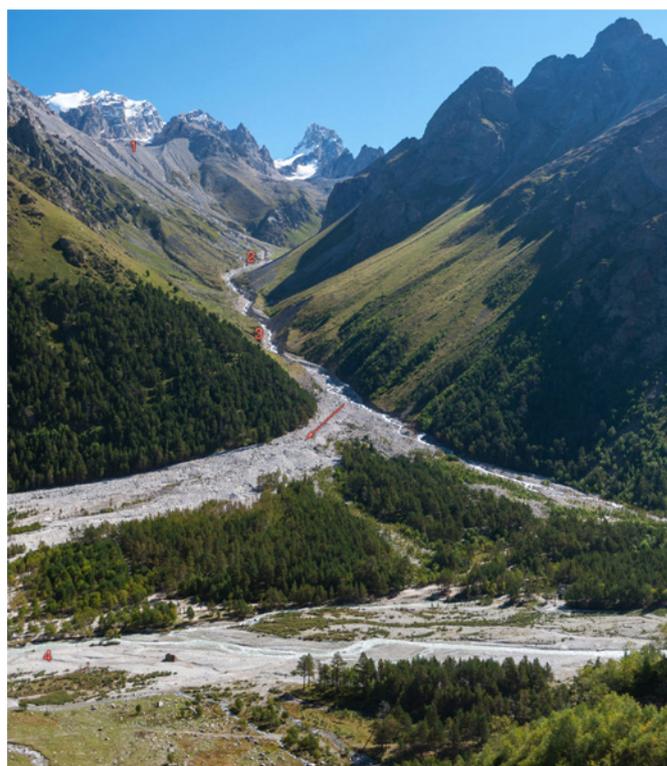
Fig. 5: A view of the fan of the Kullumkol-Suu River on 5 August, 2013 from the left slope of the Adyr-Suu river valley (Photo by V. Kamenev from the survey point chosen by E. Zaporozhchenko in August, 1983). 1 - a debris flow trench of 2011; 2 - debris flow deposits of 1973-2011 on the intermediate fan at the foot of the glacier; 3 - a reach of the channel with the maximum bottom and lateral erosion due to a debris flow on August 3, 2011; 4 - the debris flow receiving river (Adyr-Suu); -> the main direction of deposition of debris flow masses.

On 3 August 2011, 28 years after the catastrophic events of 1983, a debris flow went down the Kullumkol-Suu River. (Fig. 5). With regard to its energy and consequences for the fan it was on a par with the 1983 debris flow - the highway

the river (below the 2011 debris flow trench mouth) the erosion depth did not exceed low single-digit meters (see Fig. 5 for the longitudinal section of the movement path of the 2011 debris flow);

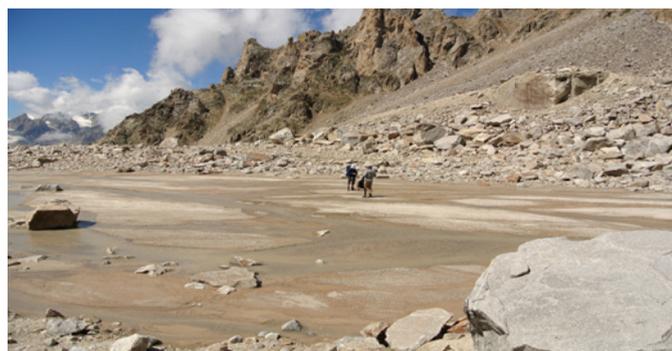
Fig. 6: The bottom of a temporary water body (approx. 3,400 m asl) at the end of July, 2011, residing approx. 150 m above the platform, adjacent to the moraine crest, near the glacier tongue, which retreated approx. 200 m in the period of 1983-2013.

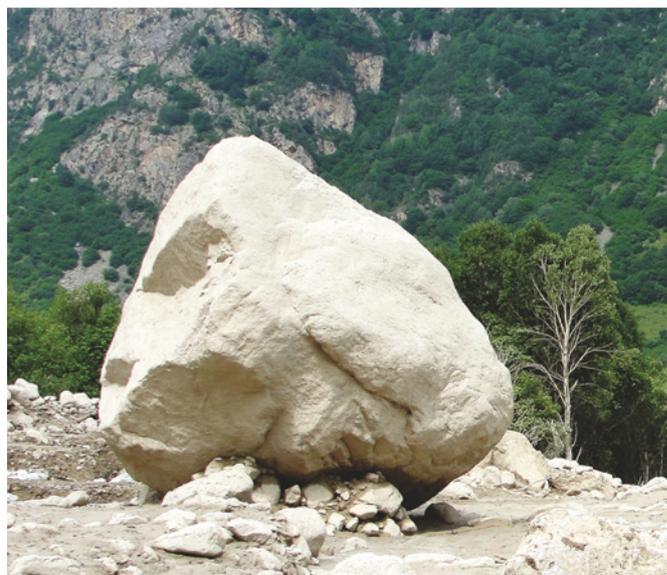
Fig. 7: A debris flow on the Gyulchi-Suu River (a right tributary of the Terek Balkarsky River) on July 16, 2011 carried granite blocks of up to 60 t.

In July 2011 on the Gyulchi-Suu River, a right tributary of the Cherek Balkarsky River, over the mouth reach of which a diversion canal of the Verhnebalkarskaya Malaya hydroelectric power station is to be built, a powerful high-density debris flow occurred, carrying huge hard rock blocks and completely destroying a highway running through the master valley (Fig. 7).

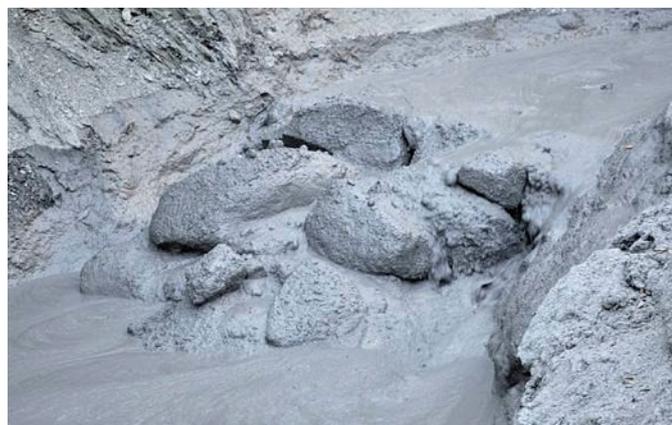
Fig. 8: At 17:00 on September 5, 2012. 17.00, a mud rock flow occurred within the channel below the rocky tributary of the Mutny Tepyak River.

The material of those flows starting from 2011 and during the whole 2012 was deposited within the river and at the lower parts of slopes down to its confluence with the Mutny Tepyak River and then on along the latter over a distance of about 2 km, washed over by surface water of the river (Fig. 8).

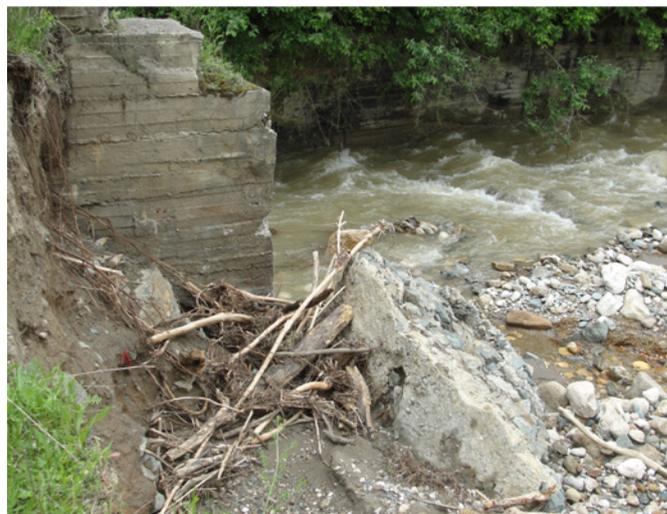
Fig. 9: Washout of the upstream slope and destruction of a part of a reinforced concrete structure of the entry portal of the tunnel on the Gizhgut River as a result of a debris flow of May 21, 2014.

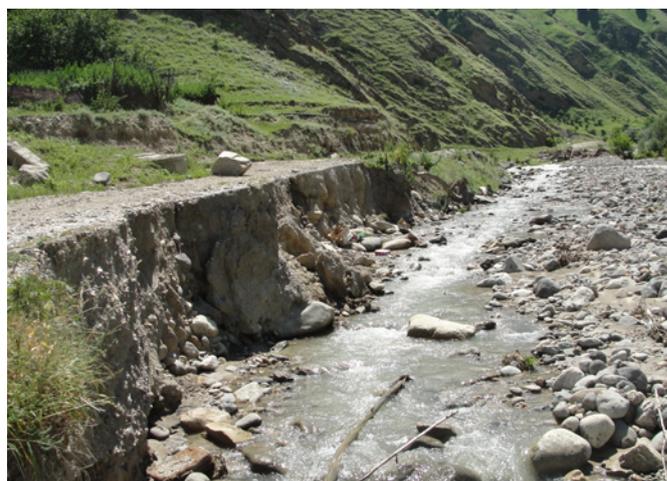
Fig. 10: Lateral erosion of the right bank of the Gestanty River as a result of a water rock flow on May, 21, 2014; a road to the potable water intake for the settlement of Bylym was destroyed.

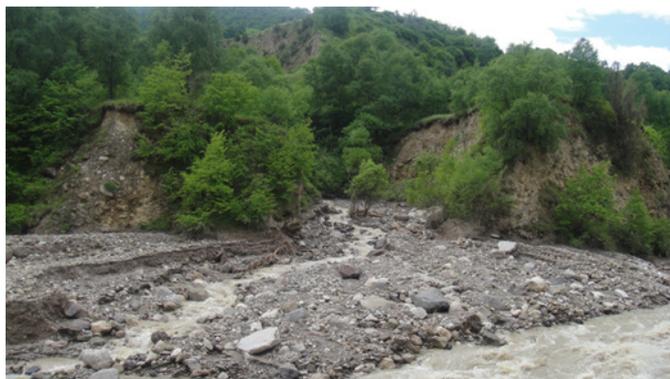
Fig. 11: A debris flow fan of the Abardan-Suu River blocked the Chegem River on May, 21, 2014 and destroyed a gas pipeline and a section of the Nizhny Chegem-El Tyube highway.

Mud-rock flows from many right tributaries of the Chegem River on 21 May 2014 reached their mouths. The most powerful ones (on the rivers of Abardan-Suu and Bykmylgy-Suu) not only destroyed the gas main pipeline (the gas supply was disrupted for a month) and a road between the plain and mountainous parts of the Republic in the Chegem river valley, but also blocked this transit river, brought about a dangerous change in the channel profile and blocked the underclearance of a single bridge in miles (Fig. 11).

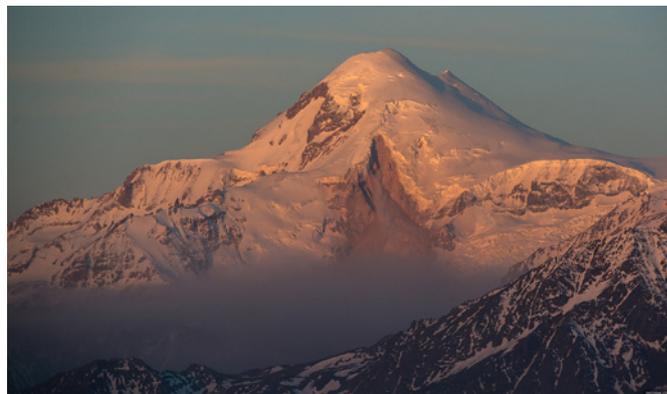
Fig. 12: View of the part of the eastern slope of Kazbek Mountain immediately after the catastrophic event (18 May). Photo by T. Agirov.

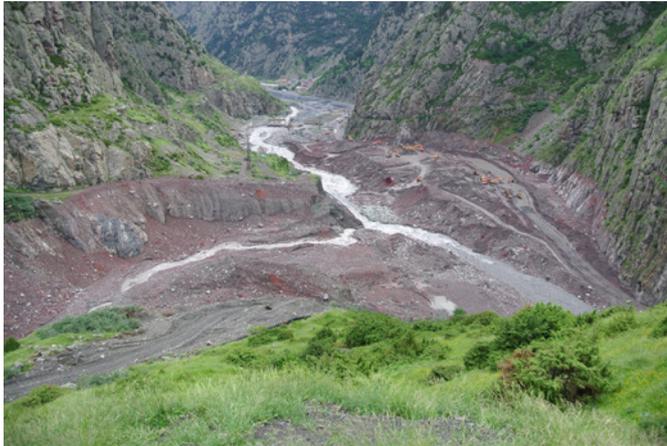
Fig. 13: The Terek River with the Daryal hydro-electric power station under construction in the distant view on June 10, 2014. Breaching of the debris rock-ice flow deposits of the Kabahi River.

million cubic meters in volume and a dammed up water body. Fortunately the spill over the blockage dam started soon (unlike in a situation on the Genaldon river near the village of Gornaya Saniba in 2002), and the backwater effect was deterred by the “self-switching” of the Terek river’s artificial channel (a diversion tunnel of the Daryal hydro-electric power station (Fig. 13)), constructed before the disaster, into operation.
