Environmental changes of Nepal Himalaya in terms of GLOF phenomena

Hiroji Fushimi

As in the other parts of Nepal, the environment of the Greater Himalaya is also rapidly changing with huge impacts on glacier, glacial lakes and GLOF occurrences. This paper briefly describes the environmental changes and GLOF characteristics in Nepal Himalaya.

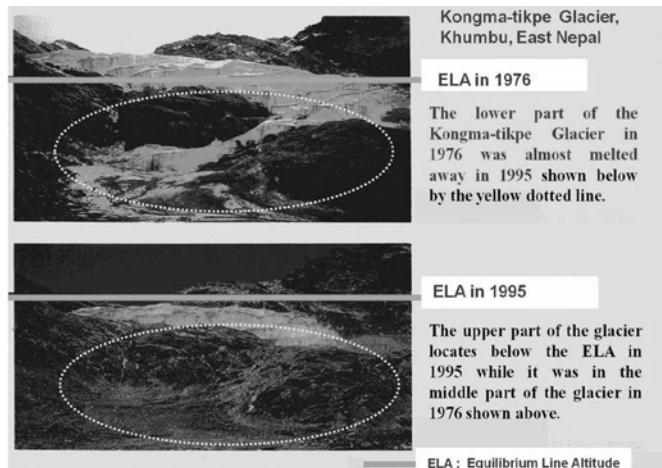
Fig. 1: Changes of perennial snow path in the Kongma-tikpe Glacier, Khumbu region, east Nepal.

Similar kind of the great change is observed in the Himalayan glacial phenomena. Fig. 1 shows the Kongma-tikpe Glacier located near the Khumbu Glacier of Mt. Everest, the ELA (Equilibrium Line Altitude) located in the middle of the glacier indicating a healthy glacier in 1970's, but now it is higher than the glacier altitude meaning all parts of the glacier are in an ablation area. That is why the glacier melts very fast. The Gyajo Glacier (Fig. 2) near Namche Bazar was also a healthy glacier in 1970, but it is retreated very rapidly and lost a perennial snow patch in 2009. These glaciers located below 7000 m might be disappeared in the middle of this century.

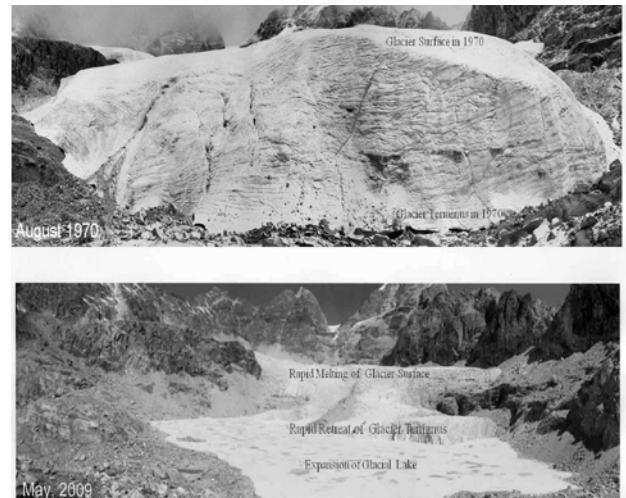
Fig. 2: Changes into a perennial snow patch in 40 years at Gyajo Glacier, Khumbu region, east Nepal.

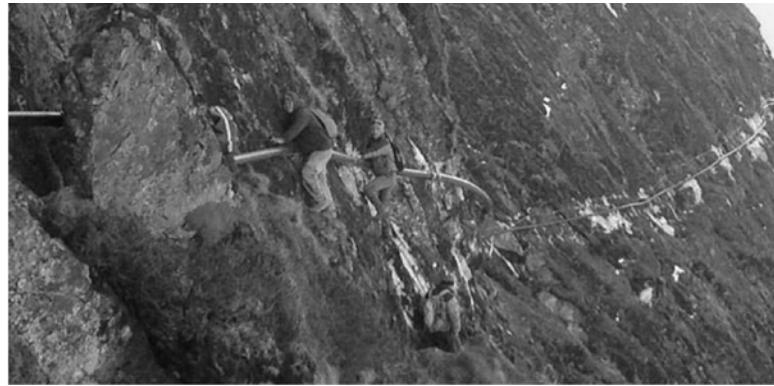
Fig. 3: Construction of the water pipe from Gyajo Khola, Namche Bazar area.

The Gyajo Glacier is an important water resource for Namche Bazar and the near-by villages in the Khumbu region and that is why they are working hard to construct a water pipe from the Gyajo Glacier (Fig. 3), but the local people may lose their water resource in near future. Such a case happened 5

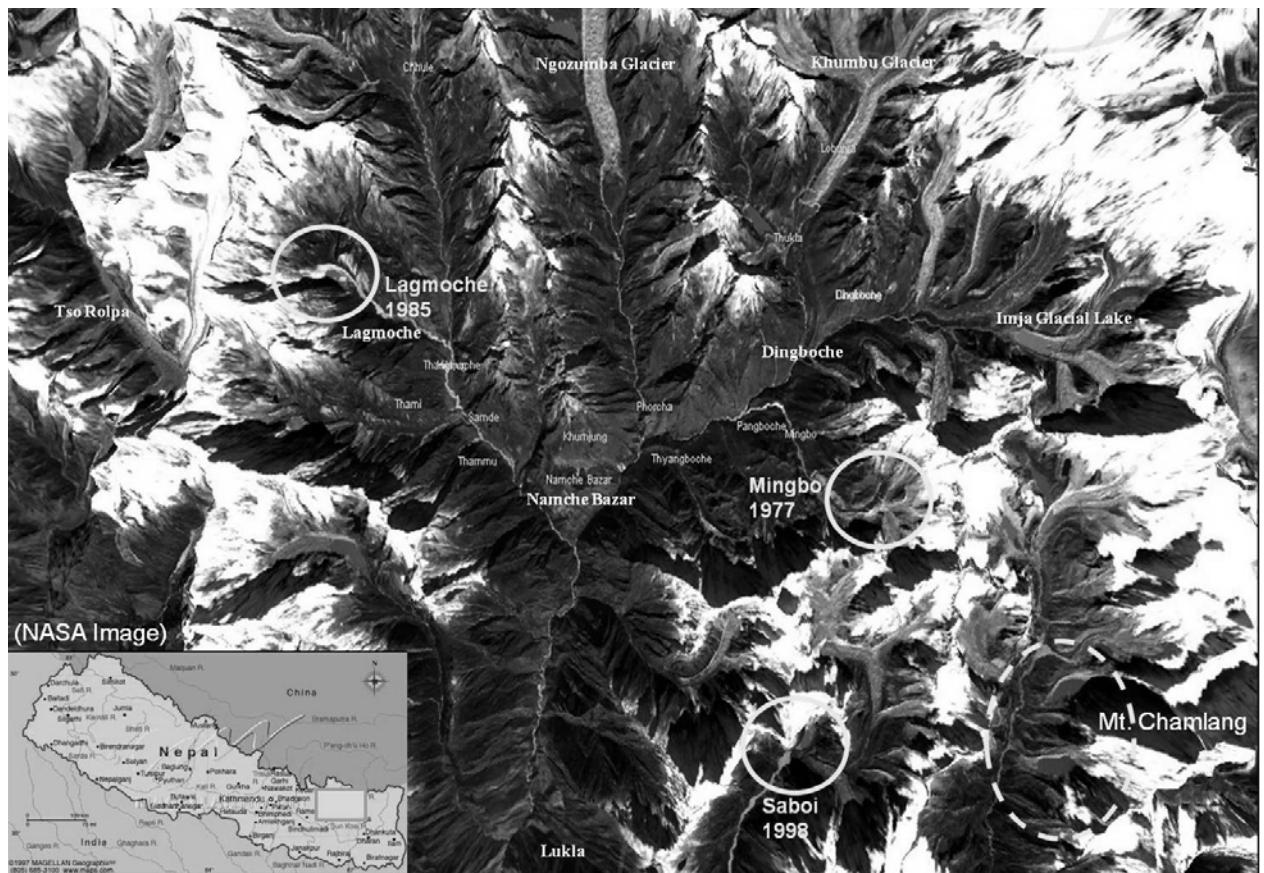
Fig. 4: GLOF map of the Khunbu region, east Nepal. Circle shows the GLOF from small lakes, dashed lines are the lakes (the smaller being at high GLOF risk in future).

occurred in the Khumbu region (Fig. 4). These reported GLOFs occurred due to outburst of smaller glacial lakes with less than 1 km^2 , but there is no record of lake outbursts of larger glacial lakes such as Imja and Tso Rolpa. The valleys eroded by GLOF are clearly seen even in the satellite image shown by the white line due to the eroded valley topography (Fig. 4).

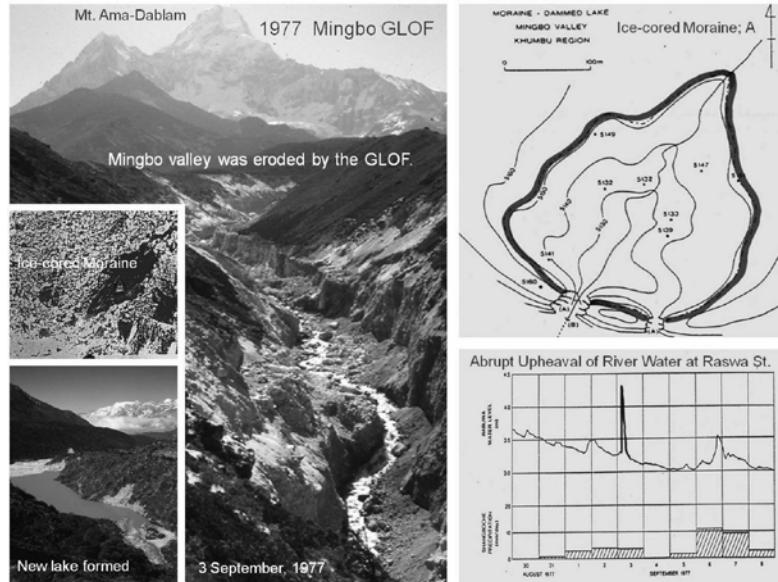
Fig. 5: 1977 Mingbo GLOF In the left phot, Mingbo valley eroded, Ice coreed moraine and newly formed lake are shown, and the vacant lake and Dudh Kosi hydrograph in the right figure.

The Mingbo (Nare) glacial lake was located in the south of Mt. Ama Dablam, Khumbu region. On 3 September, 1977, the lake caused the GLOF (Fig. 5) when we were doing

glaciological surveys in the region. So, we went up along the eroded Minbo valley caused by the GLOF (Left photo) and observed the vacant lake 300 m long, 200 m wide and 30 m deep with the terminal moraine destroyed (Upper right). There was an ice-cored moraine (Left photo).

Due to the large amount of debris caused by the GLOF, a new lake was formed in the Imja Khola near Pangboche (Lower left photo), while the river level of Dudh Koshi was raised abruptly about 1 m at Raswa Hydrological Station (Lower right). So, the GLOF has destructed roads, bridges and houses near the river bed along the Dudh Koshi.

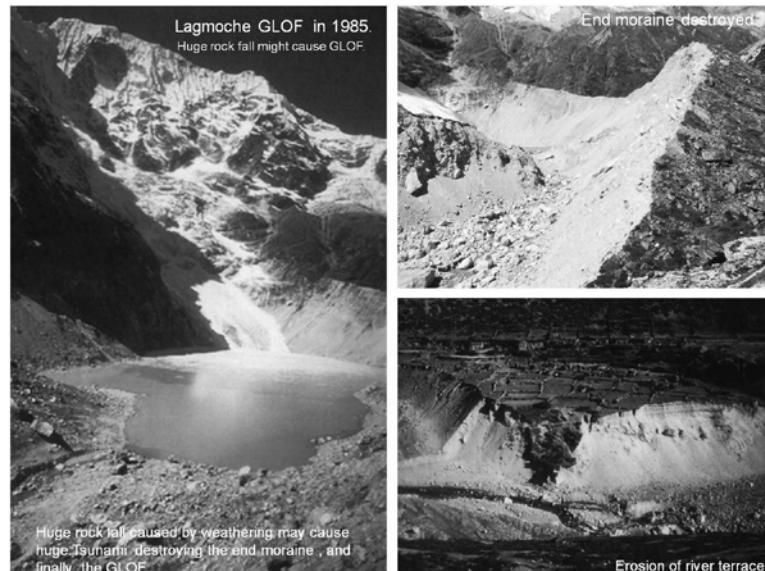
Fig. 6: Langmoche (Digtsö) glacial lake near Thame in the western part of the Khumbu region. End-moraine was destroyed at the 1985 GLOF and the GLOF disaster was reported along the Dudh Koshi.

The Langmoche (Digtsö) glacial lake near Thame in the western part of the Khumbu region has the steep cliff causing avalanches and rocks directly falling into the lake and huge waves (Tsunami) possibly destroyed the end moraine (Upper right photo) and villages along the river (Lower right photo) by the 1985 GLOF (Fig. 6).

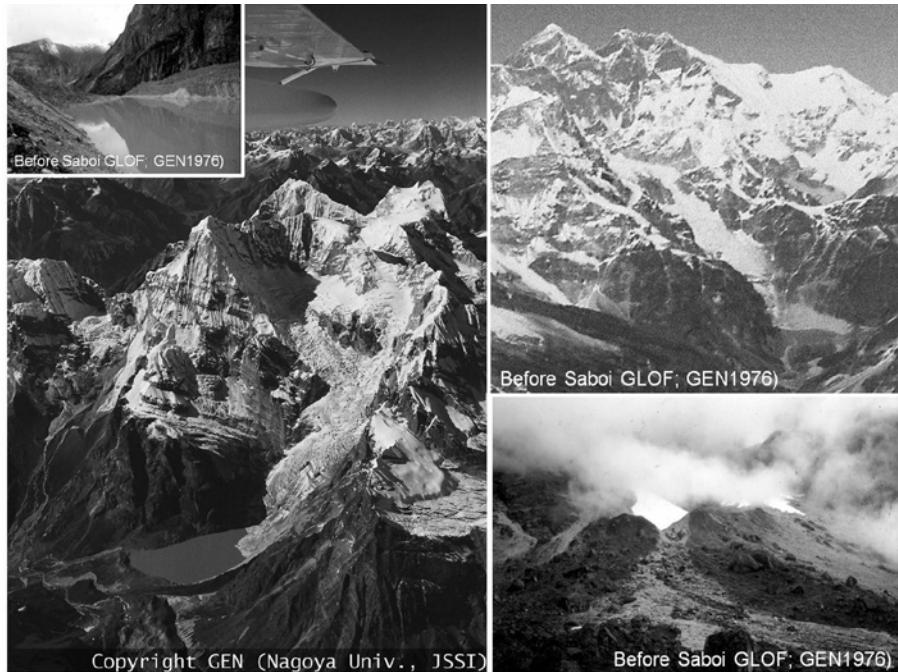
Fig. 7: Sabai glacial lake is in the south-eastern part of the Khumbu region and has a steep cliff in the upper part of the lake.

Fig. 7 is the picture of the Sabai glacial lake as well as its glacier taken from a plane and in field survey of 1976. The Sabai glacial lake in the south-eastern part of the Khumbu

region lies on Hinku Khola and has also the steep cliff in the upper part of the lake (Fig. 7). The end moraine of the lake was probably destroyed by a kind of Tsunami due to the avalanche or rock fall from the steep cliff at the time of the 1998 GLOF.

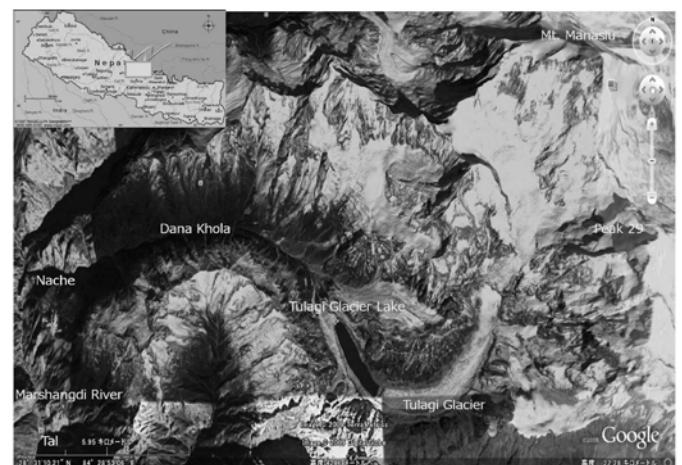
Fig. 8: The changes of the Thulagi glacial lake and its glacier terminus.

The changes of the Thulagi glacial lake and its glacier terminus were determined by air photos and field surveys. The lake size is 3 km long, 0.5 km wide and expanded at yearly rates of 31 m from 1975-1992, 47 m from 1992-2005, 68 m from 2005-2008, 60 m from 2008-2009 and no significant

change from 2009-2014 (Fig. 8). The recent changing rate had been accelerating with active calving from 1975 to 2009, but it seems to be settled down and show no remarkable calving phenomena since 2009. The terminus of the Thulagi glacier was thought to have stranded on the lake bed.

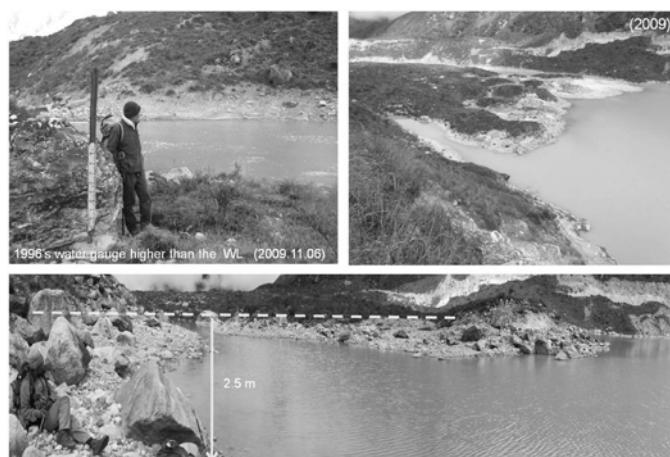
Fig. 9: The white arrows show the lowering of Thulagi lake level form 1996 to 2009.

As Department of Hydrology and Meteorology (DHM) made a glaciological survey in 1996, the topographic characteristics were compared with the photographs of 1996 and 2009 in the lower part of the lake, and the lowering of the lake level is clearly shown by the yellow arrows and a clean pond is newly formed due to the sedimentation of glacial clay at P point (Fig. 9).

The shore line without vegetation is 2.5 m above the present lake level and the 1996 water gauge has been left higher than the present lake level. The lake level lowered 2.5 m from 1996 to 2009.

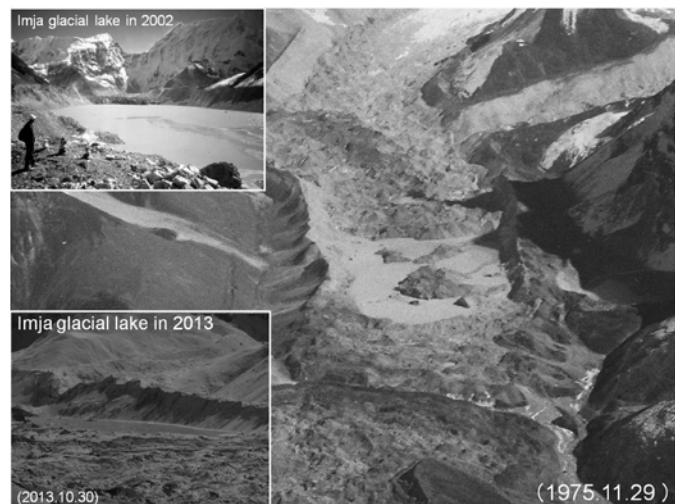
Fig. 10: Changes of the Imja glacial lake from 1975 to 2013.

Fig. 10 shows the Imja glacial lake taken in 1975 by plane, and in 2002 (upper left photo in Fig. 10) and 2013 (lower left photo in Fig. 10) taken during the field study. The size of Imja glacial lake expanded from 1975 to 2002, but reduced in 2013. The end moraine structure of Imja glacial lake is also wide and strong enough to prevent the occurrence of the GLOF. ICIMOD (2011) reported that Imja glacial lake has less likelihood of out burst than Thulagi lake.
