## **Occurrence of landslides in Nepal and their mitigation options**

**Prem Bahadur Thapa**

### **ABSTRACT**

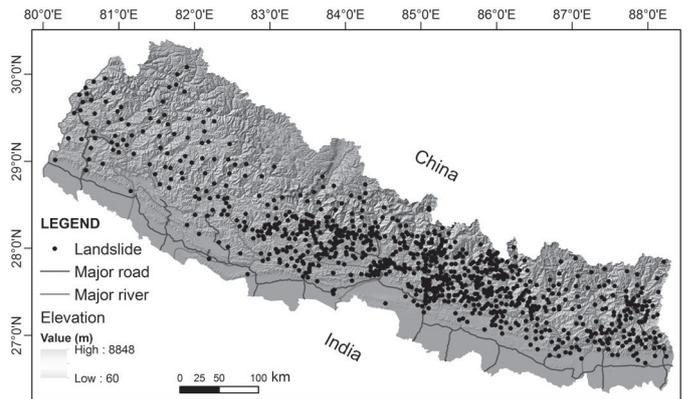
**Fig. 1: Spatial distribution of pre-earthquake (before 2015 Gorkha Earthquake) landslides in the Nepal Himalaya. (Source: DesInventar, MoHA, DWIDP, LRA/DoLIDAR/ Scott Wilson 2002, Dahal and Hasegawa 2008)**

Nepal suffers from a large numbers of landslides especially during the late monsoon period when pore water pressure builds up in the hill-slope mass or catastrophic earthquake happens. Spatial distribution of pre-earthquake landslides in Nepal is shown in Figure 1. Available landslide and related hazards database (DesInventar) during the period from 1971 to 2015 shows that average loss of life is about 200 per year in Nepal and one of the most devastating landslide-related hazards in July 1993 (e.g. Fig. 2a) that killed 1336 people in the central Nepal (Chhetri and Bhattarai 2001). On 2 August 2014, a massive landslide at Jure, Sindhupalchowk District in the central Nepal was caused by rainfall event, the deadliest in the country's history that a single landslide killed 146 peoples, buried the Arniko Highway and created a high artificial dam about 3 km long across the Sunkoshi River and blocking the flow of water completely for nine hours (Fig. 2b). Due to repeated occurrence of catastrophic slope failures in Nepal, it is important to monitor or investigate the instability indications which might give clue to precursor of transient failure. For example, developments of alluvial fan at the down-slope of stream which makes confluence to other river and drunken trees in the hill-slopes indicate potential sites of future slide (Fig. 3a, b). If any indications had known in

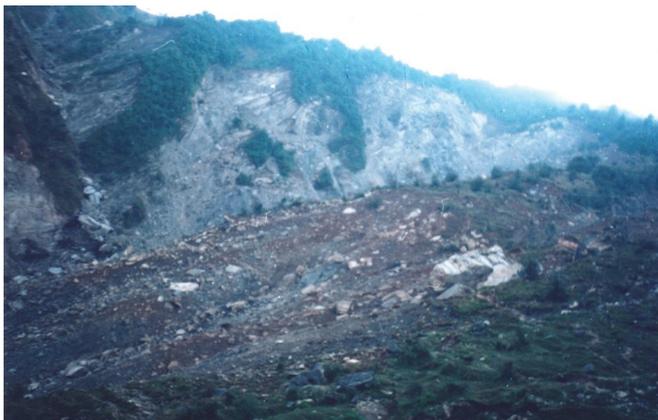
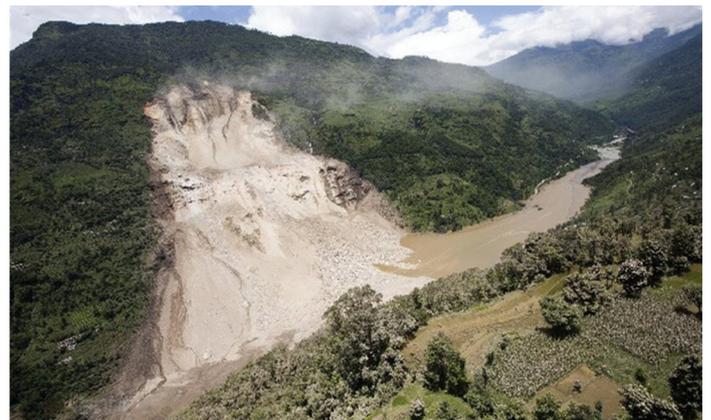
**Fig. 2: Noticeable landslides in Nepal (a) landslide at Chisapani village, Makawanpur caused by the 19–21 July 1993 water-induced disaster and (b) huge landslide at Jure, Sindhupalchowk on 02 August 2014.**

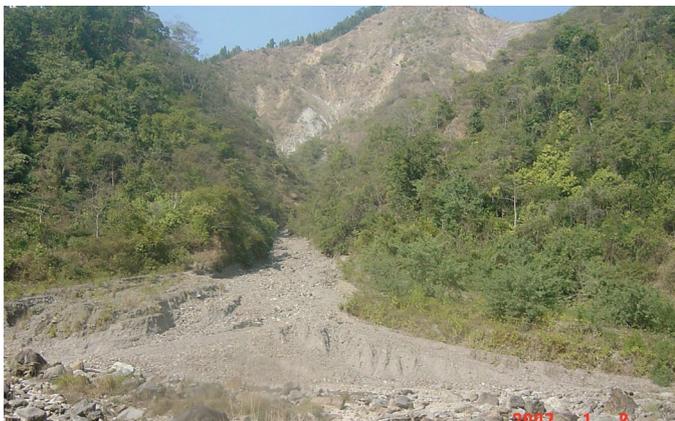
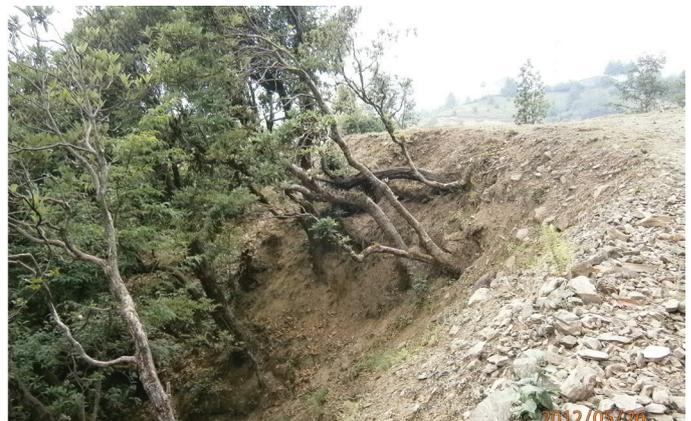
**Fig. 3: Indications of hill-slope instability in mountainous terrains (a) alluvial fan and (b) drunken trees.**

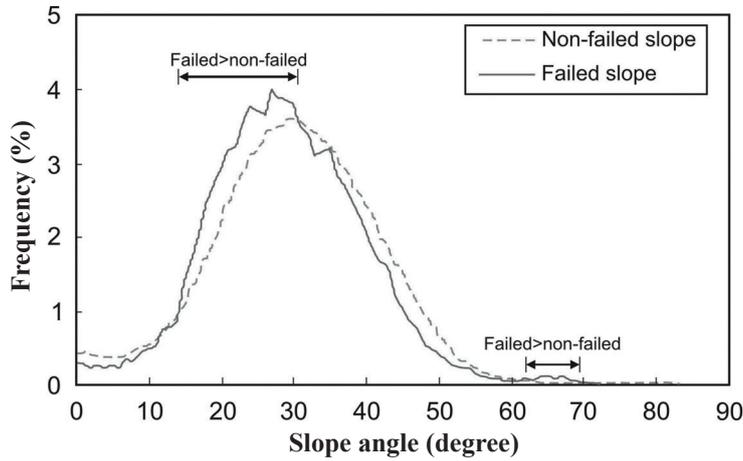
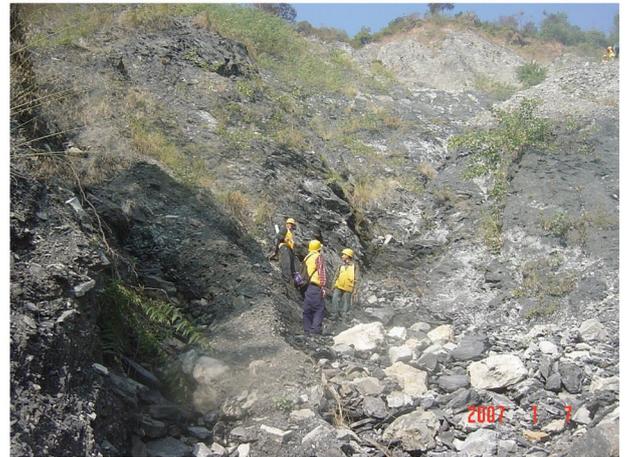
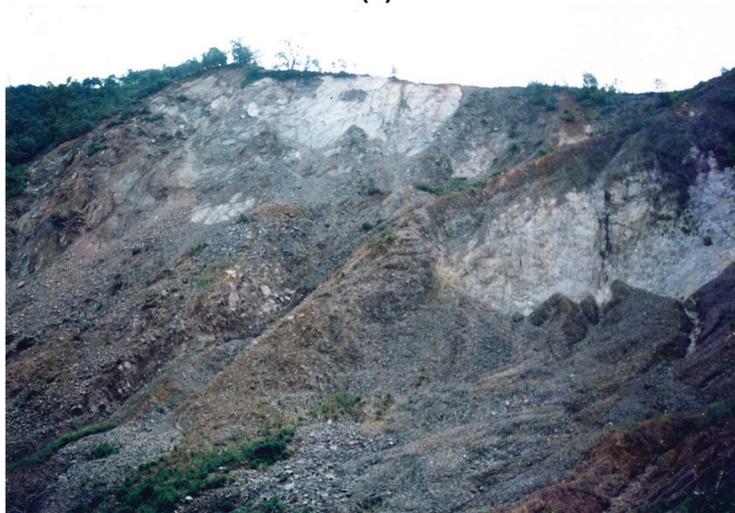
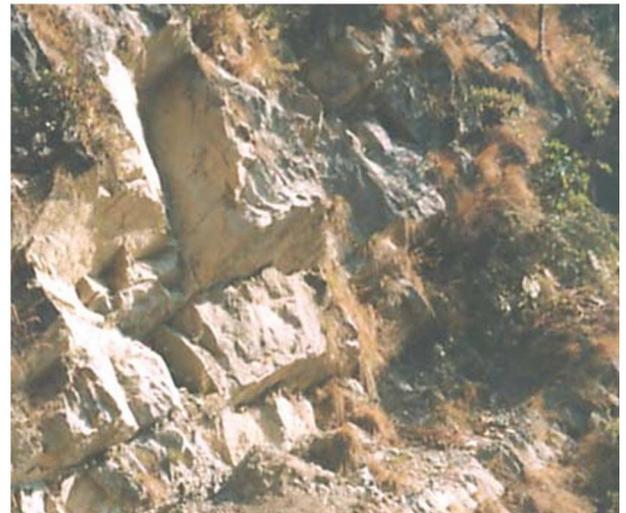
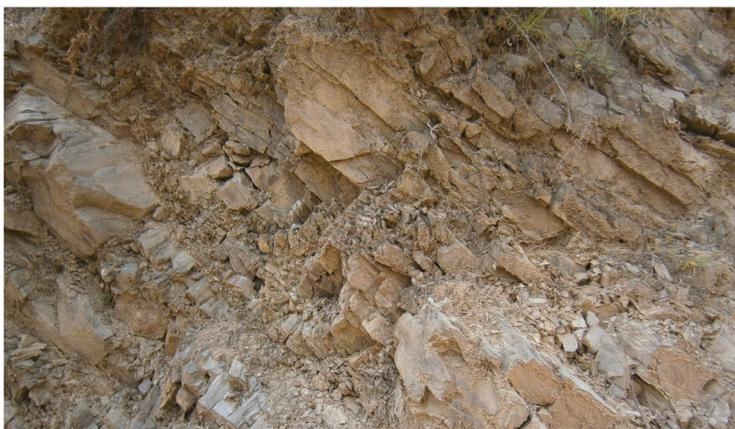
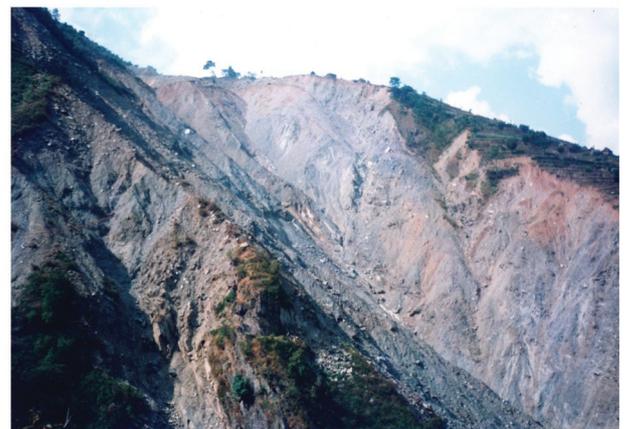
**Fig. 4:** Topographic and geologic cause for landslide initiation in Nepal (a) slope gradient (Thapa 2011), (b) shear zones at Main Boundary Thrust (MBT), (c) orientation of discontinuity in the direction of slope-face, (d) intersection of joints forming unstable wedge, (e) high degree of jointing/fracturing, and (f) granular soil in steep hill-slope.

study in the central Nepal showed that predominant occurrences of landslides are found in the slope angle range from 25 to 35 degrees (Fig. 4a). Hillslope orientation is also the topographic factor and shows a strong inheritance from bedrock structure, especially by bedding or metamorphic foliation because the

The landslides in Nepal are densely distributed in close proximity to the major faults/thrusts or linear boundary formed by competent and incompetent strata (Fig. 4b). When excavations are made into dip slopes or slopes with upward inclined strata, potential planes of weakness are truncated and exposed. These are called out-of-dip, or daylighted cut slopes. Many dip slope failures are ascribable to strain incompatibility between materials of contrasting permeability or stiffness, such as sandstone and shale. Dip slope conditions are also created by inclined discontinuities, such as systematic or secondary valley-side joints; especially in strongly foliated rocks, such as schist. Dip slope failure caused by surcharging slope with unkeyed fill and excavating toe of slope for development. Many landslides in mountain hill-slopes are originating as planar slides at initiation point (Gerrard 1994) and converted into debris slide to flow which generally moves in downslope with high velocity (Fig. 4c). Foliations dipping back into slope or vertically stratified strata often undergo massive toppling failures along inclined joints and intersection of joints lead to the wedge failure (Fig. 4d).

Rock weathering, jointing, and fracturing (Fig. 4e) lead to slope failures that may have been accelerated by a complex interplay of active tectonic and climatic forcing factors in Nepal. Soil dynamics is another factor, most often the presence of incoherent granular soil in steep mountain slopes and usually characterised by frequent slope failures due to less inter-particles cohesion of the soil (Fig. 4f) and fine soil or swelling clayey soil shows much complex behaviour in landsliding. With highlighting the landslides in terms of topographic and geologic control, the landslides occurrences in distinct geological sub-divisions of the Nepal Himalaya and their characteristic features are further described as:

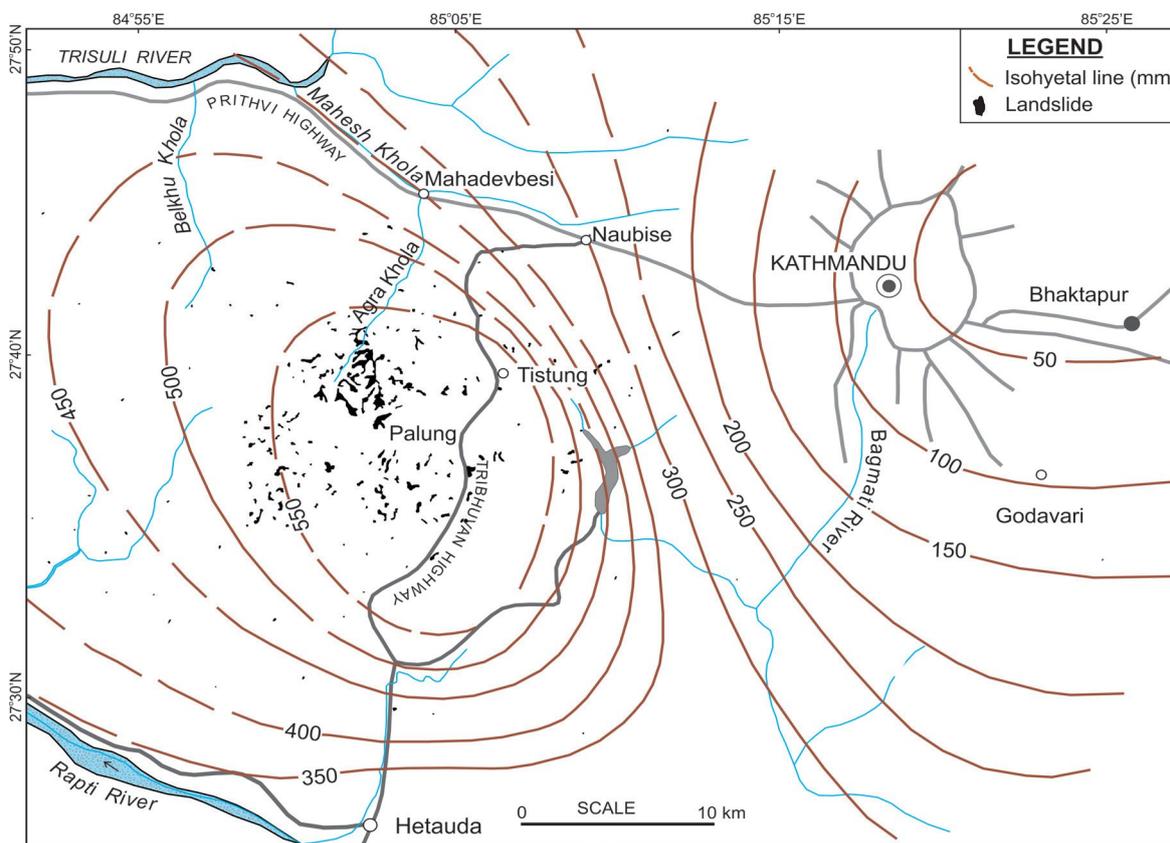
Fig. 5: Rainfall triggered landslides (isohyetal map showing 24-hour rainfall of extreme weather events during 19–21 July 1993 and occurrence of landslides in the central Nepal). (Source: DHM)

evidences showed that precipitation has infiltrated downward and forms perched water or saturated zones on top of impermeable layers, so as to reduce soil strength. Precipitation also adds to the weight of rock and soil mass, creates pore water pressure and reduces suction (Zhang and Liu 2010). The effective strength of the colluvial or thin residual soils is reduced, and thereby landslides are triggered. Shallow slides are usually triggered by short intense rainstorms whereas the deep-seated landslides are caused by long-duration rainfall event. Large-scale landslides can be also seen as landmasses in natural slopes that might have moved long ago (hundreds to thousands of years ago), and still retain the original slope form without complete collapse (Bhandary et al. 2013). Extreme weather events are common in Nepal during summer Monsoon season (Dhital et al. 1993), for example extreme weather event (with maximum rainfall of 440 mm in 24 hours) of 19–21 July 1993 was the key factor to causes the spatial localisation of landslides in the central Nepal (Fig. 5).

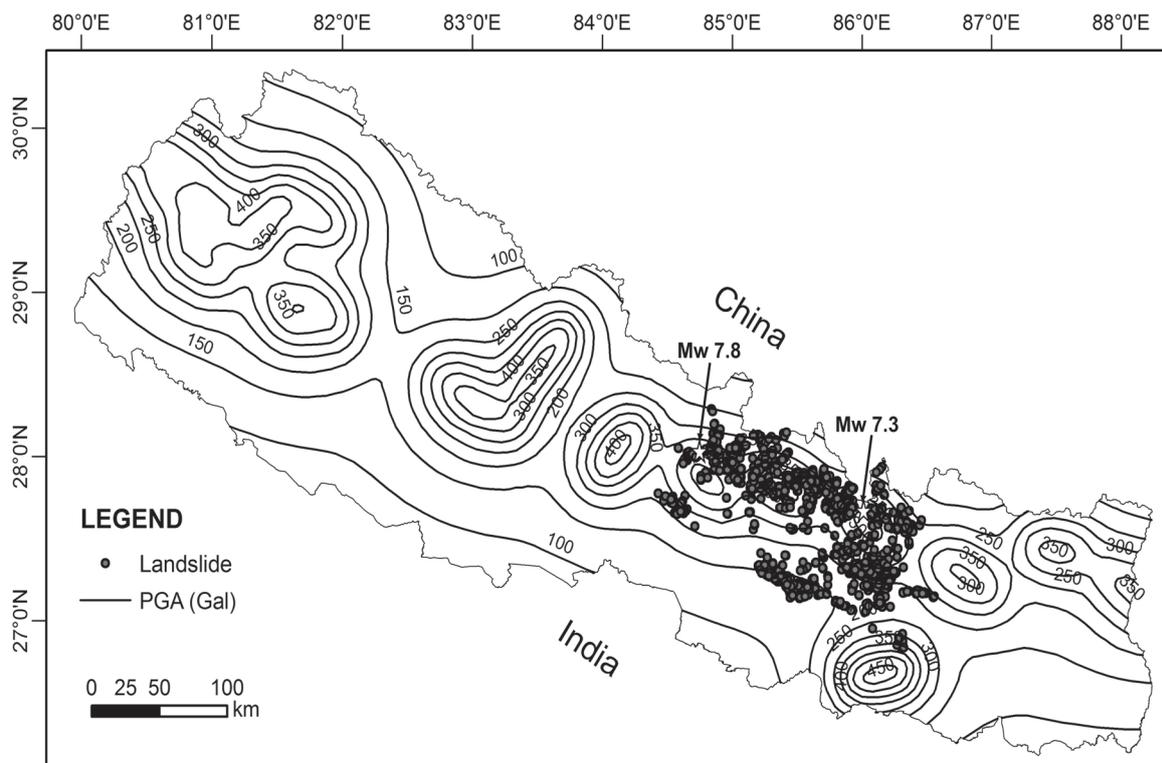
Fig. 6: Earthquake triggered landslides (preliminary inventory), Mw 7.8 2015 Gorkha Earthquake and occurrence of landslides in the central Nepal and overlaying with peak ground acceleration (PGA) values of Nepal (Source: Department of Mines and Geology, Nepal).

On 25 April 2015, the Gorkha Earthquake with Mw 7.8 triggered a large number of landslides with various types, including highly disrupted shallow slides, rock falls, and large-scale avalanches (Fig. 6) whilst monsoon rain continues that may trigger numerous new landslides as the mountain slopes were already weakened by the Gorkha Earthquake and its heavy aftershocks. Thus, Nepal is located in seismically active belt of the Himalayas and earthquake is another major dynamic factor that can trigger a large number of landslides but from the statistical point of view, precipitation is a much more important triggering factor than earthquakes (Bertolini 2010).

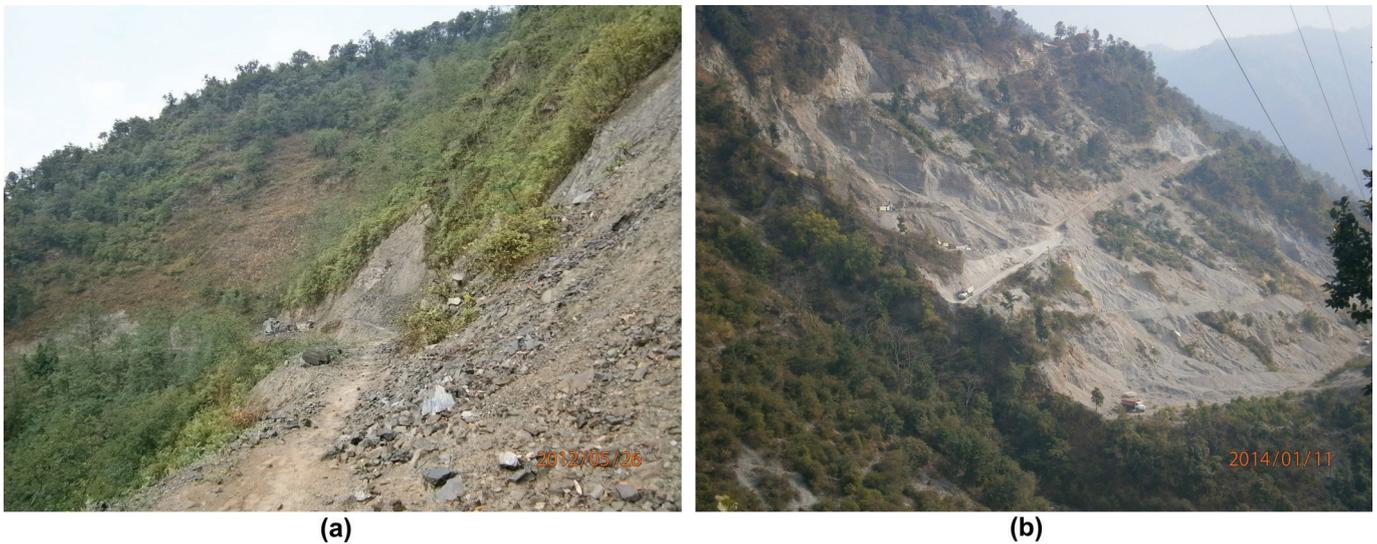
**Fig. 7: Human intervention and landslide occurrences (a) road construction without due consideration of engineering geological conditions and (b) quarrying/mining activities.**

Among the factors contributing landslides, human activities are the easiest to manage and change. A number of landslides occurred along the highways and road corridors of Nepal (Fig. 7a); the road is considered to increase the probability of landslides in hilly terrains as a result of undercutting and the application of surcharges which is particularly true in places where the topographic slope and the dip of the beds are in conformity (Petley 2007). Thus, landslides are highly localised along the major highways as well as in recently expanding rural roads that significantly increases the losses and damages. Deoja (1994) estimated that 400-700 cubic meters of landslides occurs per kilometre per year along the mountain roads and 3000 to 9000 cubic meters of landslide occurs per kilometre during the construction of mountain roads in Nepal. In attempt to reopen the damaged roads, the alignment is always shifting towards hill-side which further destabilises the fragile colluvial slope (Adhikari 2001). With fast economic development, human engineering activities have become ever more intensive and prominent. Usually most engineering works are carried out in dry seasons when steep slopes can be created. These remain stable until the next rainy season or longer, and may become unstable after an exceptionally wet period or because of other triggering factors (Zhang and Liu 2010). Moreover, human activities like mining, quarrying etc. are also aggravating the hill-slopes which ultimately accelerates the landslides process (Fig. 7b).

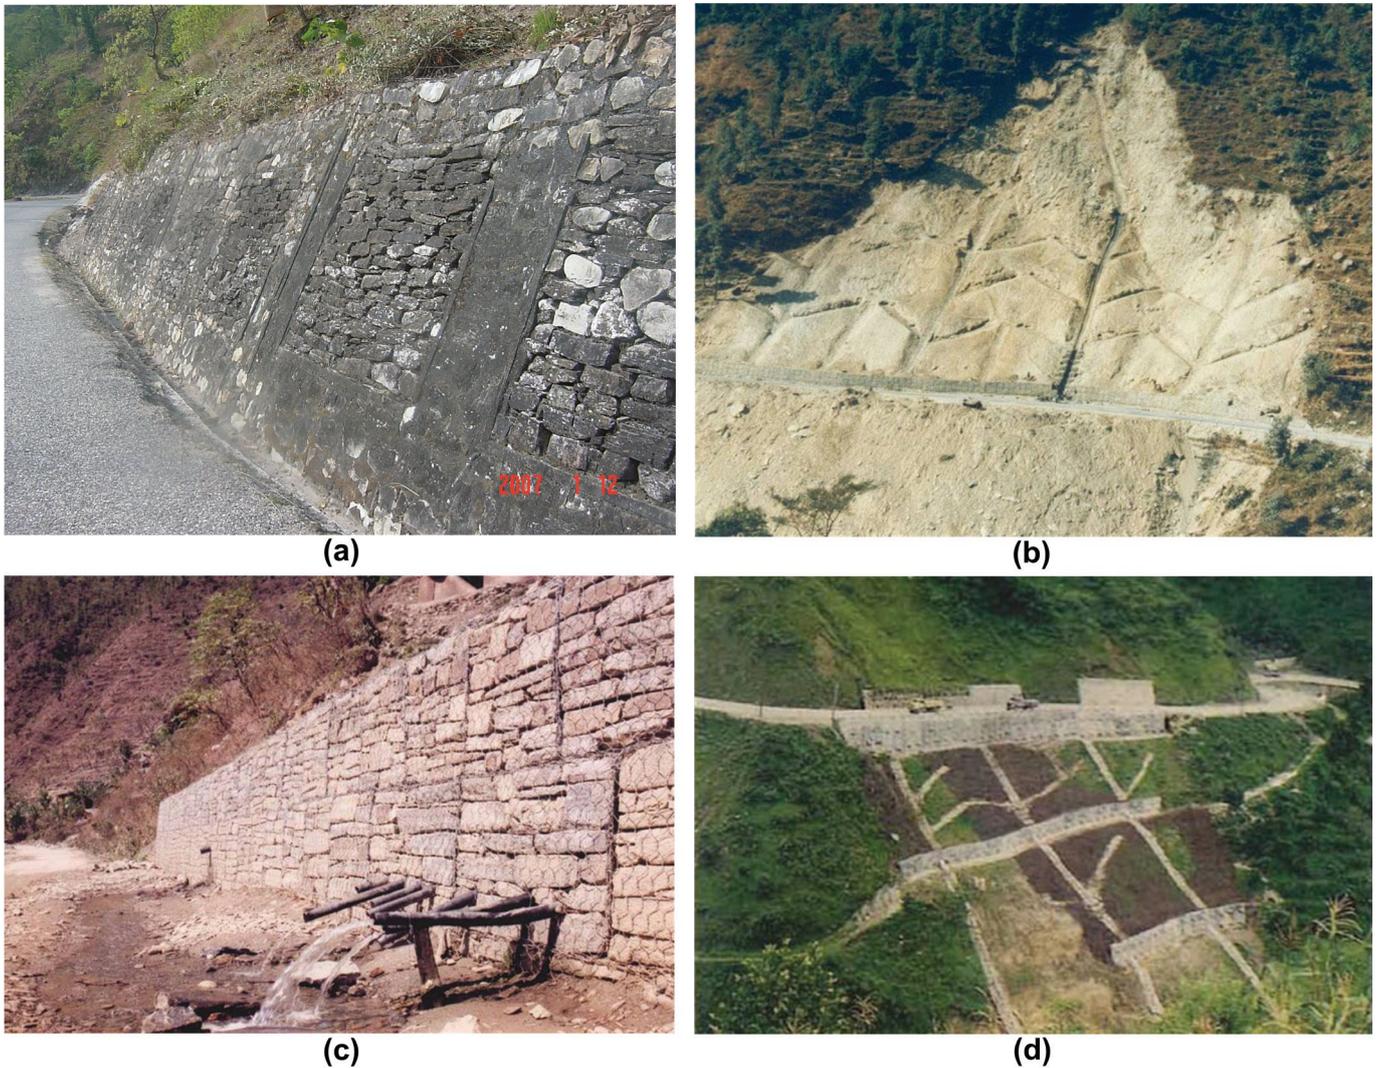
**Fig. 8: Slope stabilisation practices in Nepal (a) mortared frame masonry wall, (b) surface drainage, (c) gabion wall with installed horizontal drains and (d) retaining walls and rock anchorage.**

(2014) analysed the various types of landslide mitigation works along the highways and roads in the different parts of the country. The bioengineering, drainage, and geotechnical measures were extensively used along the road combined with labour-intensive road construction practices. In addition to the replication of successful measures from Dharan-Dhankuta and Lamosangu-Jiri roads, further innovative geotechnical solutions applied in the roads included various forms of composite revetment structures, different types of spurs with face block protection, launching aprons with composite frames or articulated concrete blocks, boulder riprap, boulder armouring using interconnected boulders, rock fall netting etc. Quite a good number of geotechnical practices were introduced and advanced in the construction of Japan-assisted Bardibas-Sindhuli-Banepa Highway. Extensive use of geogrids, reinforced earth, ground anchors, horizontal drains, diverse foundation types, and river training works were applied in the road projects in conjunction with bio-engineering measures (Adhikari 2014). An example of retaining walls, rock anchoring, surface, and subsurface drains can be found along the Naubise and Thankot road section (Fig. 8d).
