Kolka Glacier and Genaldon River valley: yesterday, today, and tomorrow

E. V. Zaporozhchenko
Institute “Sevkavgiprovdhoz”
Pyatigorsk, Russia

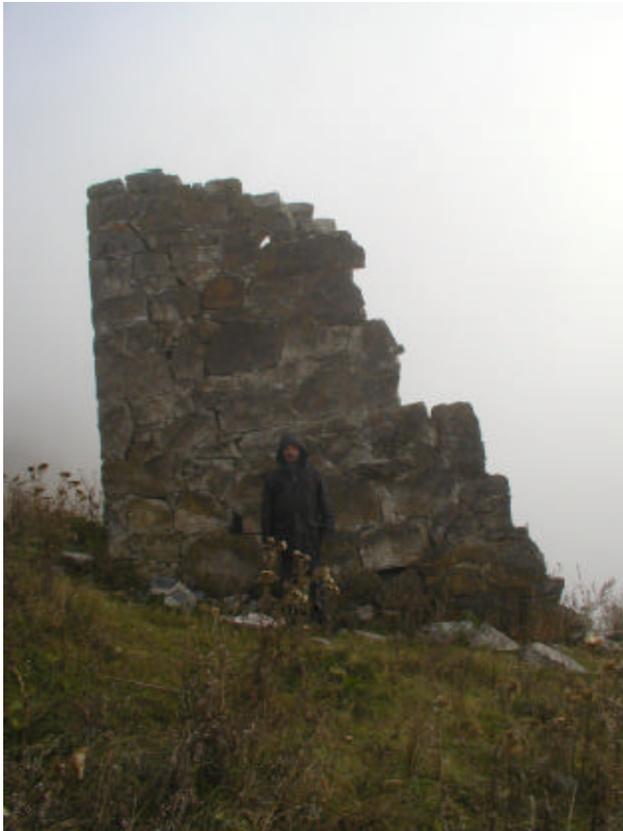
Fig. 1: The ruins of Genal village. (Photo by E. Zaporozhchenko 04.11.2002.)

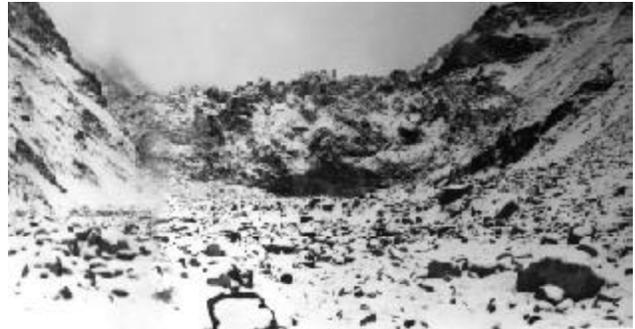
Fig. 2 : The ice front of the moving glacier Kolka is filling the valley of the Genaldon River at an altitude of 1980 m. Verkhne-Karmadonskies mineral springs are blocked on 29 January 1970.

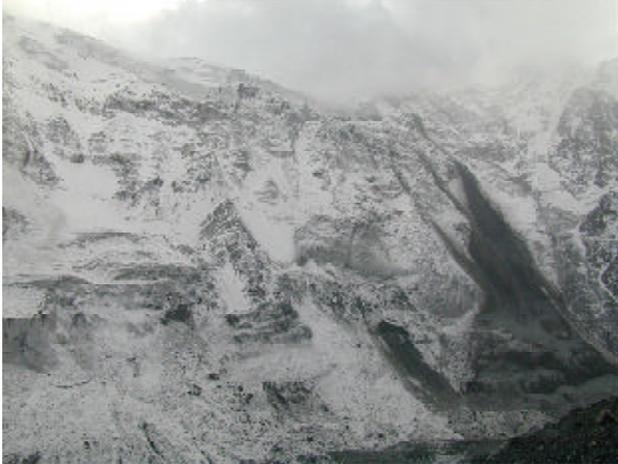
Fig. 3: The ice masses on the northern slope of the Maily-Dzhimaraj-Hokh mountain range. Note dark background on the right, in the outlined border of the ice avalanche of 20 Sept 2002. (Photo by O. Ryzhanov, 20 Oct 2002).

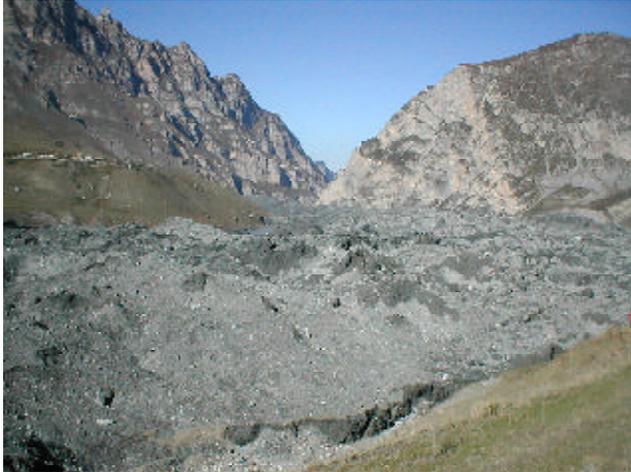
Fig. 4: The rock-ice blocking masses near the “Karmadon Gates” (Photo by E. Zaporozhchenko, 6 Oct 2002)

of the village of Gizel, the debris flow became a sediment-laden flood. It would be more correct to speak not about “ice masses” but “rock-ice masses”, which include about 30% of rock material with clasts of a very wide range of sizes and about 70% of ice itself. This mass moved down a distance of about 19 km from the place of its collapse on the Kolka Glacier down to the narrows of the Skalistyy Range (Fig. 4).

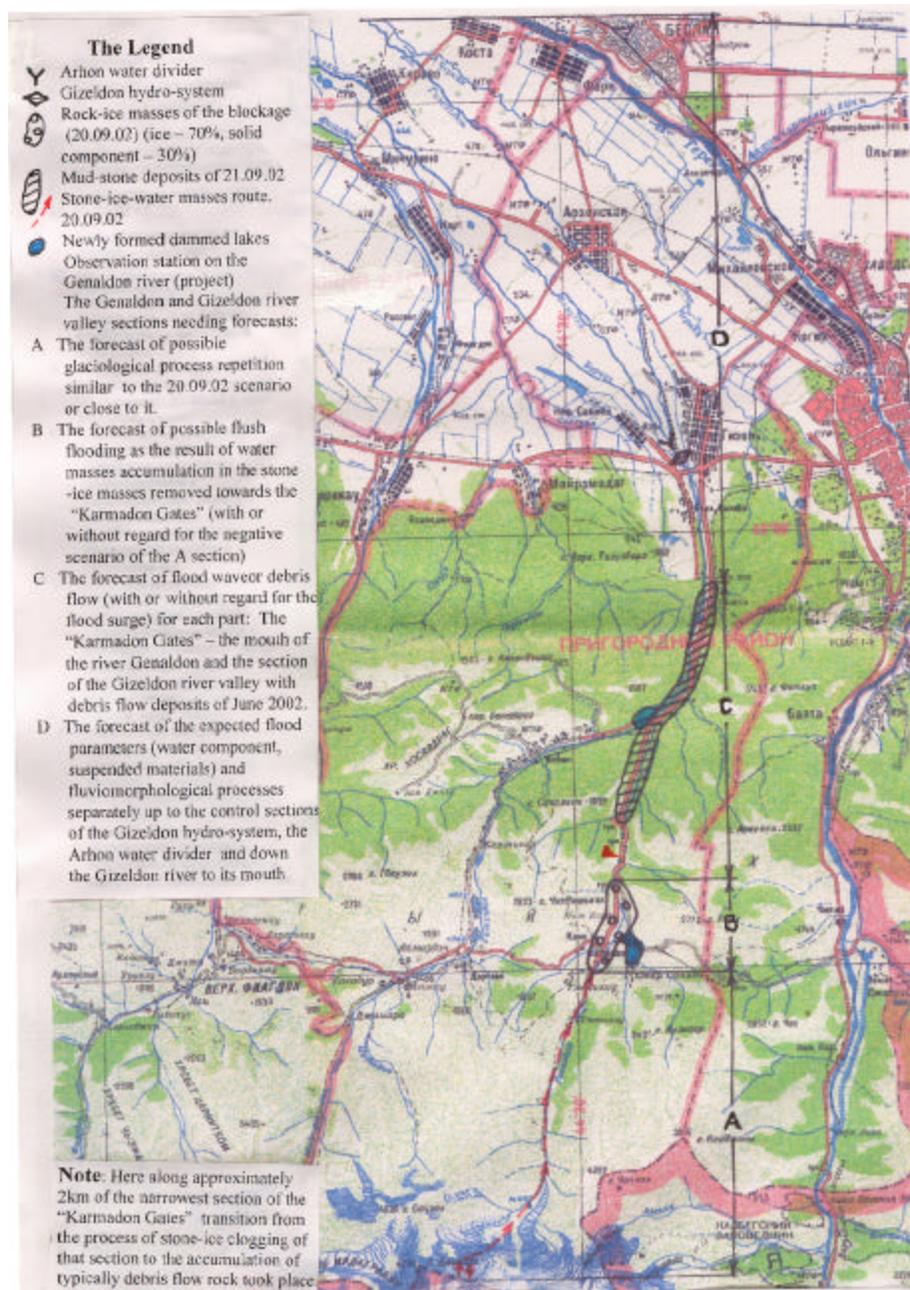
Fig. 5: Map of Genaldon glacier catastrophe of 2002

The consequences of the Kolka Glacier collapse and the undertaken rescue and rehabilitation measures up to February 2003 are depicted in Fig. 5.

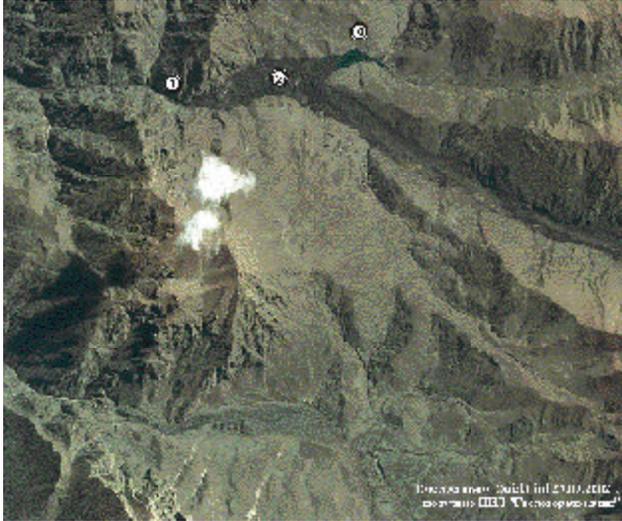
Fig. 6.: Satellite imagery of the Genaldon river valley: 1 – “The Karmadon Gates”; 2 – rock-ice masses of 20 Sept 2002 blockage; 3 - newly formed Lake “Gornaya Saniba”

The lake came into existence due to the blockage of the Fardon and Kauridon Rivers and was rapidly being filled up. It was inundating and damaging buildings and other infrastructures (Fig. 6).

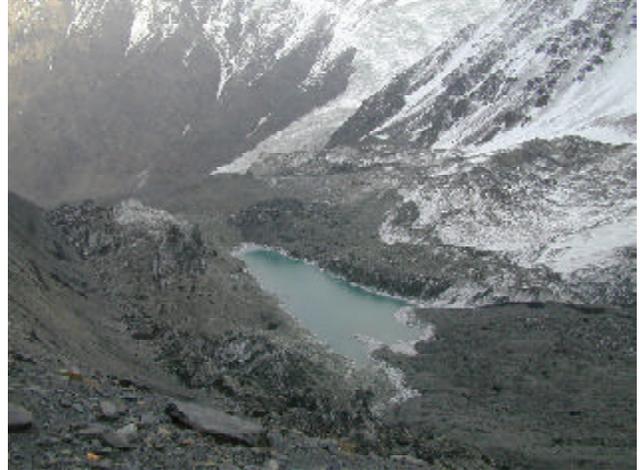
Fig. 8: 20.10.2002. New lake formation in the mountain valley previously covered by the Kolka Glacier (till 20 Sept 2002). (Photo by O. Ryzhanov)

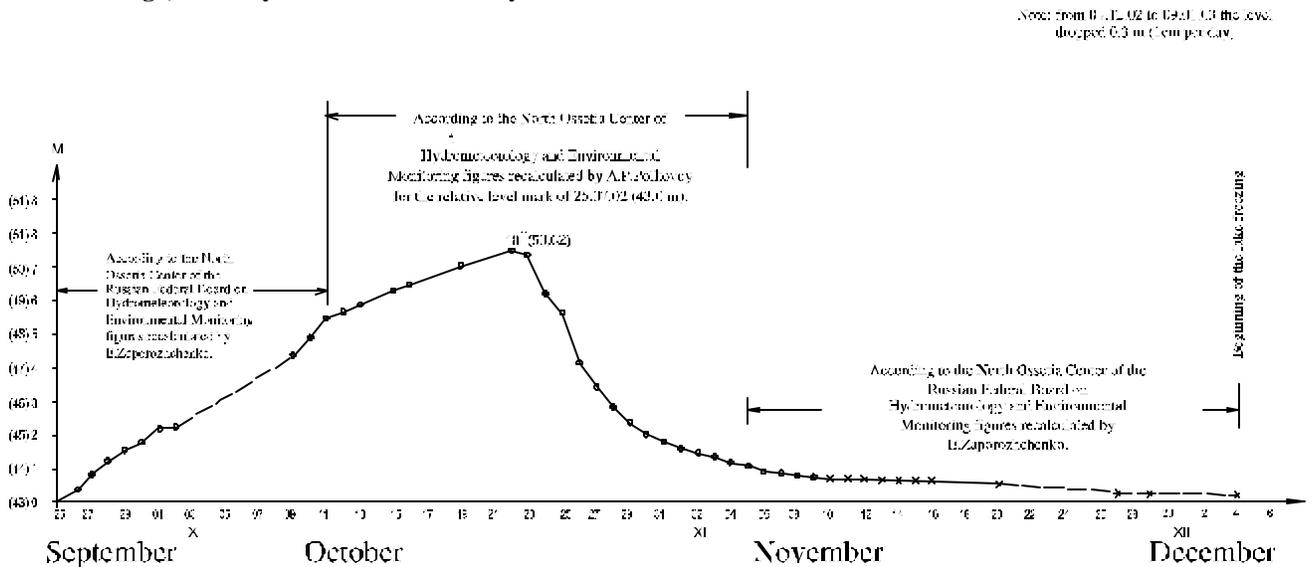
Fig. 7: The diagram of Lake “Gornaya Saniba” water level fluctuations

to the first ten-day period of December 2002, when the lake finally froze (Fig. 7). The water level returned to the mark, fixed on 25 September 2002, and the natural water discharge was 0.5 million m³. The water level monitoring was terminated on 9 January 2003.

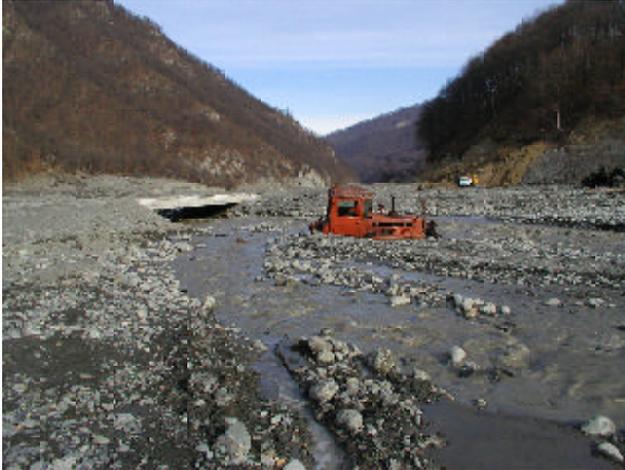
Fig. 9: Debris flow stone-mud masses in the mouth of the Genaldon river. The downstream view. (Photo by E. Zaporozhchnko, 6 Dec 2002).

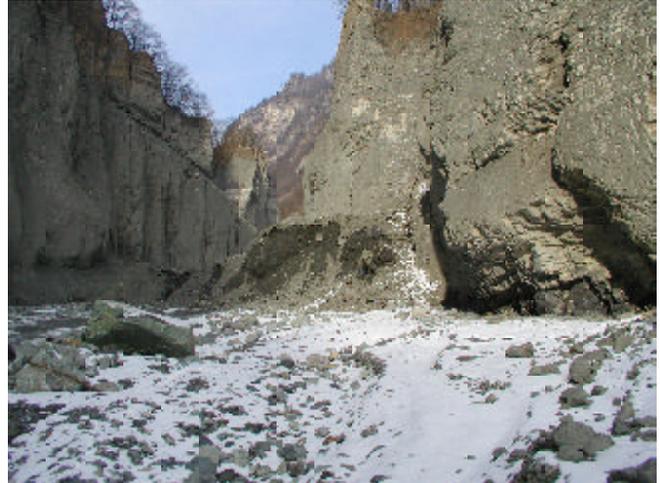
Fig. 10: An ice block on the Genaldon river's right bank (the lower highway tunnel section). The downstream view. (Photo by E. Zaporozhchenko 20 Feb 2003).

The exit from the "Karmadon Gates" is situated on the lower section (downstream of the Karmadon River) of the highway tunnel (destroyed) on the right bank. Large ice blocks were still seen near the north portal of the tunnel at the end of February 2003 (Fig. 10), near the south portal (Fig. 11), the

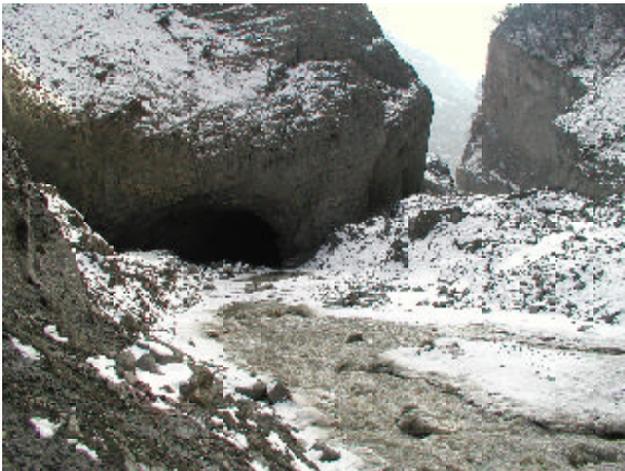
Fig. 11: The Genaldon River is flowing through the south end of highway tunnel remnant. (Photo by E. Zaporozhchenko, 20 Feb 2003).

river flows out from under the rock-ice blockage (the bottom is raised about 7–8 m above the level of September 2002). During the first days after the debris flow, the ice blocks could be found 10 km downstream than the “Karmadon Gates”!
