# Hydro-torrential hazard vs. anthropogenic activities along the Seti valley, Kaski, Nepal: Assessment and recommendations from a risk perspective

The Seti River originates from the Annapurna Massif in the Higher Himalaya of Nepal and flows through the Pokhara valley in the Lesser Himalaya. The Seti River witnessed a disastrous flash flood on May 5th, 2012 causing the death of 72 people, obliterating dozens of homes and damaging infrastructures worth millions of dollars. Despite the 2012 flood event and several warnings by scientists for more yet bigger scale future floods in the Seti valley, fluvial risk is being aggravated by anthropogenic activities such as unplanned human settlement, encroachment of riverbanks, haphazard construction of road, drinking water, and hydropower projects in potential flood hazard areas in addition to the increased impacts of climate change on geological and hydro-metrological hazards as in other parts of Hindu Kush Himalayan Range. Covering some 40-km distance from the Seti headwater (Sabche Cirque) down to Pokhara city, the study is carried out based on hydro-geomorphological mapping, analysis of land-use and land-cover change, hydrological analysi

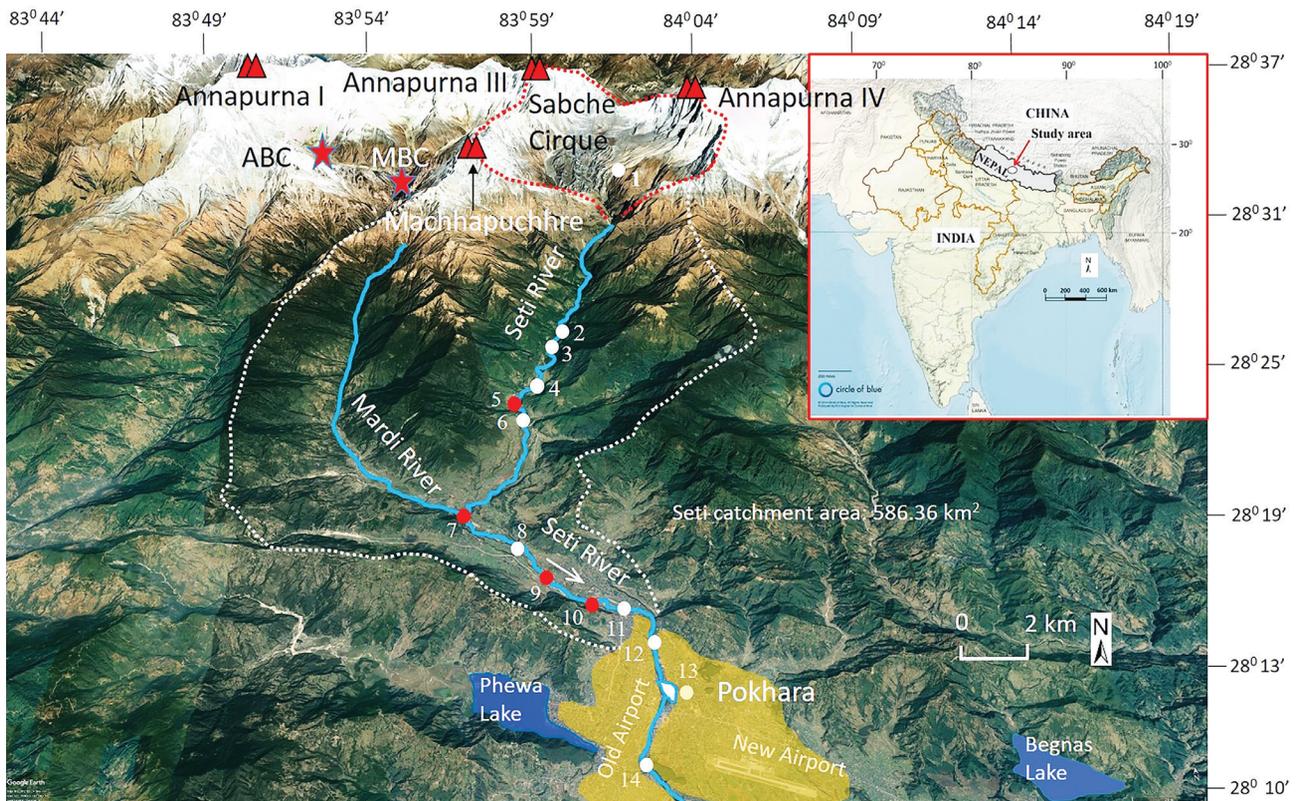
**Fig. 1:** Seti catchment showing prominent places that are vulnerable to hydro-torrential hazards. Red dots are places discussed in detail in this paper for their hydro-torrential risks. ABC: Annapurna Base Camp; MBC: Machhapuchhre Base Camp. 1: Sabche Cirque; 2: Jimirbaari; 3: Saadal, Ebang and Kapuche; 4: Bharabhuri Bagar; 5: Khaarpaani Tatopani; 6: Seti Mureghat (lies some 3 km downstream from Khaarpaani Tatopani); 7: Mardi Dovan; 8: Hemja Bensi; 9: Masina Bagar, Upallo Gosti and Tallo Gosti; 10: Kaseri Bazaar (Laltin Bazaar) and Shanti Tole; 11: Sukhawati Gumba and KI Singh Bridge; 12: Narayanthan; 13: Ramghat; 14: Ratopahiro (Source: Google Earth, 14 January 2020).

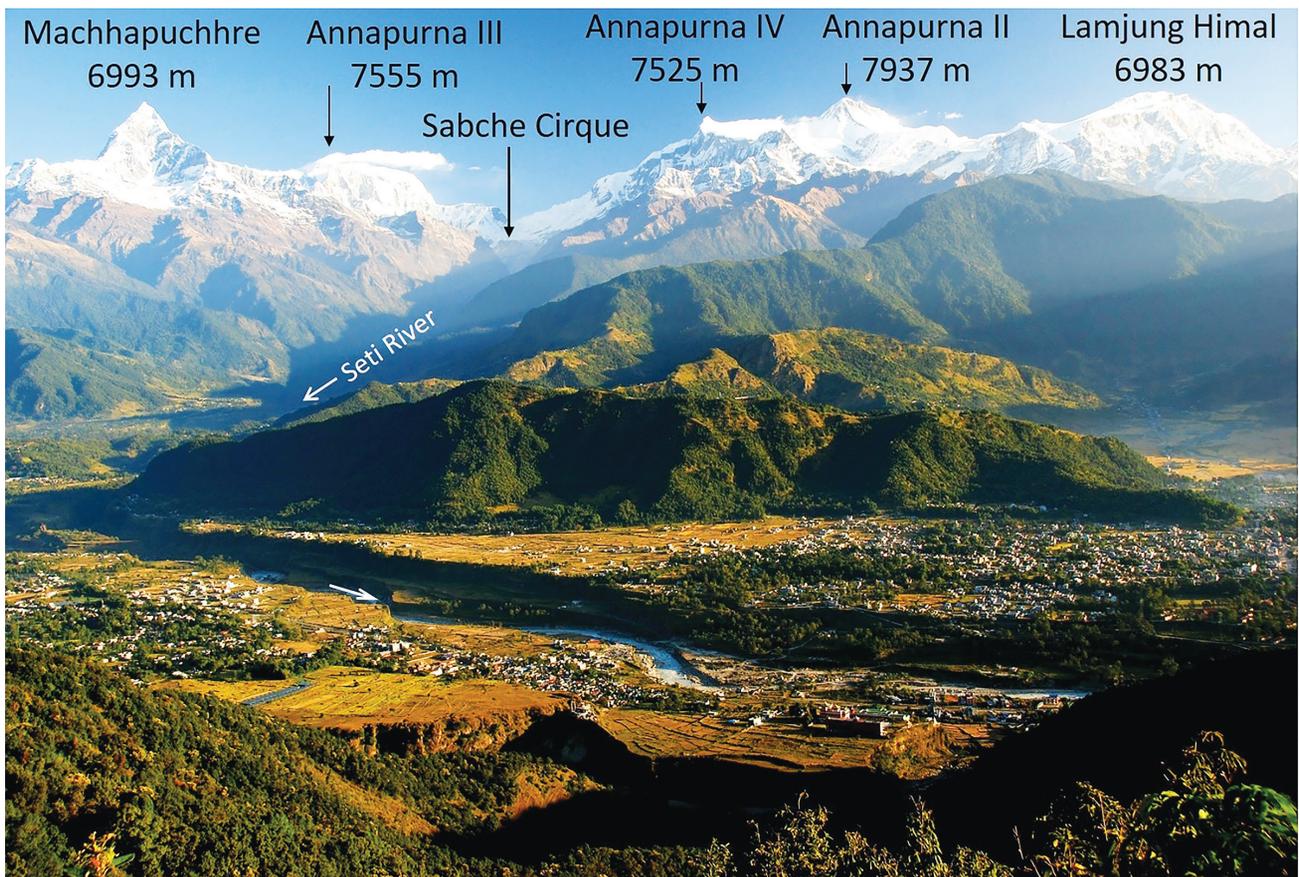
**Fig. 2: Panoramic view of Machhapuchhre and Annapurnas from Pokhara showing the Sabche Cirque and the headwater of Seti catchment (Photo by M. Fort, 2013).**

from giant mountain-wall collapses in the West face of Annapurna IV (7525 m), East of Sabche Cirque (Fig. 2), and were triggered by mega-earthquakes (Fort, 1986, 1987, 2010; Schwanghart et al., 2016; Stolle et al., 2017). The landforms derived from these two Ghachok and Pokhara Formations are quite different due to their differential resistance to erosion and to their geometric relationship in relation to differential uplift (Hormann, 1974; Yamanaka et al., 1982; Fort, 1987, 2010). North of the valley, the indurated Ghachok Formation (locally called “gaunda”) forms an upper terrace bounded by steep cliffs; it was progressively entrenched by the Seti River then abruptly and partly filled by the Pokhara gravels, now forming the lower, most recent terraces sets. In contrast, in the centre of the valley, the Pokhara gravels are superposed upon the Gaunda-Ghachok conglomerates (Hormann, 1974; Fort, 1987, 2010). The Ghachok Formation, intensely lithified due to its high content of calcium carbonate, behaves rather like a rock; this explains (i) the extended karstification, a process which creates wide open cracks and large caves in the sub-ground, and (ii) the local narrow gorges across the Pokhara city, prone to dangerous blockages during flooding. Contrary to this, the Pokhara Formation, made of loose, gravels deposits (including a few gneissic boulders – like the Bhim Kali one – incorporated to the debris flow material during the mega floods), is

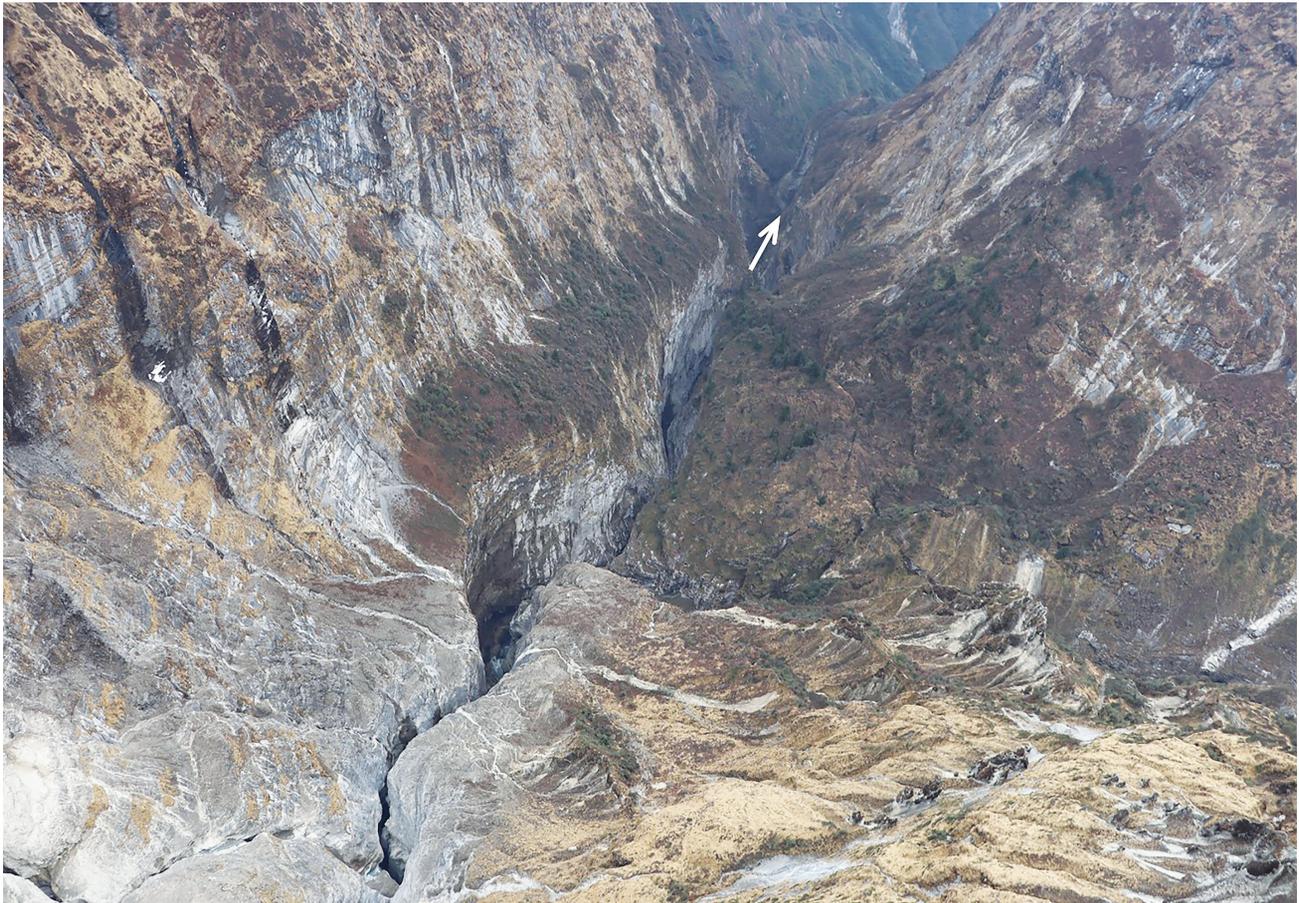
**Fig. 3: Deep and narrow gorge of the Seti River at the outlet of Sabche Cirque. Avalanches and rock falls from the steep slopes of Machhapuchhre and Annapurnas frequently block this section (Photo by N. Gurung, 4 December 2020)**

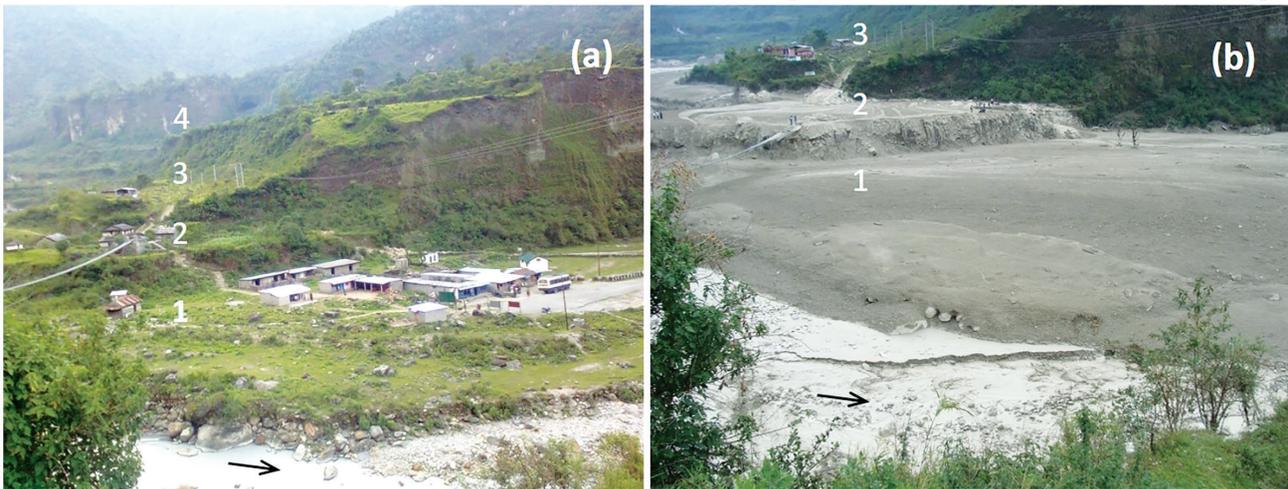
**Fig. 4:** View of Khaarpaani Tatopani [site 5, Fig. 1]. (a) Before (Photo by N. Gurung, 13 April 2012), and (b) After the May 5, 2012 Seti River flash flood (Photo by N. Gurung, 7 May 2012). This is where a total of 69 people died. 1: Lower terrace; 2: Middle terrace; 3: Higher terrace; 4: Top terrace. Both terraces 1 and 2 were completely flooded during the 2012 Seti flood. All terraces are made of Pokhara Formation loose gravels.

Many floods took place in the catchment but we consider the 2012 Seti flood because it impacted humans, infrastructures and river morphology noticeably (Fig. 4 and 5). It took lives of 72 people and damaged infrastructures worth millions of dollars (Dwivedi and Neupane, 2013, Kargel et al, 2014). The main damages took place in Saadal, Bharabhuri (Karuwa), Khaarpaani Tatopani, Seti Mureghat, Mardi Dovan, Hemja Bensi, Masina Bagar, Upallo Gosti and Tallo Gosti (dots 3 to 9, Fig. 1). The flood had also brought changes on river cross sections. The summary of impacts is given in Table 1. Many anthropogenic

4. Bharabhuri Bagar	<ul style="list-style-type: none"> <li>• A suspended bridge was partly damaged.</li> </ul>
5. Khaarpaani Tatopani (natural hot-spring site)	<ul style="list-style-type: none"> <li>• 69 people were either buried or washed away to their deaths.</li> <li>• A suspended bridge was badly damaged.</li> <li>• 16 houses were swept away.</li> <li>• Road was washed-away.</li> </ul>

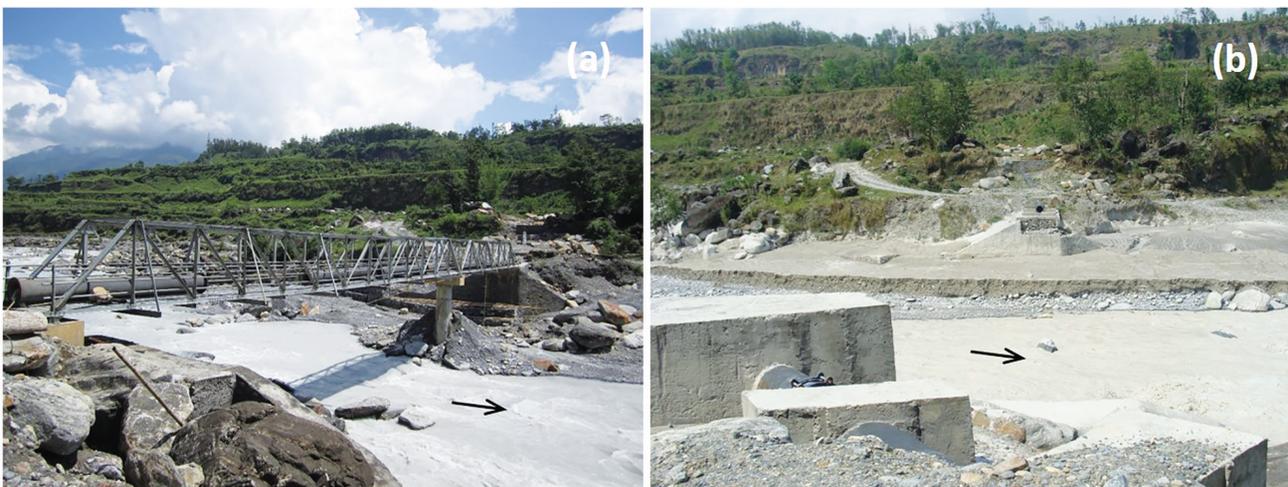
**Fig. 5:** The 42 m long steel truss bridge carrying drinking water pipes for Pokhara city at Hemja Bensi [site 8, Fig. 1]. (a) Before May 5, 2012 Seti flood (Photo by Nepal Water Supply Corporation, Pokhara Branch, 16 June 2011), and (b) After the flood. The bridge was completely swept away (Photo by N. Gurung, 14 May 2012).

8. Hemja Bensi Bridge site	<ul style="list-style-type: none"> <li>• A 42-m long steel truss bridge that was built to cross drinking water pipes for Pokhara city, was completely washed away.</li> </ul>

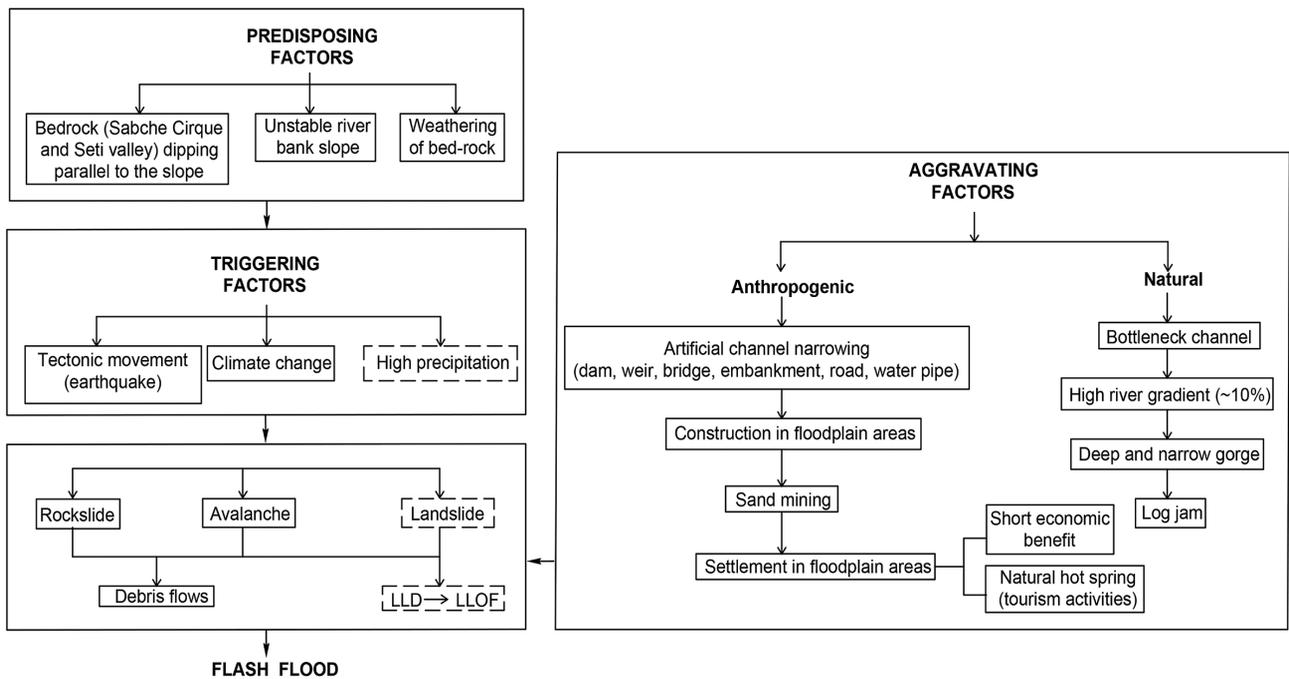
**Fig. 6: Chart of the systemic approach to show how the flood risk is developed in the Seti catchment. Those shown within the dotted bracket were not applicable to the May 5, 2012 Seti flood event (Source: Adapted and modified from Malavoi et al., 1998 and Arnaud-Fassetta et al., 2009).**

2012 onwards. A detail of the systemic approach of the fluvial risk developed along the Seti valley, which ultimately led to the 2012 disastrous flood is presented (Fig. 6). Though rainfall was not the only triggering factor for the 2012 Seti flood event, it often appears as the main trigger for more common floods in the Seti valley.

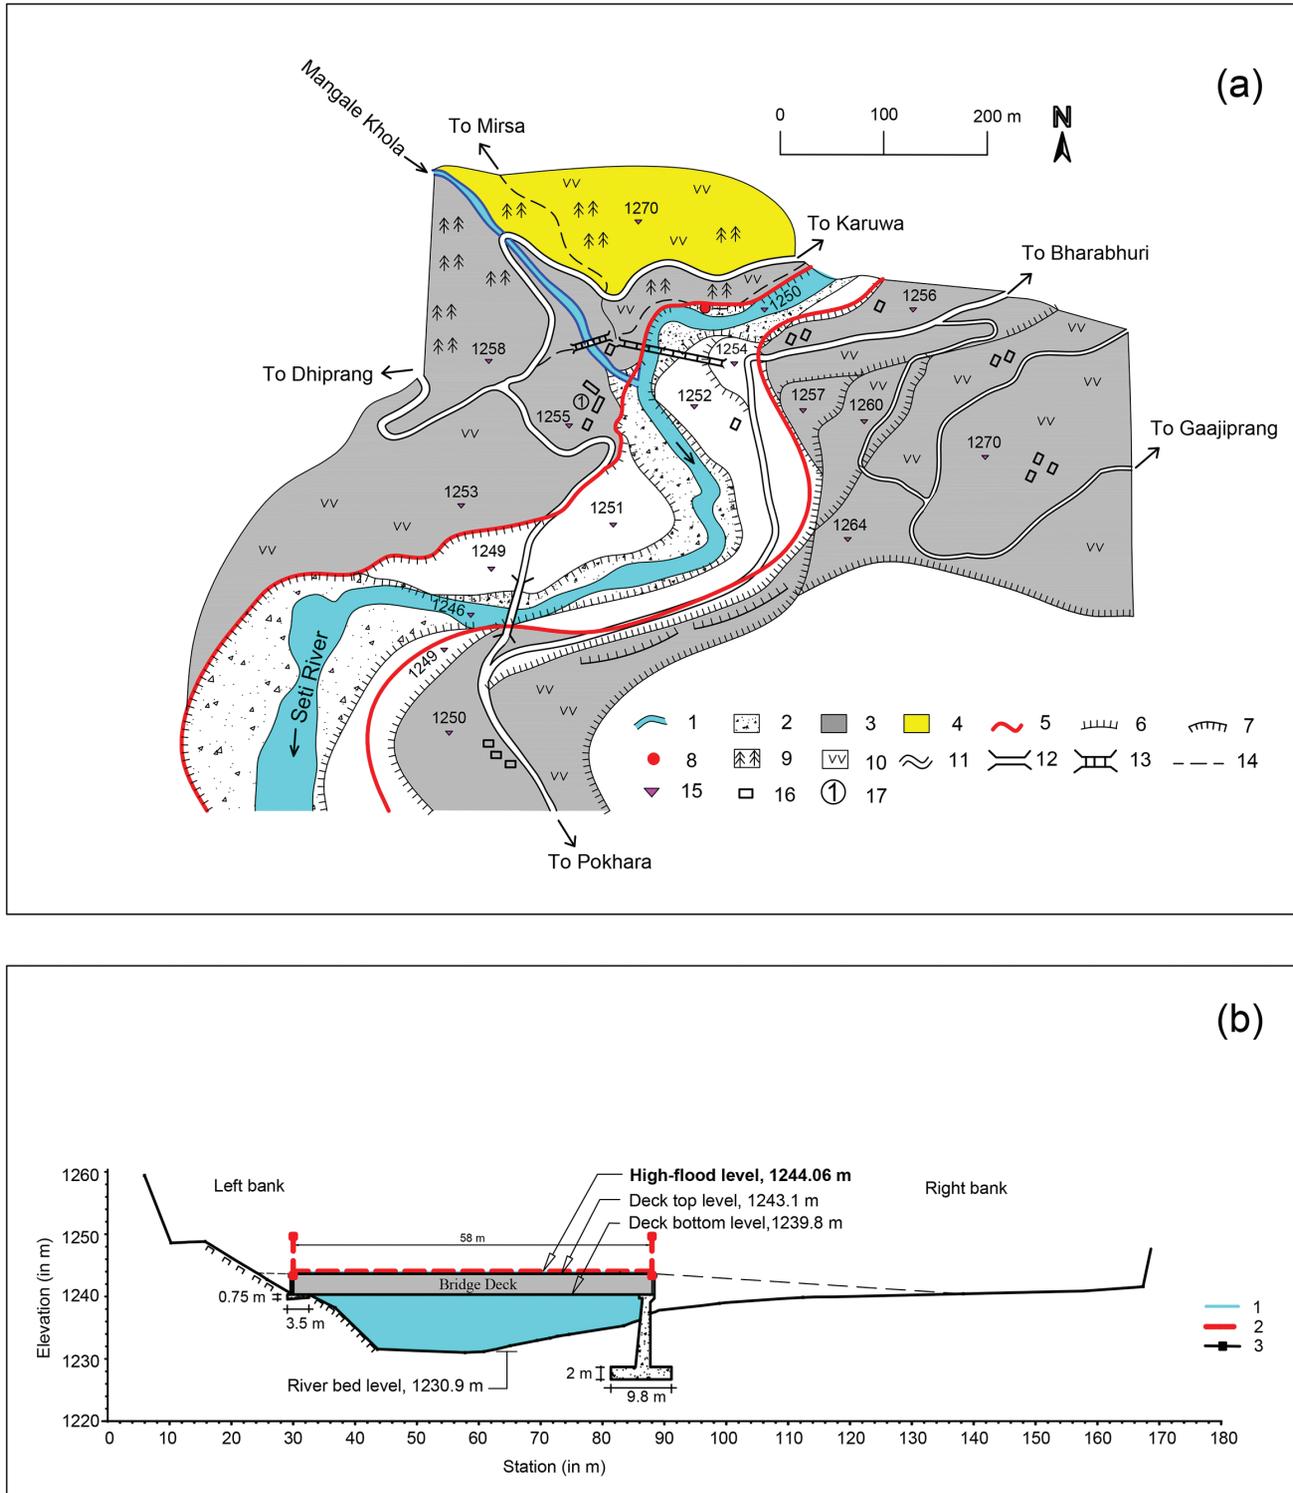
**Fig. 7: Khaarpaani Tatopani [site 5, Fig. 1]. (a) Hydro-geomorphological map of Khaarpaani Tatopani with outlining the river functional space. 1: Ordinary (present) water flow channel; 2: River bed (monsoon and flood levels); 3: Lower terraces: loose gravels deposited by Pokhara formation; 4: Higher terrace: Ghachok Formation; 5: Boundary for the river functional flooding space; 6: Terrace edge; 7: Edge fall and river bank collapse; 8: Natural hot-spring; 9: Tree; 10: Bush; 11: Motor road; 12: Motorable bridge; 13: Suspended bridge; 14: Foot path; 15: Ground elevation in m; 16: Building; 17: School. (b) Newly built 58 m long Khaarpaani Tatopani bridge modelling in HEC – RAS software (version 5.0.3) in order to check its suitability for the Seti River peak flood discharge of 100 years. The computed highest water-surface elevation from HEC – RAS analysis is 1244.06 m, which is 4.26 m (1244.06 m minus 1239.80 m) above the bottom level of the deck or, 0.96 m (1244.06 m minus 1243.10 m) above the top level of the deck. This shows that the bridge is at high risk to extreme flood of 100 years. 1: Water surface profile; 2: Level of high flood level; 3: Ground level.**

Seti valley seem to be vulnerable to extreme floods. As such, from the HEC-RAS analysis both 58 m long motorable bridge built over the Seti River at Khaarpaani Tatopani and 60 m long motorable bridge built over the Seti River at Mardi Dovan (confluence of Seti River and Mardi River) seem vulnerable to peak floods [Fig. 7 (b), 8 (b)]. The provided freeboard of the Seti bridge (Khaarpaani Tatopani) is found to be insufficient for the extreme flood of 100-year's return period [Fig. 7 (b)]. The computed highest water-surface elevation for the 100-year's return period peak flood discharge at the bridge section is 1244.06 m, which is 4.26 m (1244.06 m minus 1239.80 m) above the bottom level of the deck or 0.96 m (1244.06 m minus 1243.10 m) above the top level of the deck. Similarly, from the HEC-RAS model analysis, the freeboard of the Seti bridge at Mardi Dovan is found to be insufficient for the extreme flood of 100-year's return period [Fig. 8 (b)]. The computed highest water-surface elevation for 100-year's extreme flood discharge at the bridge section is 1033.90 m, which is 0.95 m (1033.90 m minus 1032.95 m) above the bottom level of the deck. That means the river flow is constricted at the bridge location due to the insufficient flow area to safely pass the extreme flood discharge. The river flow width is also reduced due to the construction of dykes, walls, roads on the right bank of the Seti bridge (Khaarpaani Tatopani) [Fig. 7 (b)]. and on both banks of Mardi Dovan bridge [Fig. 8 (b)]. This will cause the damage to the bridge due to (i) the constriction in flow area required for the safe discharge of extreme flood, and (ii) the large amount of debris (both mineral and vegetal) that may have come along with the flow at the time of flood event. Further, the narrow cross sections developed after the construction of bridges at these locations restrict the flow area causing abrupt rise in the water level during flooding, thus making them even more vulnerable to high floods.

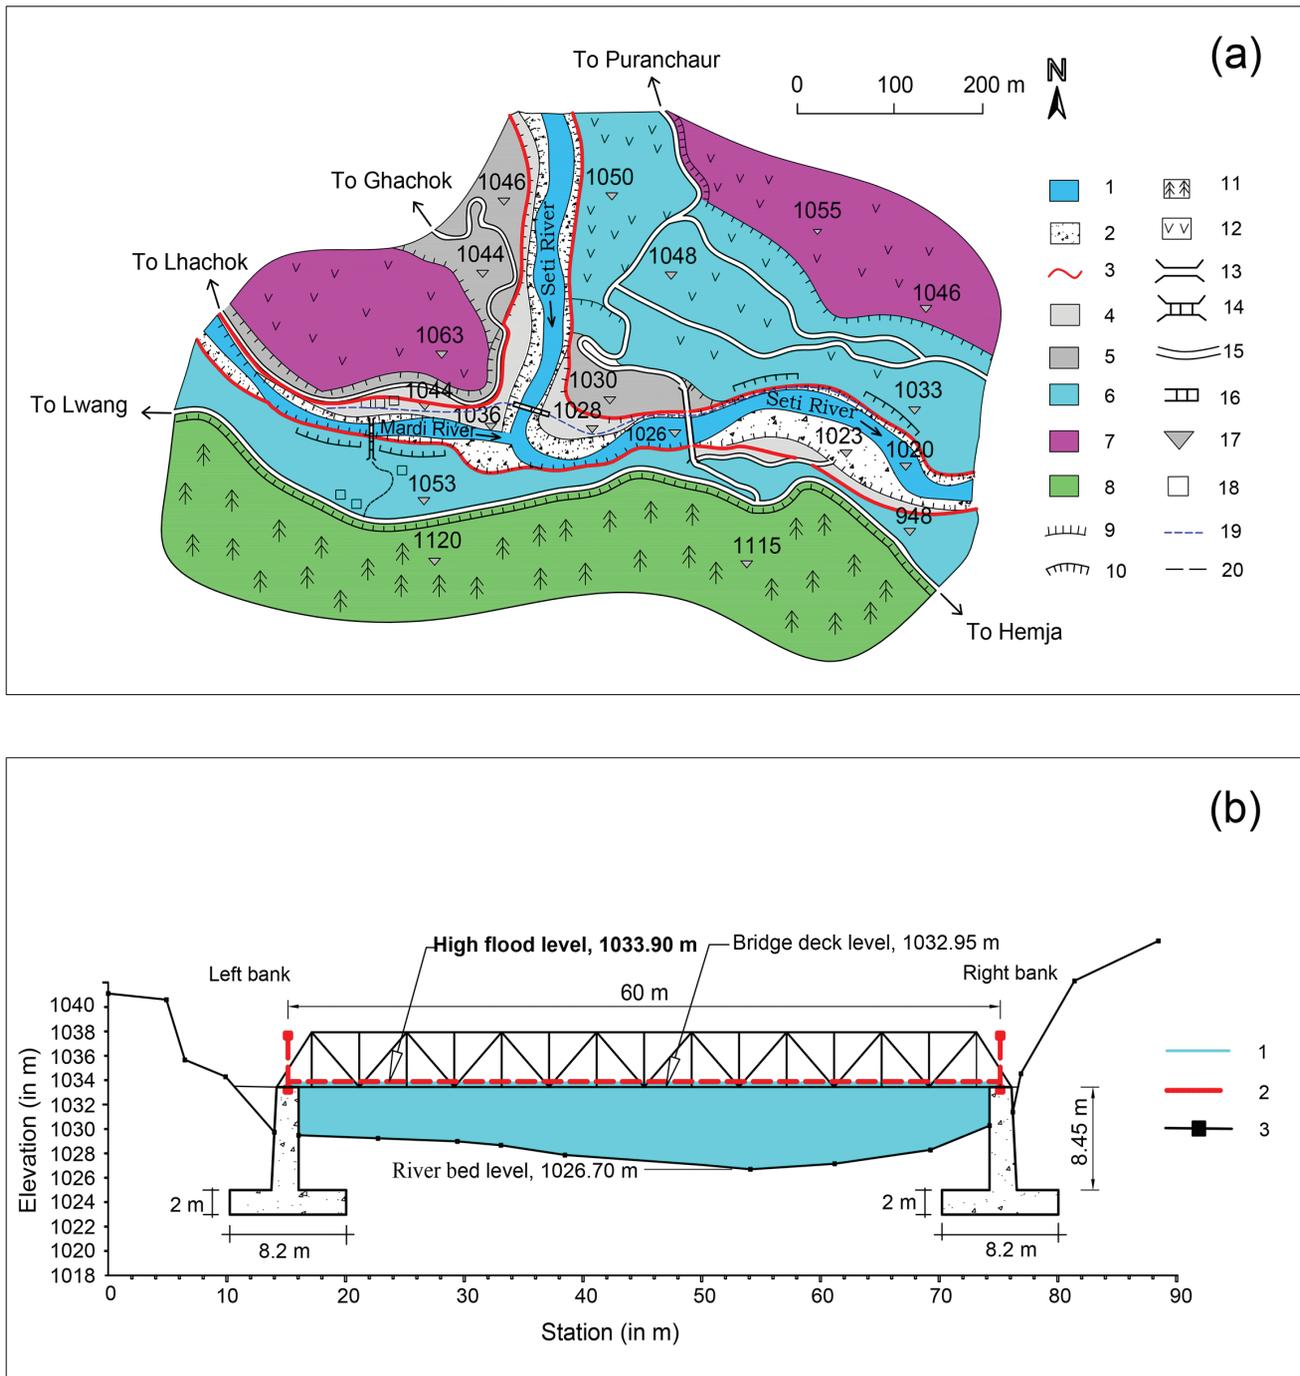
**Fig. 8: Mardi Doval (confluence of Seti River and Mardi River) [site 7, Fig. 1]. (a) Hydro-geomorphological map of Mardi Doval with outlining the river functional space. 1: Ordinary (present) water flow channel; 2: River bed (monsoon and flood levels); 3: Boundary for the river functional flooding space; 4: Lower terrace; 5: Medium terrace; 6: Higher terrace (Pokhara Formation) – Seti River alluvium deposit overlain by landslide deposit; 7: Top terrace (Ghachok Formation) – Seti River alluvium deposit; 8: Hill slope (Kuncha Formation); 9: Terrace edge; 10: Edge fall and river-bank collapse; 11: Tree; 12: Shrubs; 13: Motorable bridge; 14: Suspended bridge; 15: Motor road; 16: Bridge for water pipe crossing; 17: Ground elevation in m; 18: Building; 19: Drinking water pipe line for Pokhara; 20: Foot path. (b) 60 m long Mardi Doval bridge modelling in HEC- RAS software (version 5.0.3) in order to check its suitability for the peak flood discharge of 100 years. The computed highest water-surface elevation for 100 year's extreme flood discharge at the bridge location is 1033.90 m, which is 0.95 m (1033.90 m minus 1032.95 m) above the bottom level of the deck. This shows that the bridge is at high risk to extreme flood of 100 years. 1: Water surface profile; 2: Level of high flood level; 3: Ground level.**

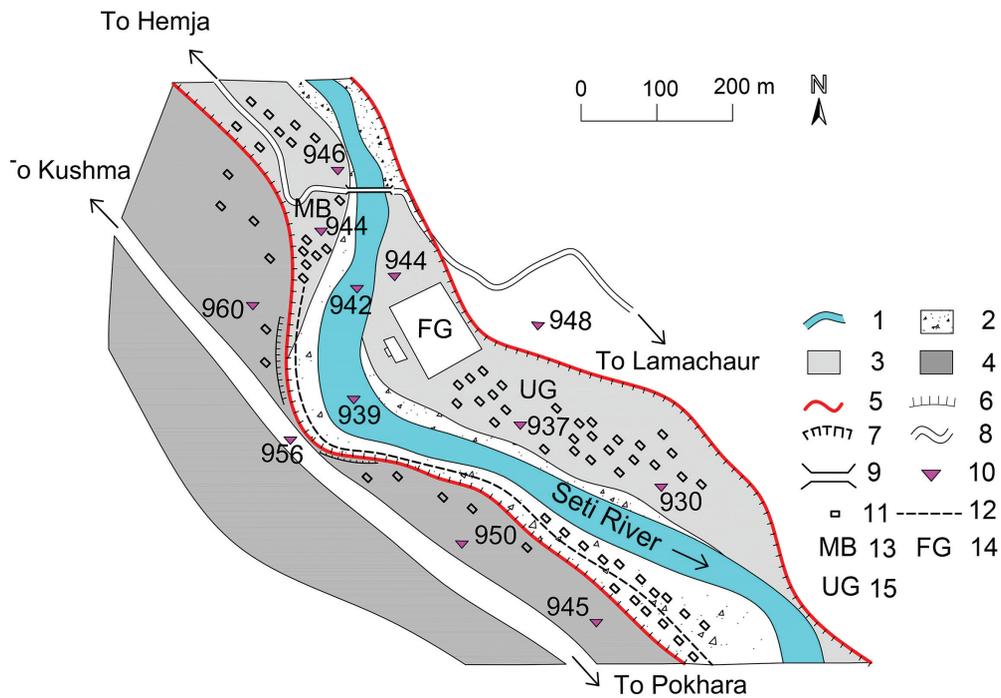
**Fig. 9: Hydro-geomorphological map of Masina Bagar and Upallo Gosti with outlining the river functional space [site 9, Fig. 1]. 1: Ordinary (present) water flow channel; 2: River bed (monsoon and flood levels); 3: Floodplain; 4: Higher terrace: loose gravels deposited by Pokhara formation; 5: Boundary for the river functional flooding space; 6: Terrace edge; 7: Edge fall and River bank collapse; 8: Motor road; 9: Motorable bridge; 10: Ground elevation in m; 11: Building; 12: Drinking water pipe line for Pokhara city; 13: Masina Bagar (MB); 14: Football ground (FG); 15: Upallo Gosti (UG).**

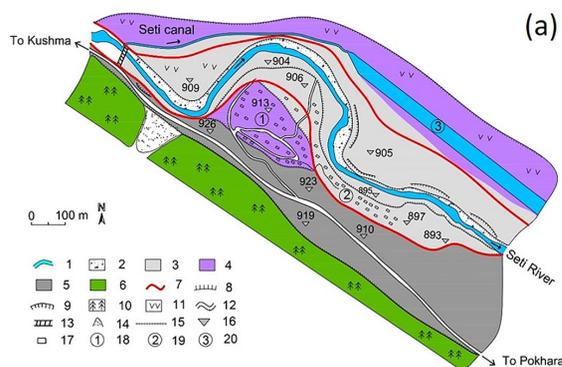
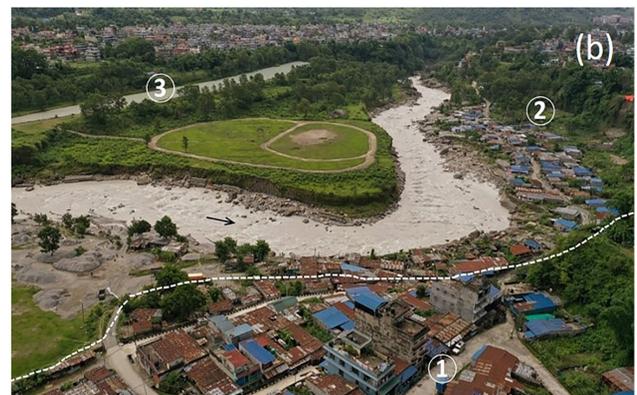
**Fig. 10: Kaseri Bazzar (a.k.a. Laltin Bazzar) and Shanti Tole with outlining of the river functional space [site 10, Fig. 1]. (a) Hydro-geomorphological map of Kaseri Bazzar (Laltin Bazzar) and Shanti Tole with outlining of the river functional space. 1: Ordinary (present) water flow channel; 2: River bed (monsoon and flood levels); 3: Floodplain; 4: Middle terrace; 5: Top terrace (Pokhara formation loose gravel deposition); 6: Hill slope (Kuncha formation); 7: Boundary for the river functional flooding space; 8: Terrace edge; 9: Edge fall and river-bank collapse; 10: Tree; 11: Bush; 12: Motor road; 13: Irrigation dam weir (headworks); 14: Talus (debris fan); 15: Foot path; 16: Ground elevation in m; 17: Building; 18: Kaseri (Laltin) Bazzar; 19: Shanti Tole; 20: Seti Irrigation dam. (b) View of Shanti Tole slum area, located to the east of Kaseri (Laltin) Bazzar (Photo by N. Gurung, 25 July 2020). 1: Kaseri (Laltin) Bazzar; 2: Shanti Tole; 3: Seti irrigation dam. The white dotted line is the boundary for the river functional space.**

Ramghat [Fig. 1 (13)]. Shanti Tole [Fig. 10 (b)], located to the east of Kaseri (Laltin) Bazaar, is known to be the latest slum settlement that sprung up on the Seti riverbank. According to locals, Shanti Tole slum started developing with few houses in 2005 during the peak Maoist insurgency period (1996 – 2006) in Nepal. At that time, law and order situation was very weak, people had taken advantage of the situation, and over the years expanded to block the very course of the river; there are as many as 180 houses in Shanti Tole alone. The hydro-torrential hazard places along the Seti valley from the studied area, are presented in Table 9.

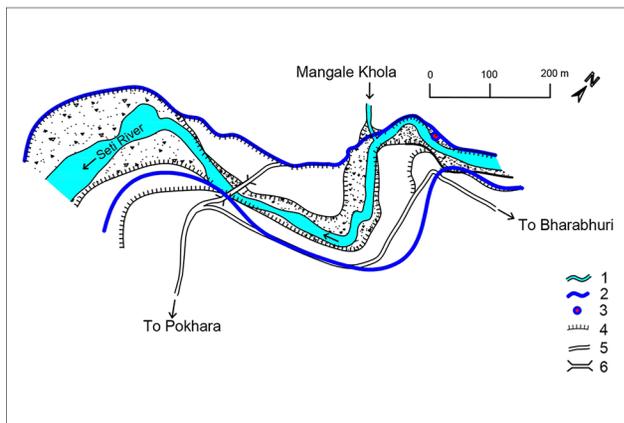
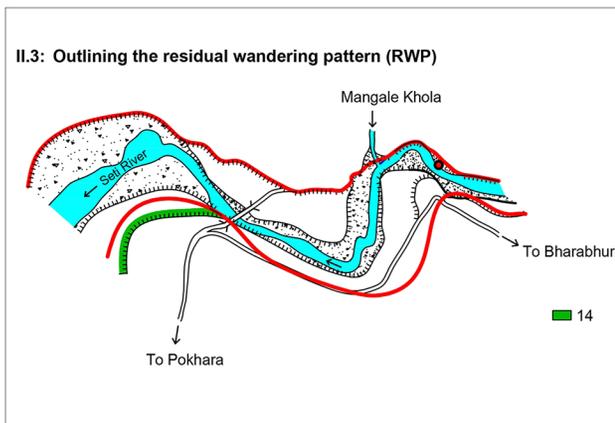
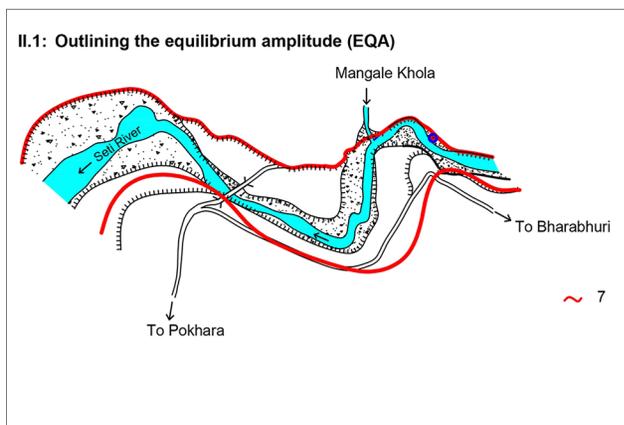
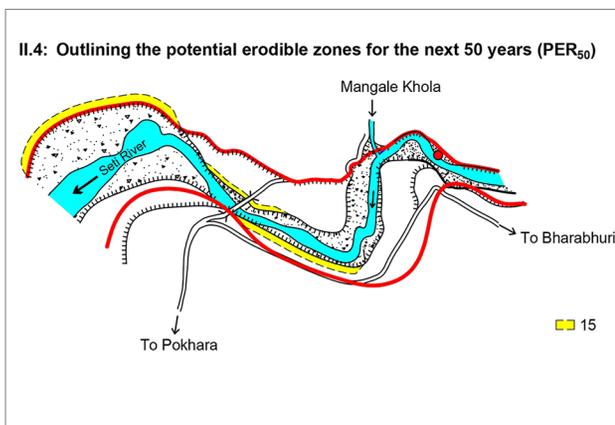
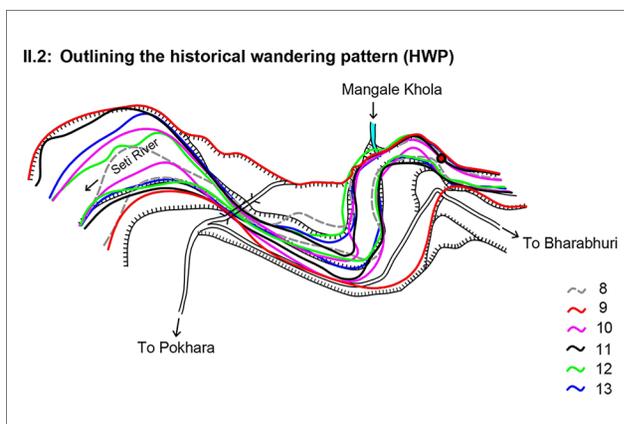
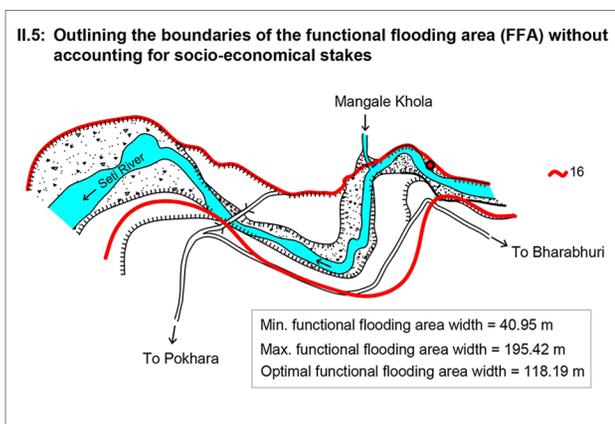
Fig. 11: The concept of “functional flooding area” (adapted from Malavoi et al., 1998 and Arnaud-Fassetta et al., 2009) applied to the Seti River at Khaarpaani Tatopani [site 5, Fig. 1]. 1: Present channel (2020); 2: Boundary of maximum flooding area; 3: Natural hot-spring; 4: Terrace edge; 5: Motor road; 6: Motor bridge; 7: Boundary of the theoretical amplitude = active channel of the >80-year flood (2012); 8: 2011 channel; 9: 2012 channel; 10: 2014 channel; 11: 2016 channel; 12: 2017 channel; 13: 2020 channel; 14: Bank protection (gabions); 15: Potential erodible zone; 16: Boundary of the functional flooding area (FFA) without accounting for socio-economical stakes. Also see Fig. 10 (a) for the hydro-geomorphological map with the FFA, which can be outlined from steps as shown above.

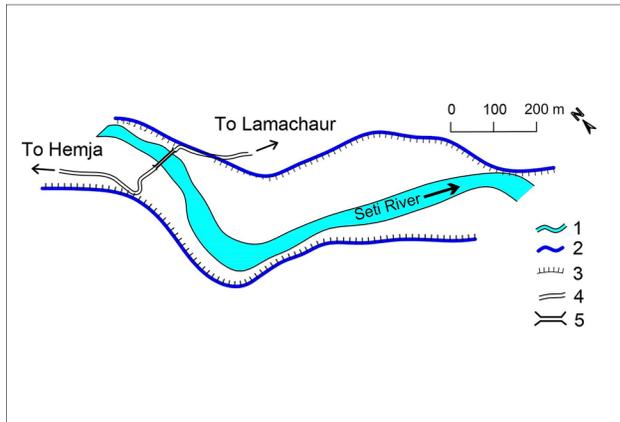
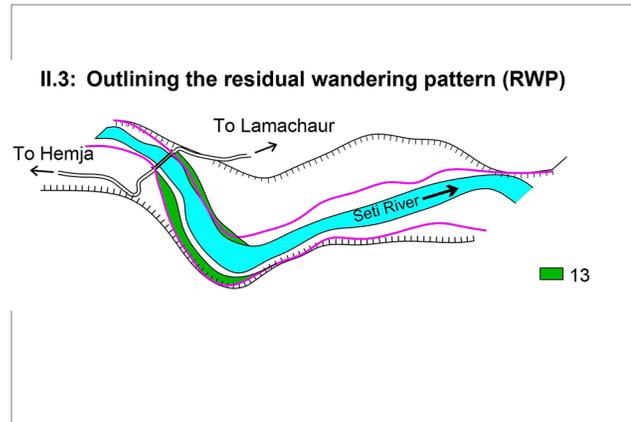
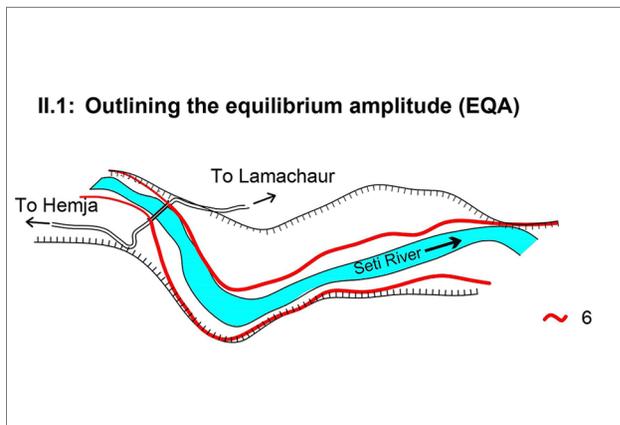
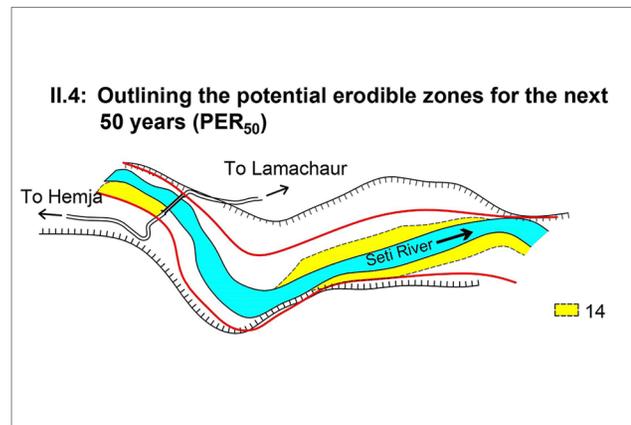
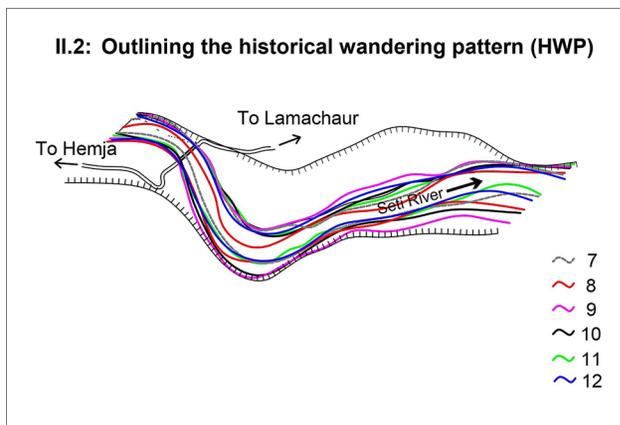
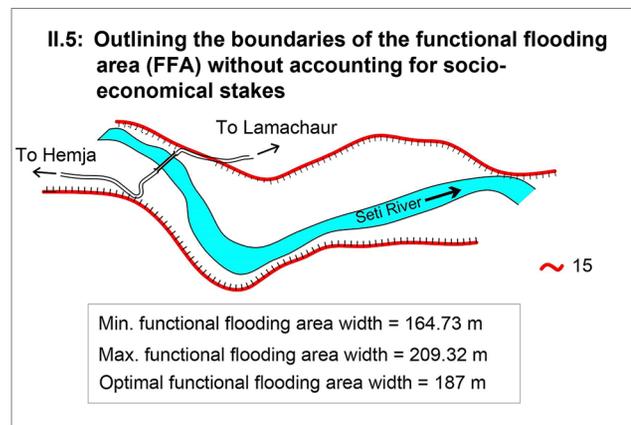
**Fig. 12: The concept of “functional flooding area” (adapted from Malavoi et al., 1998 and Arnaud-Fassetta et al., 2009) applied to the Seti River at Masina Bagar and Upallo Gosti [site 9, Fig. 1]. 1: Present channel (2020); 2: Boundary of maximum flooding area; 3: Terrace edge; 4: Motor road; 5: Motor bridge; 6: Boundary of the theoretical amplitude = active channel of the >80-year flood (2012); 7: 2004 channel; 8: 2008 channel; 9: 2012 channel; 10: 2014 channel; 11: 2018 channel; 12: 2020 channel; 13: Bank protection (gabions); 14: Potential erodible zone; 15: Boundary of the functional flooding area (FFA) without accounting for socio-economical stakes. Also see Fig. 12 for the hydro-geomorphological map with the FFA, which can be outlined from steps as shown above.**

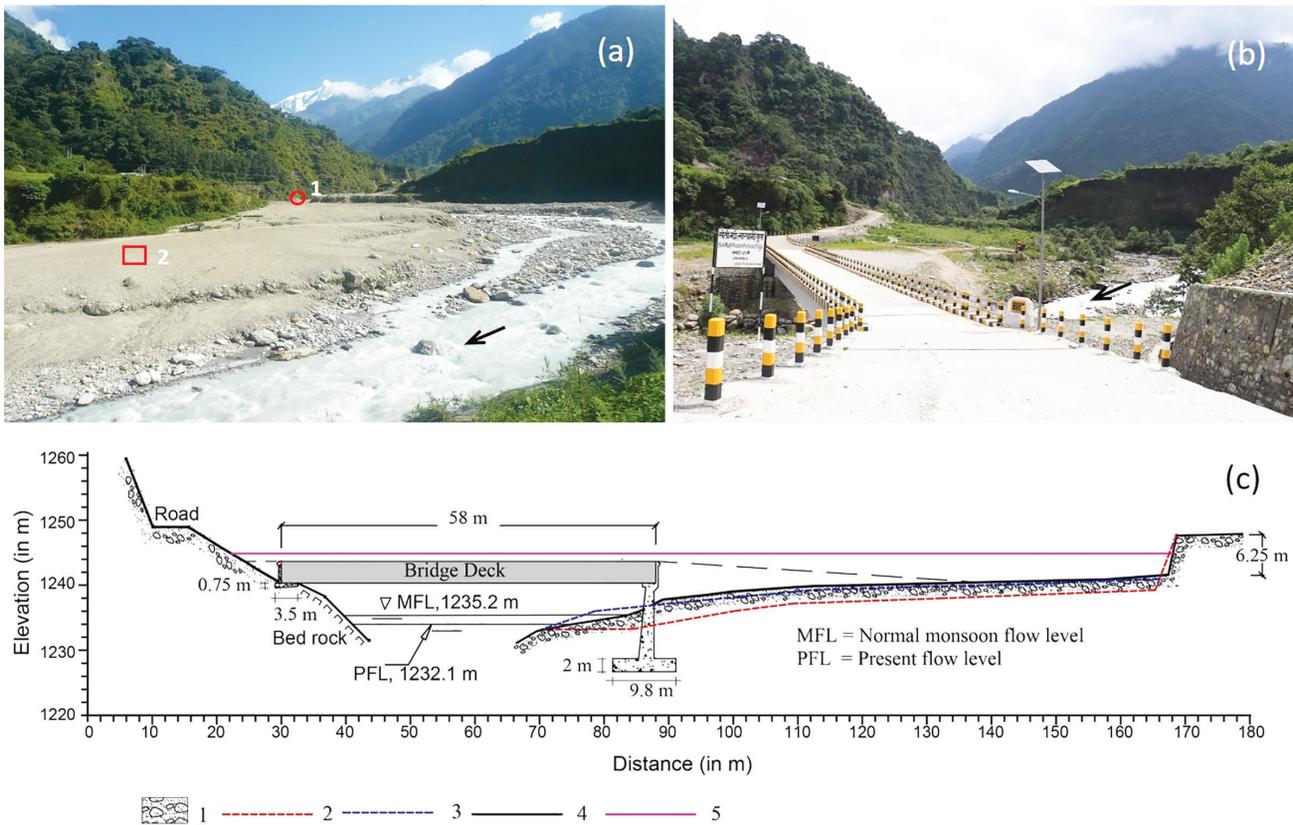
**Fig. 13: View of Khaarpaani Tatopani [site 5, Fig. 1]. (a) Just after the 2012 Seti River flash flood (Photo by M. Fort, 23 September, 2012). 1. Location of natural hot spring; 2. Location of right bank abutment of the newly built 58-m long Seti River motorable bridge. The motorable bridge was built in 2020. (b) 8 years later (Photo by N. Gurung, 4 July, 2020). Note that the road, bridge and dykes have been built on the floodplain within the river functional flooding space as outlined in Fig. 7 and 11. (c) Cross-sections measured across the Seti River where motorable bridge is built (before and after the 2012 flood, and 2020). The bridge has been built without considering the high-flood level of 2012. Note that the 2012 high-flood level was measured above the newly built motorable bridge. 1: River bed deposit; 2: River profile before 2012 Seti flood; 3: River profile after 2012 Seti flood; 4: River profile of December 2020; 5: HFL (Highest Flow Level) during 2012 Seti flood.**

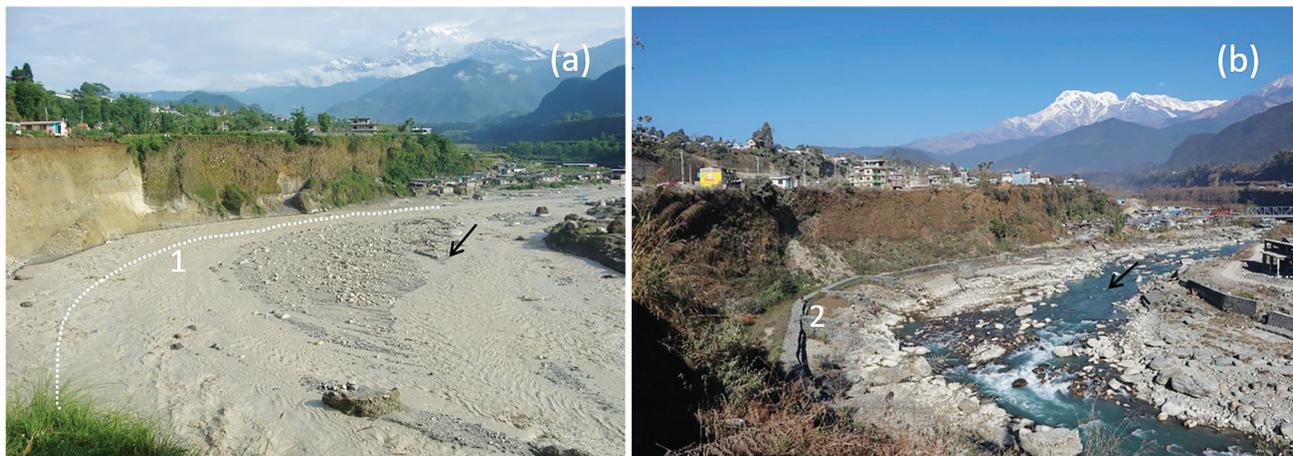
**Fig. 14: Drinking water pipe for Pokhara city built in the floodplain to the east of Masina Bagar and across Upallo Gosti. (a) After the 2012 Seti flash flood (Photo by N. Gurung, 18 June 2012). The flood had completely washed away water pipes. The dotted line (depicted by 1) shows the water pipe line for Pokhara city. (b) Rebuilt of water pipe line for Pokhara city at the same place that was flooded in 2012 (Photo by N. Gurung, 6 January 2021). The gabion protection works (2) seem to work only for normal floods and the pipe line is vulnerable to for high floods.**

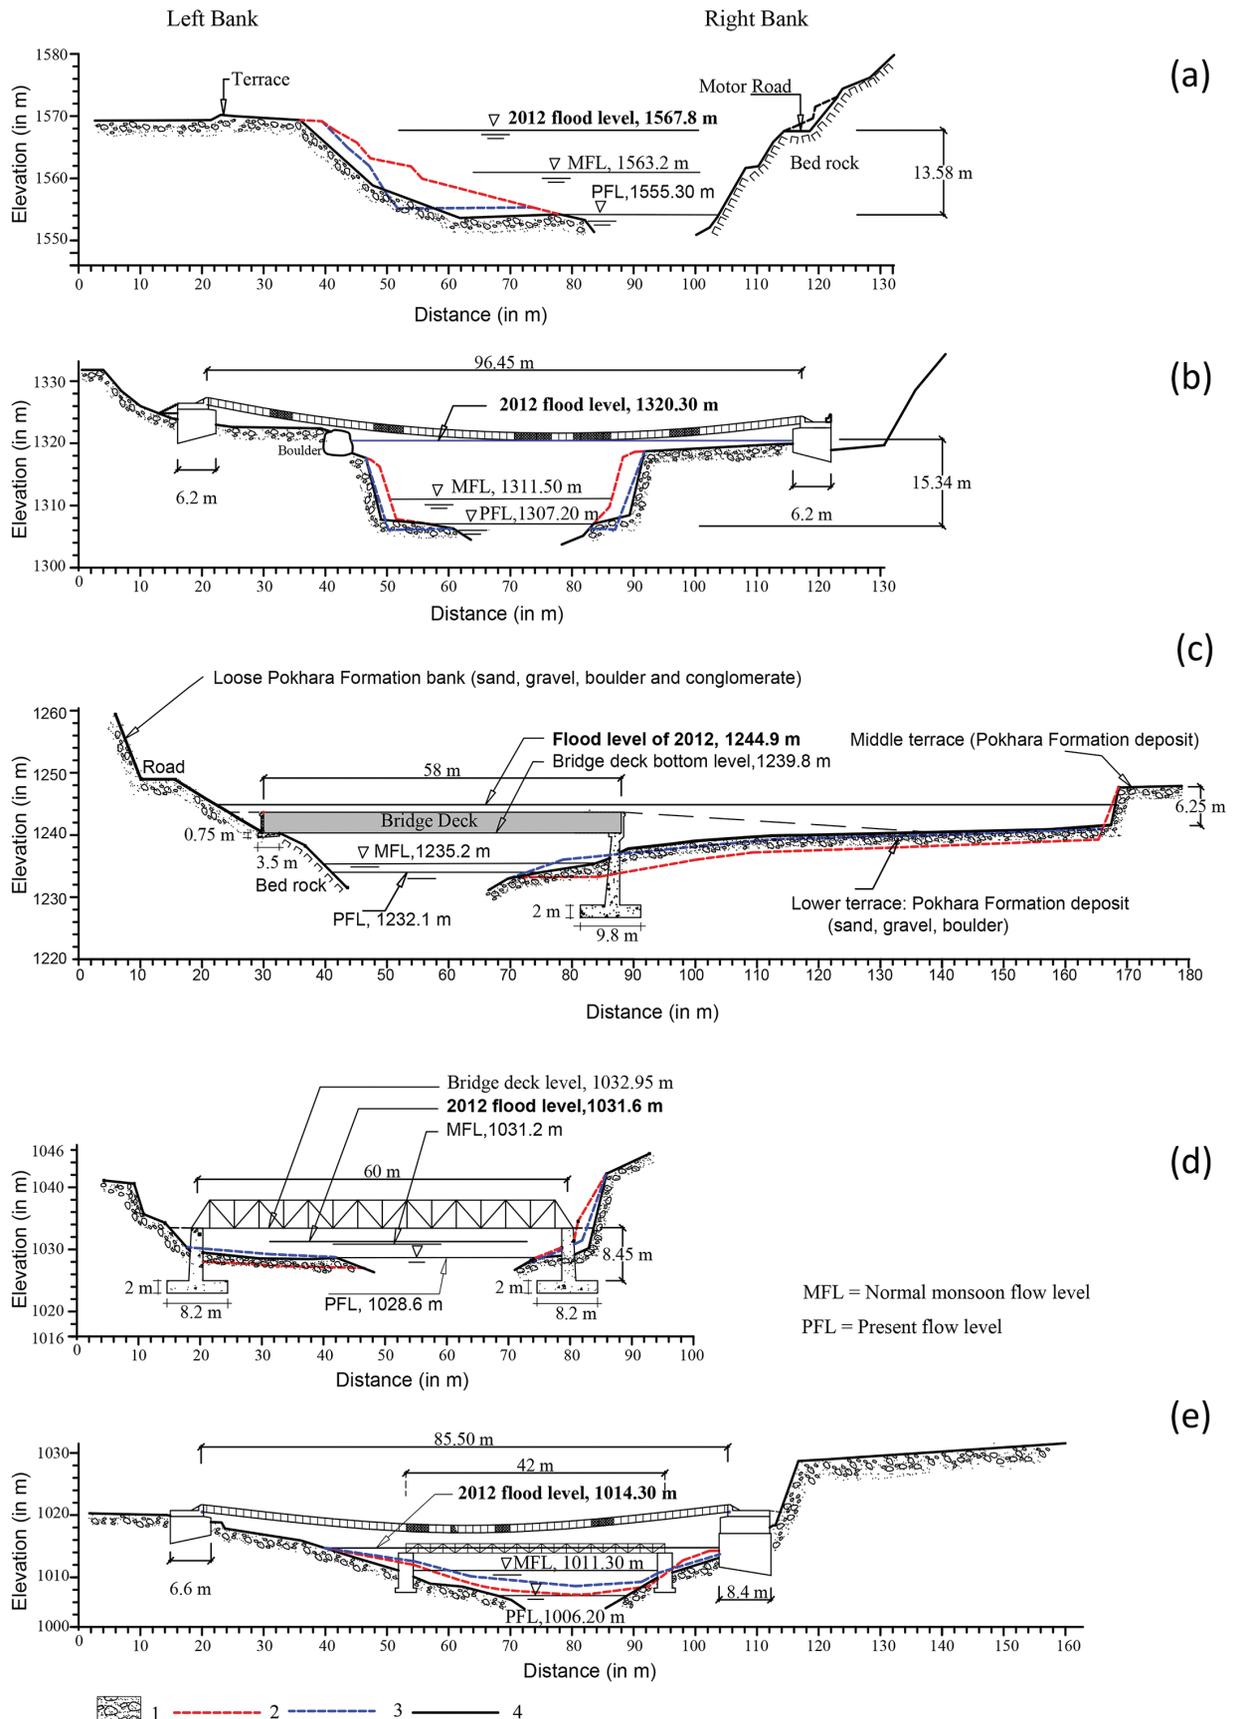
**Fig. 15: Comparison of cross-sections of the Seti River at five locations before and after the 2012 flood and present (2020). a. Saadal; b. Bharabhuri Bagar (Karuwa); c. Khaarpaani Tatopani motorable bridge; d. Mardi Dovan motorable bridge; e. Hemja Bensi suspended bridge site. 1: Riverbed deposit (sand, gravel and boulder); 2: River profile before 2012 Seti flood; 3: River profile after the 2012 Seti flood; 4: River profile of December 2020. All river profiles before the 2012 Seti flood were provided by Kadoorie Agricultural Aid Association except for Khaarpaani Tatopani and Mardi Dovan (Department of Roads). The river profiles after the 2012 Seti flood and 2020 were measured by authors.**

**Table 6: Result from the comparison of cross-sections at five prominent places along Seti River to assess the aggradation and degradation from 2012 to 2020 (Fig. 15).**

Section	Erosion from 2012 to 2020			Deposition from 2012 to 2020		
	Area (in $\text{m}^2$ )	Length (in m)	Volume (in $\text{m}^3$ )	Area (in $\text{m}^2$ )	Length (in m)	Volume (in $\text{m}^3$ )
A	5	100	$500 \pm 50$	20.80	100	$2080 \pm 208$
B	6	100	$600 \pm 60$	18.20	100	$1820 \pm 180$
C	12	100	$1200 \pm 120$	—	—	—
D	61	100	$6100 \pm 610$	—	—	—
E	80	100	$8000 \pm 800$	—	—	—
Total	164	500	$16,400 \pm 1,640$	39	200	$3900 \pm 390$
