# Hydro-torrential hazard vs. anthropogenic activities along the Seti valley, Kaski, Nepal: Assessment and recommendations from a risk perspective

The Seti River originates from the Annapurna Massif in the Higher Himalaya of Nepal and flows through the Pokhara valley in the Lesser Himalaya. The Seti River witnessed a disastrous flash flood on May 5th, 2012 causing the death of 72 people, obliterating dozens of homes and damaging infrastructures worth millions of dollars. Despite the 2012 flood event and several warnings by scientists for more yet bigger scale future floods in the Seti valley, fluvial risk is being aggravated by anthropogenic activities such as unplanned human settlement, encroachment of riverbanks, haphazard construction of road, drinking water, and hydropower projects in potential flood hazard areas in addition to the increased impacts of climate change on geological and hydro-metrological hazards as in other parts of Hindu Kush Himalayan Range. Covering some 40-km distance from the Seti headwater (Sabche Cirque) down to Pokhara city, the study is carried out based on hydro-geomorphological mapping, analysis of land-use and land-cover change, hydrological analysi

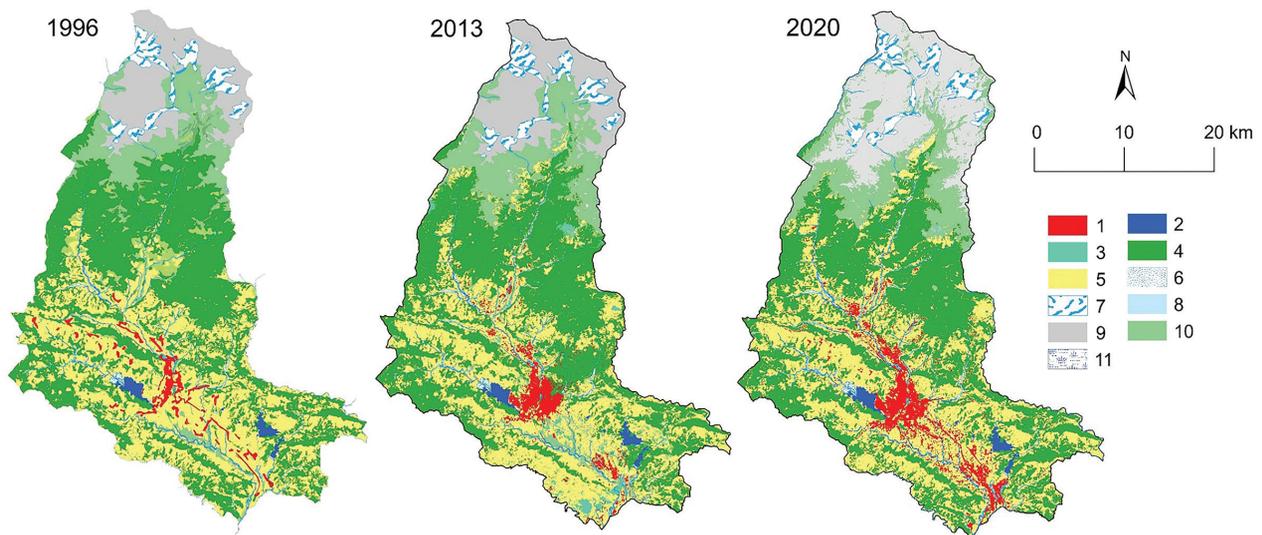
**Fig. 16: Land-use and land-cover (LULC) map of the Seti catchment including Pokhara valley for 1996, 2013 and 2020. The 1996 map was prepared based on the topographic survey map of 1996 (scale 1:25,000) and the 2013 and 2020 maps were prepared based on Landsat 8 satellite images of 30-m resolution. 1: Urban/Built-up; 2: Water body; 3: Open field; 3: Forest cover; 5: Cultivated land; 6: Sandy area; 7: Glacier; 8: Snow cover; 9: Barren land; 10: Grass land; 11: Swamp area.**

According to the LULC maps of the Seti catchment including Pokhara valley (Fig. 16), the LULC has changed significantly from 1996 to 2020. The significant change was observed on urban / built-up area (Table 7) : from 1996 to 2013 (17 years), it has increased by 245% from  $13.2 \text{ km}^2$  to  $45.5 \text{ km}^2$ ; from 2013 to 2020 (7 years), it has increased by 47% from  $45.5 \text{ km}^2$  to  $66.7 \text{ km}^2$  ; from 1996 to 2020 (24 years), it has increased by 405% from  $13.2 \text{ km}^2$  to  $66.7 \text{ km}^2$  . This confirms a rapid urbanisation in Pokhara valley and its surroundings, mainly due to the construction of housing and infrastructures. The high rate of

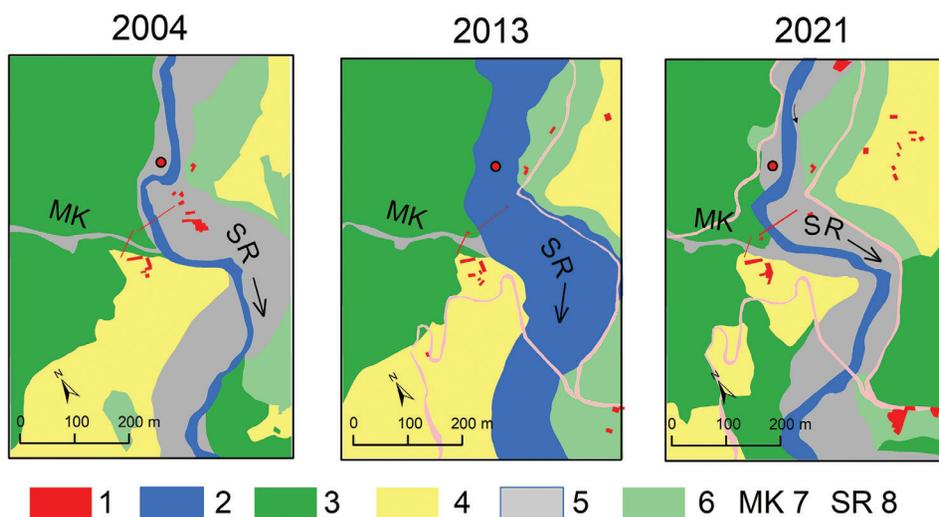
Fig. 17: Land-use and land-cover map of Khaarpaani Tatopani for 2004, 2013, and 2021 [site 5, Fig. 1]. 1: Urban/Built-up; 2: Water body; 3: Forest cover; 4: Cultivated land; 5: Flood plain; 6: Open field; 7: Mangale Khola (MK); 8: Seti River (SR). All base maps were sourced from Google Earth. Dates are 20.11.2004 for 2004, 06.10.2013 for 2013, and 10.01.2021 for 2021.

The analysis of the LULC maps of four specific sites i.e. (i) Khaarpaani Tatopani, (ii) Mardi Dovan, (iii) Masina Bagar, Upallo Gosti and Tallo Gosti and (iv) Kaseri Bazzar and Shanti Tole (Fig. 17 to 20), confirms the significant increase observed on urban / built-up area. From 2004 to 2013 (9 years), the urban/ built-up area has increased by 28.07% for Mardi Dovan, 112.37% for Masina Bagar, Upallo Gosti, Tallo Gosti, and 125.20% for Kaseri Bazzar and Shanti Tole, but is reduced by 68.68% for Khaarpaani Tatopani (Table 8 a to d), a reduction attributed to the 2012 Seti flash flood that had completely wiped out houses at Khaarpaani Tatopani. Similarly for the period from 2013 to 2021 (8 years), the urban/built-up area has increased by 367.44% for Khaarpaani Tatopani, 144.87% for Mardi Dovan, 118.15% for Masina Bagar, Upallo Gosti, Tallo Gosti, and 66% for Kaseri Bazzar and Shanti Tole (Table 8 a to d). This shows a high encroachment by many newly built dwellings and infrastructures over the floodplains along the Seti valley where flood risk is very high.

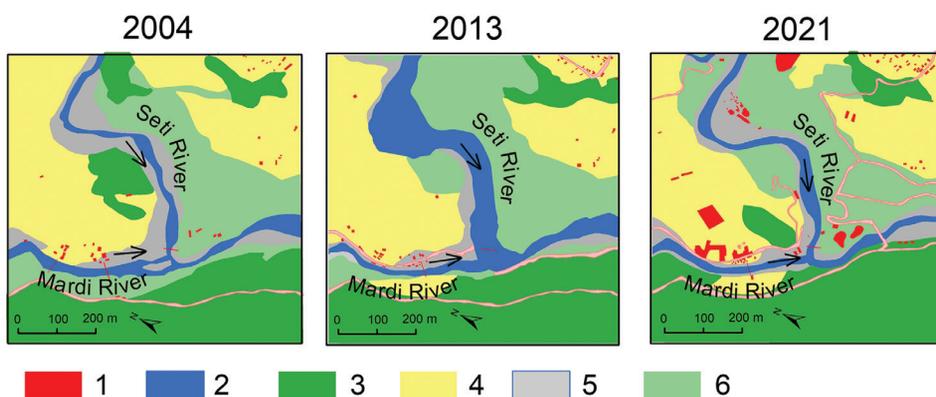
Fig. 18: Land-use and land-cover map of Mardi Dovan (confluence Seti River/Mardi River) for 2004, 2013, and 2021 [site 7, Fig. 1]. 1: Urban/Built-up; 2: Water body; 3: Forest cover; 4: Cultivated land; 5: Flood plain; 6: Open field. All base maps were sourced from Google Earth. Dates are 20.11.2004 for 2004, 10.12.2013 for 2013 and 10.01.2021 for 2021.

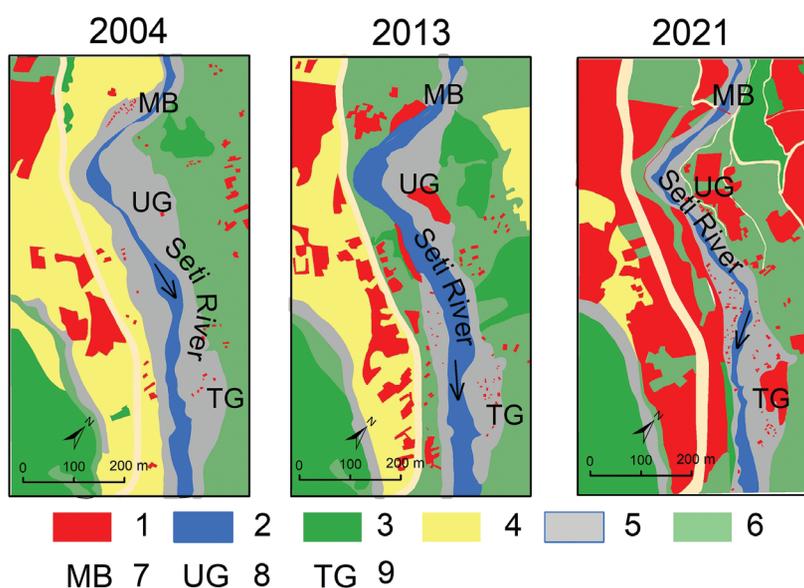
Fig. 19: Land-use and land-cover map of Masina Bagar (MB), Upallo Gosti (UG) and Tallo Gosti (TG) for 2004, 2013, and 2021 [site 9, Fig. 1]. 1: Urban/Built-up; 2: Water body; 3: Forest cover; 4: Cultivated land; 5: Flood plain; 6: Open field; 7: Masina Bagar (MB); 8: Upallo Gosti (UG); 9: Tallo Gosti (TG). All base maps were sourced from Google Earth. Dates are 20.11.2004 for 2004, 06.10.2013 for 2013, and 10.01.2021 for 2021.

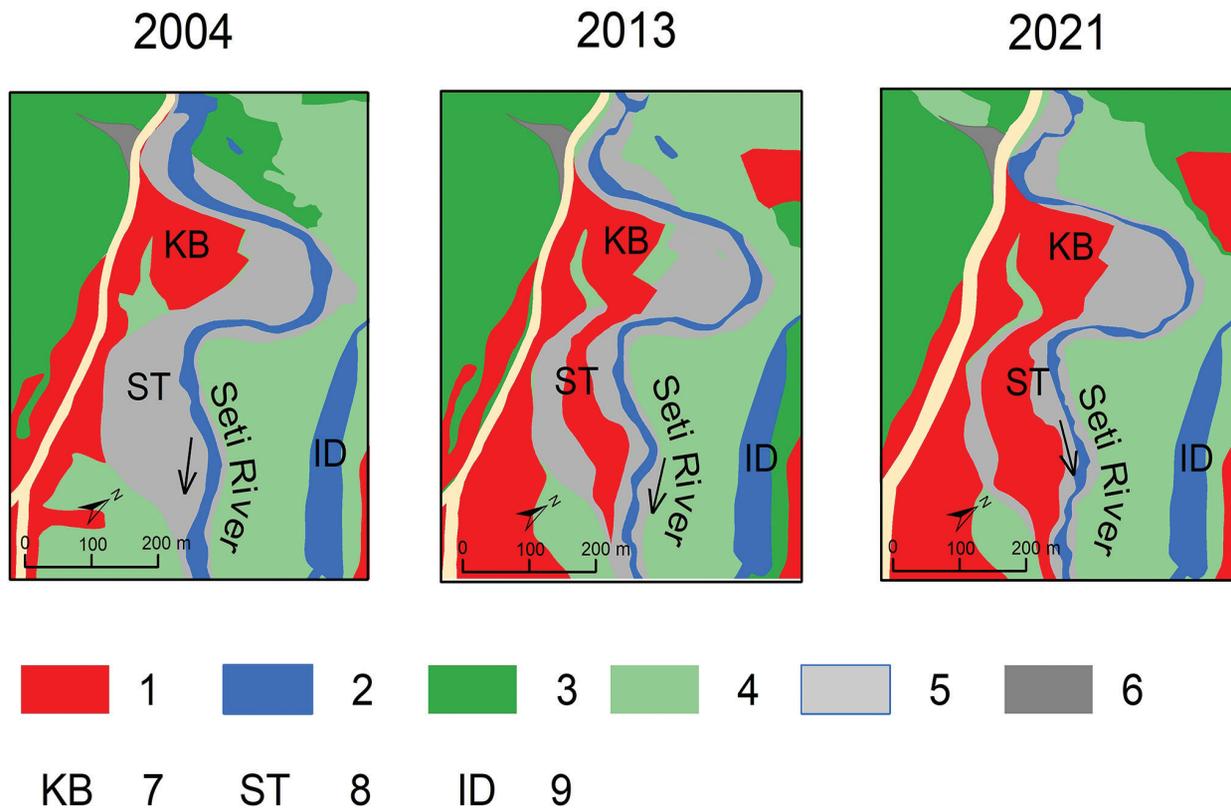
**Fig. 20: Land-use and land-cover map of Kaseri Bazaar and Shanti Tole for 2004, 2013, and 2021 [site 10, Fig. 1]. 1: Urban/Built-up; 2: Water body; 3: Forest cover; 4: Open field; 5: Flood plain; 6: Debris fan; 7: Kaseri Bazaar (KB); 8: Shanti Tole (ST); 9: Irrigation dam (ID). All base maps were sourced from Google Earth. Dates are 21.11.2004 for 2004, 10.01.2013 for 2013, and 10.01.2021 for 2021.**
