Deterioration of the Nakhu River: impairment on dynamic and recreational functions of the river

Binod Maharjan and *Naresh Kazi Tamrakar

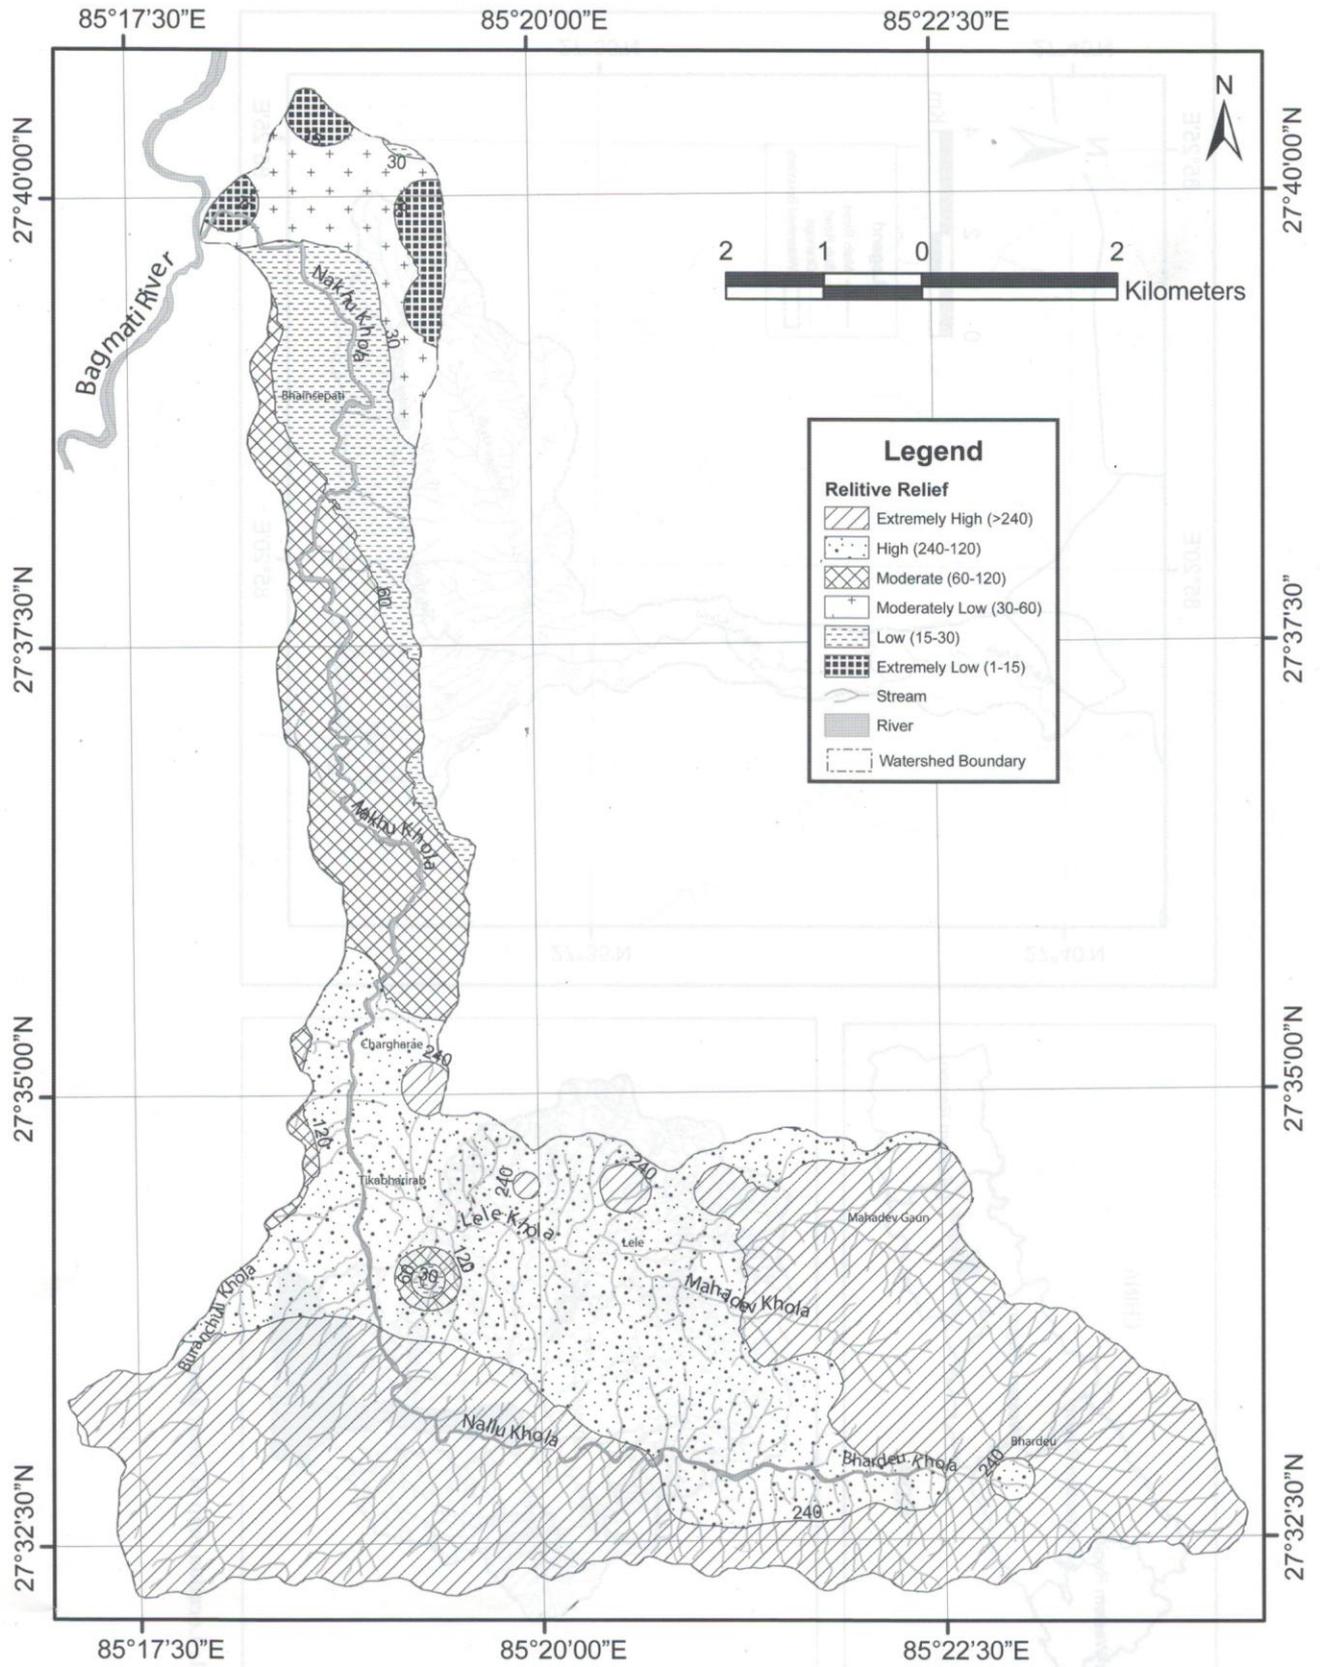
Fig. 2: (a) Relative relief map

The southern part of the watershed, which is surrounded by hills, has high relative relief and northern part with low lying area has low relative relief (Fig.2a). The higher relief in the southern part is due to presence of ridges with hard rock. The drainage texture of the watershed is fine to moderate at the southern part with bed rocks and coarse to very coarse at the central and northern part (Fig. 2b).

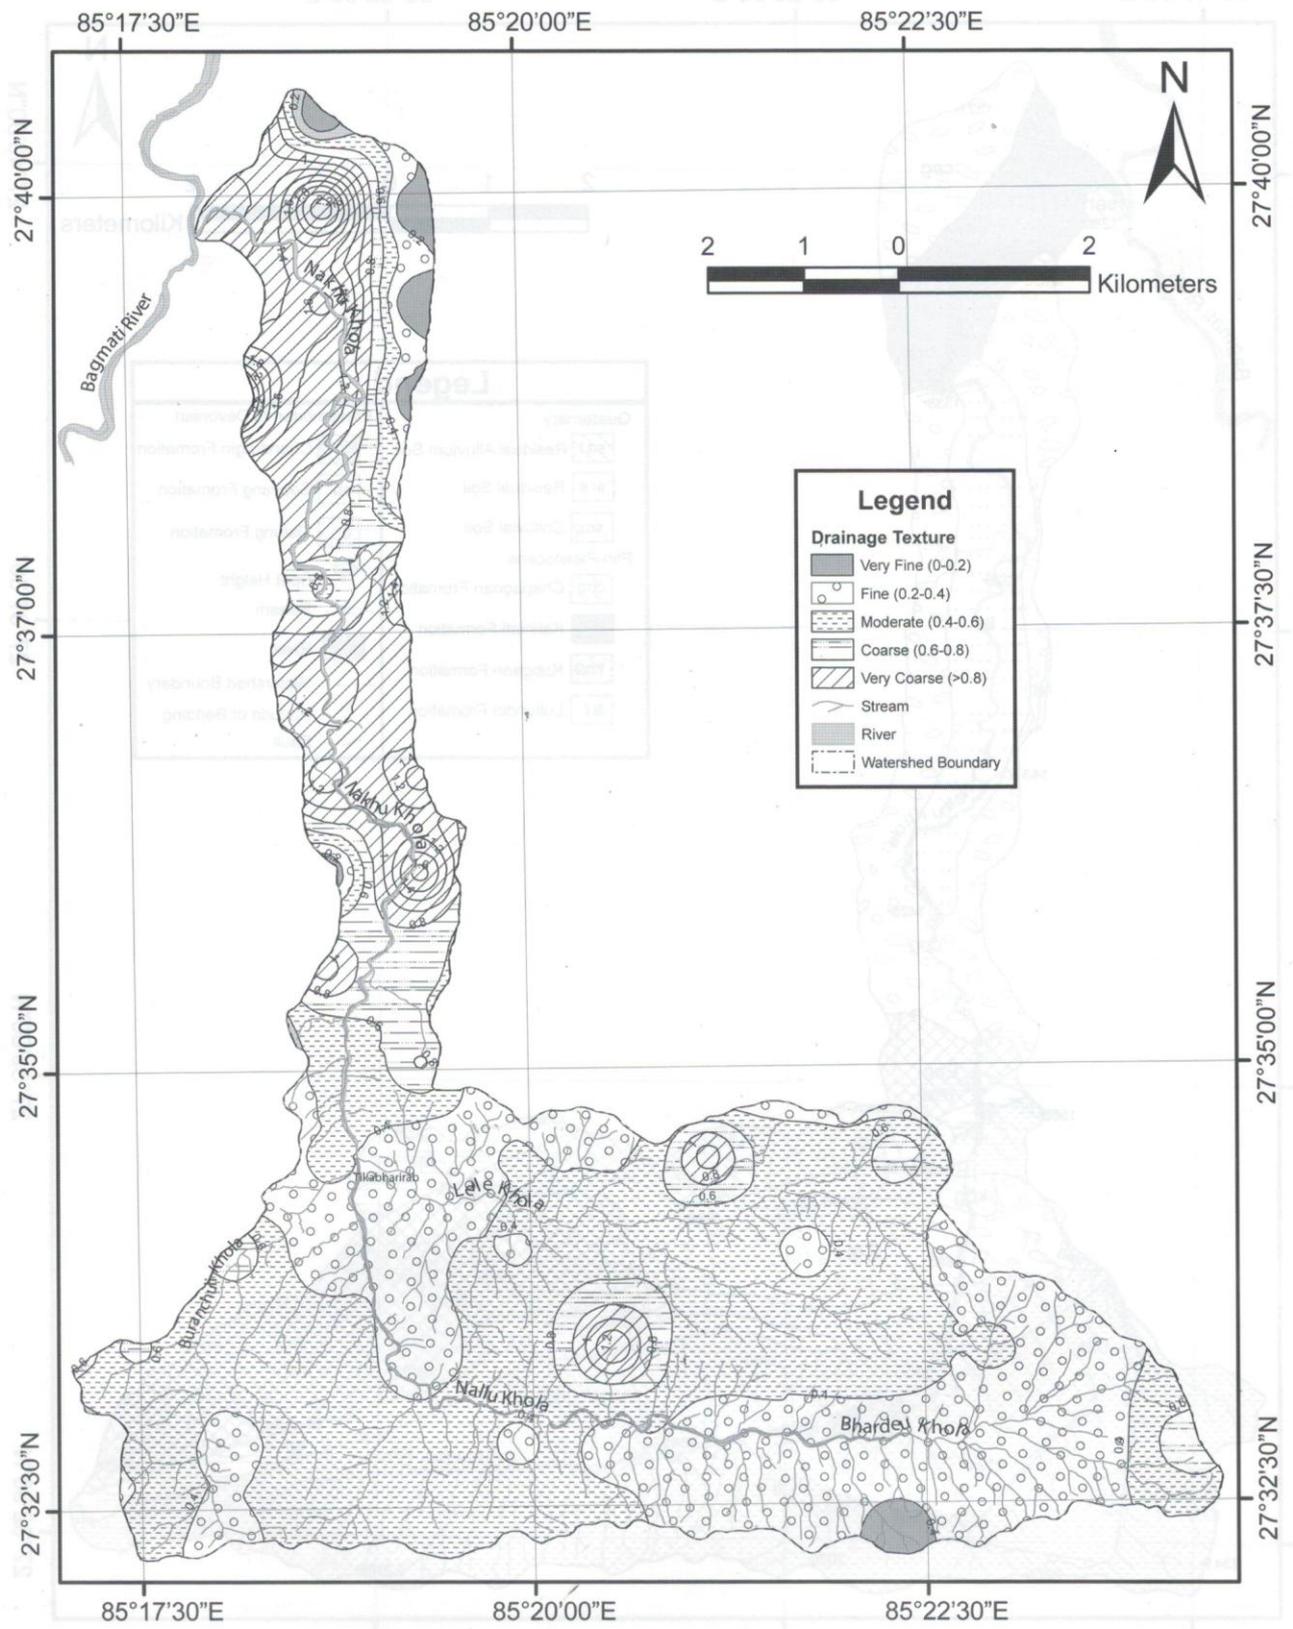
Fig. 2: (b) Drainage texture map of the Nakhu River watershed

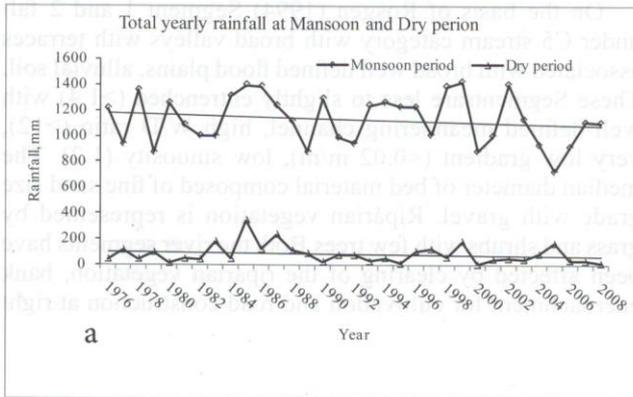
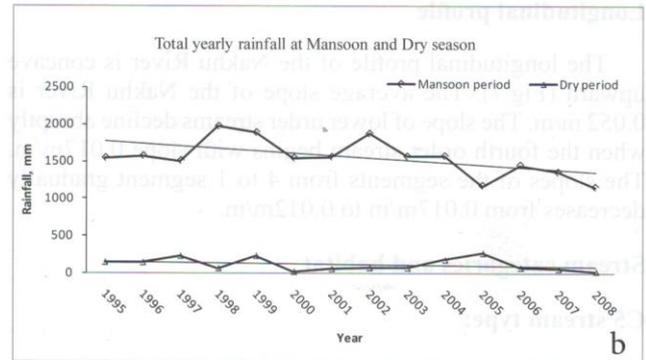
Fig. 4: Total yearly rainfall during Monsoon and dry season at Chapagaon (a) and Lele station (b)

The temporal variation of precipitation shows that the rainfall also varies with altitude and mostly occurs during monsoon period (June to September) and low rainfall occurs during dry period at both stations. The rainfall trend during both dry and monsoon period at both stations is in decreasing trend with time (Fig.4a and b).

Comparing the monthly average rainfall in two stations during 1995-2008 (Fig. 5), Lele station receives the largest amount of rainfall and the Chapagaon station receives least amount during June-September. Since the Lele River (fourth order stream) receives the greatest rainfall during monsoon period based on the data obtained from the Lele station (Fig. 4a and b).

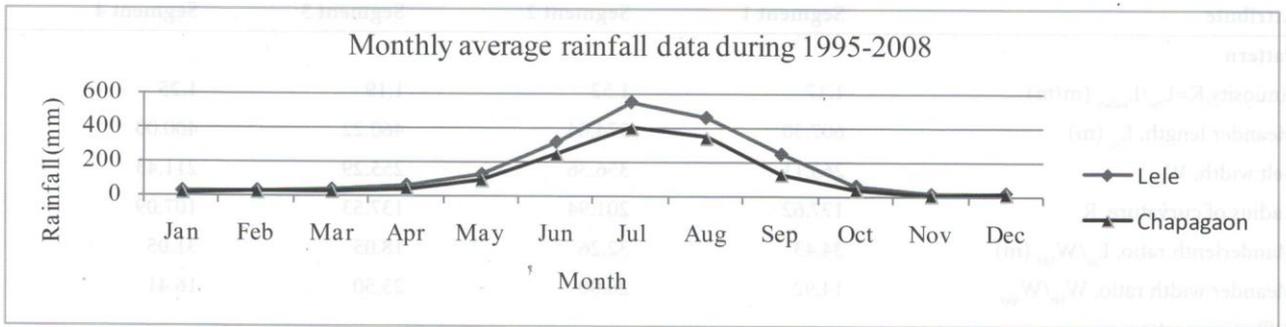
Fig. 5: Monthly average rainfall data during 1995-2008

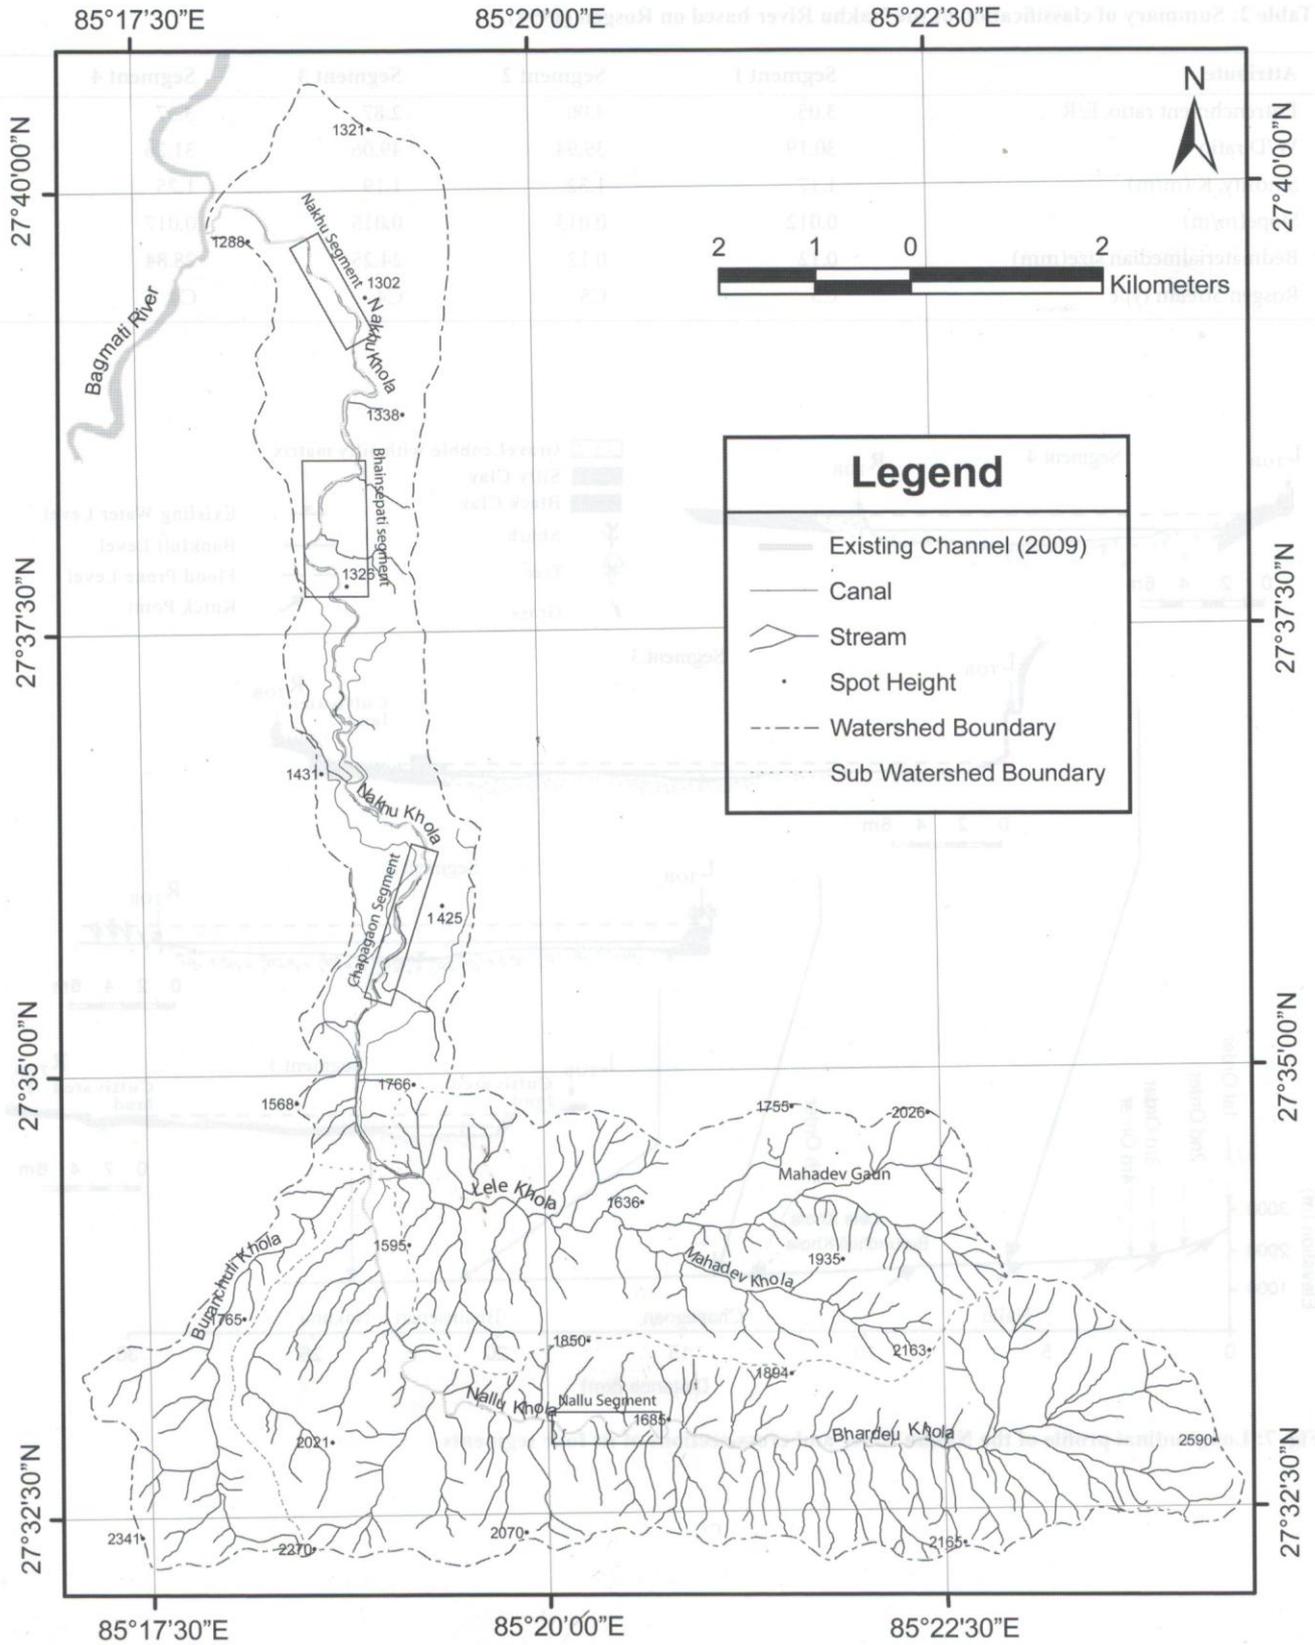
Fig. 6: Four surveyed segments of the Nakhu River

Four representative segments of the Nakhu River were investigated for plan-form and hydraulic parameters based on resembling more or less morphological patterns, riparian vegetation, stream order and distribution position of the stream stretch (Fig. 6). The entrenchment ratio in all the four segments has nearly same value and all segments are moderately entrenched. Segment 2 has greatest value showing greater affinity towards flooding than other segments. Width depth ratio (W/D) is in the range of 30 to 40 for segments 1, 2 and 4. Segment 3 has the greatest W/D ratio compared to other segments. Segment 3 also has the greatest bank height ratio (BHR) of 5.28. The downstream segments possess comparatively low value of BHR and are vulnerable to lateral shifting of river and flooding.

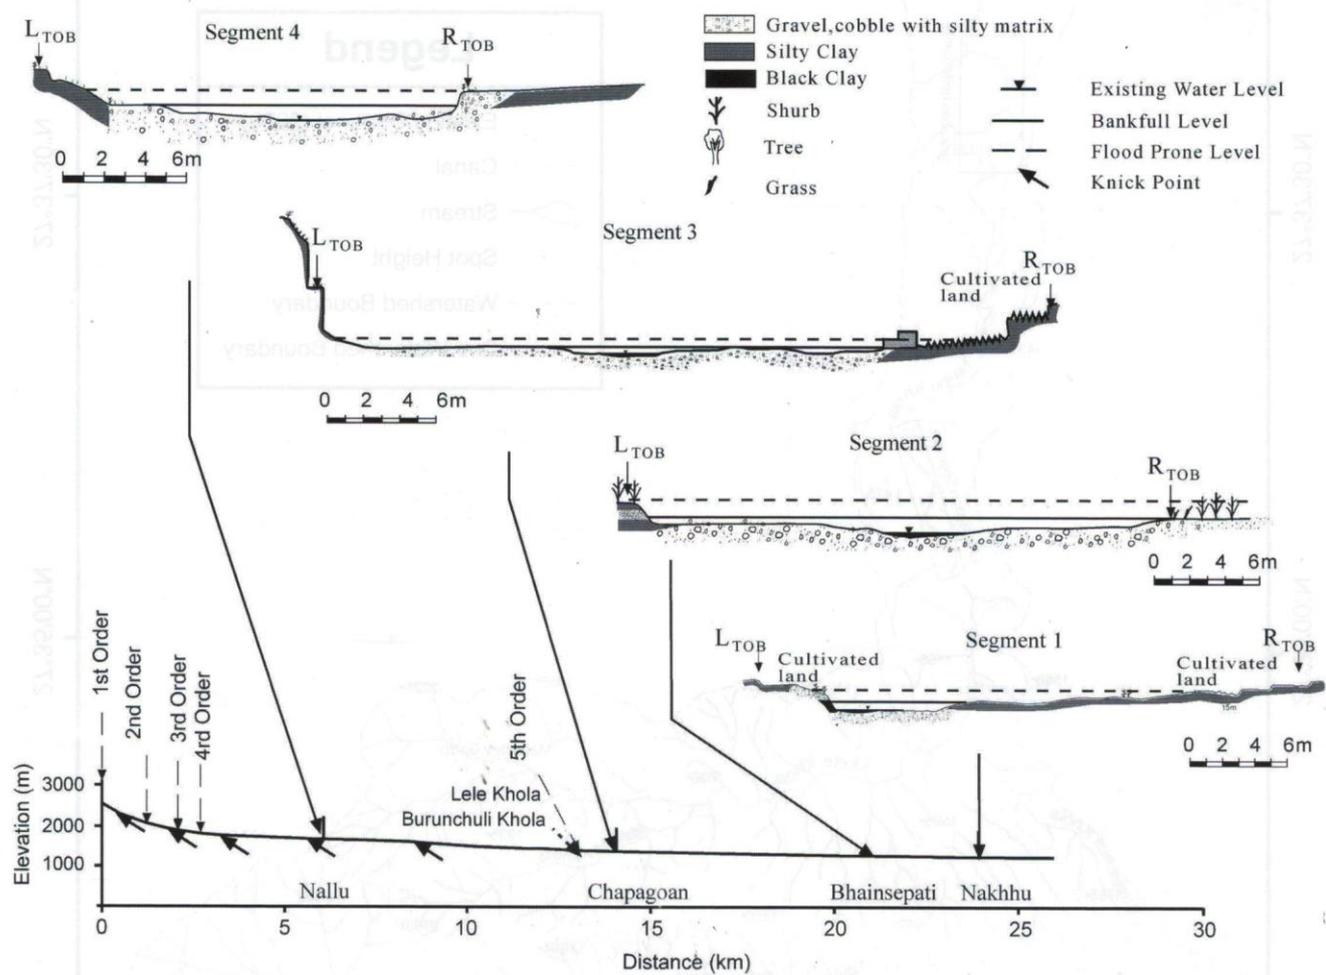
Fig. 7: Longitudinal profile of the Nakhu River and cross-sections of its four segments

The longitudinal profile of the Nakhu River is concave upward (Fig.7). The average slope of the Nakhu River is 0.052 m/m. The slope of lower order streams decline abruptly when the fourth order stream begins with slope 0.017m/m. The slopes of the segments from 4 to 1 segment gradually decreases from 0.017m/m to 0.012m/m.

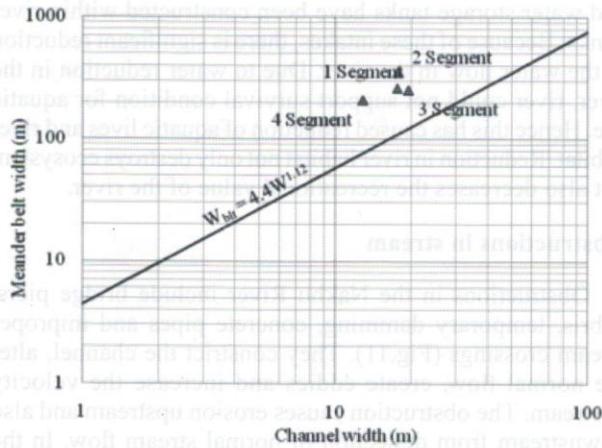
Fig. 8a channel Stability

Deviation from the stability condition of the Nakhu River is represented in Figs. 8 a and b. The plots of all four segments of the Nakhu River deviate from the predicted curve for stable river after Leopold and Wolman (1960). This suggests deviation of stability of stream from dynamic equilibrium.

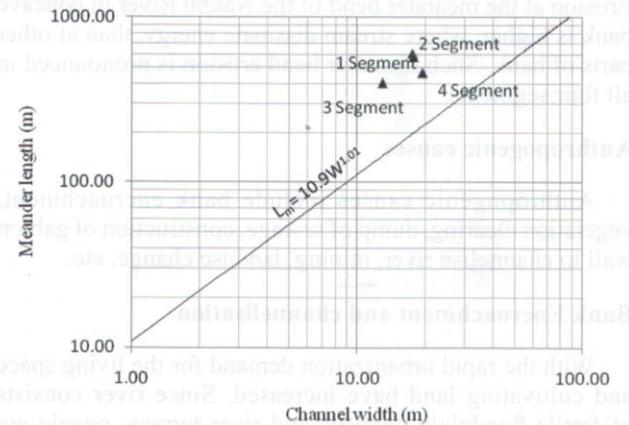
Fig. 8b channel Stability

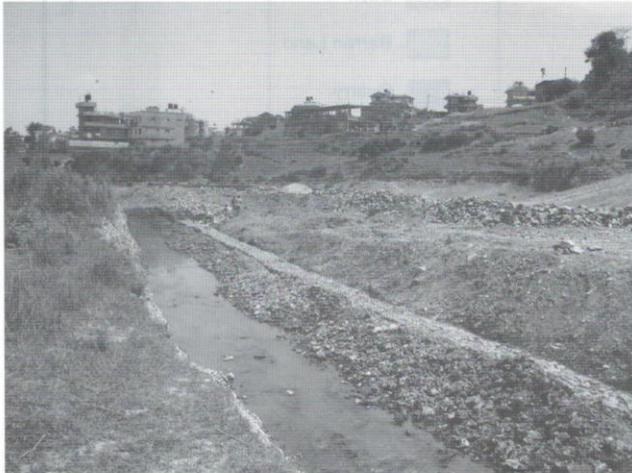
Fig.9: Bank encroachment and channelization for settlement

With the rapid urbanization demand for the living space and cultivating land have increased. Since river consists of fertile floodplain deposits and river terrace, people are attracted towards cultivating in flood plain and river terraces. Therefore, bank encroachment by clearing riparian vegetation is increased along the Nakhu River. Consequently, erosion problem has triggered. In order to control erosion, structures such as gabion walls have been constructed (Fig.9) by government agency. These structures channelize the river and hence cause river instability. Scouring of river bed during high discharge is caused due to upstream channelisation (Fig.10).

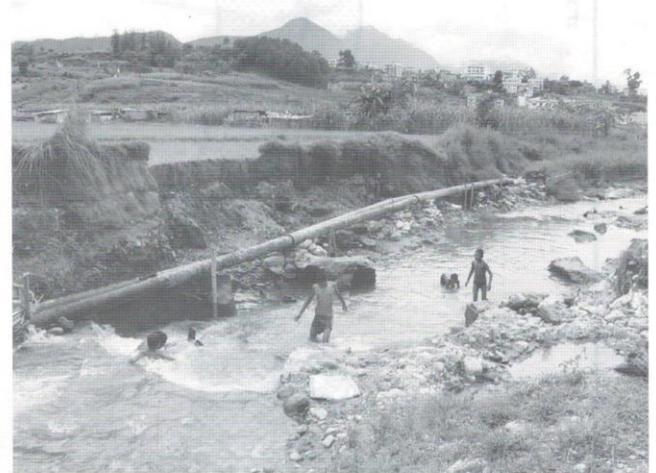
Fig.10: Scour of the river channel due to channelization at upstream

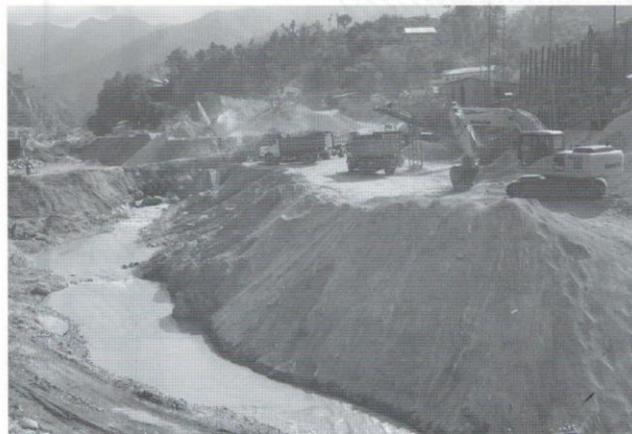
Fig. 11: Sediments from quarry dumped along river channel and obstruction to river flow

Obstructions in the Nakhu River include bridge piers, debris, temporary damming, concrete pipes and improper stream crossings (Fig.11). They constrict the channel, alter the normal flow, create eddies and increase the velocity upstream. The obstruction causes erosion upstream and also downstream from deflection of normal stream flow. In the Nakhu River obstructions at different parts along the whole river are observed.

Huge quarry for aggregates and few gravel mining activities are operating along the Nakhu River at Nallu village development committee. Sediments from the quarry are dumped in the river channel and river bank. These sediments dumped in the river have increased turbidity in the river water and hence no aquatic lives can survive and have destroyed river ecosystem. Other impact of quarrying is the channelization and bank encroachment for road in the quarry area. The purpose of such road is to transport quarried material from the site. Vegetation clearing along the river channel and hills of the quarry area has also reduced the recreational value of the river landscape.

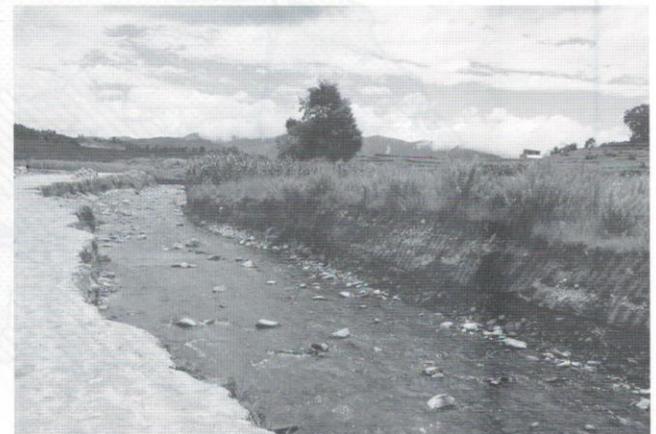
Fig. 12: Excessive erosion in cut bank and road extended at right bank or river

Extension of road at the right bank along the river segment from Nakhu to Tika Bhairabis another major deteriorating cause of the Nakhu River. Due to untechnical road extension, the river channel and bank are encroached destroying riparian vegetation and consequently, increasing bank erosion (Fig. 12). Construction of road has also channelised and increased the depth and slope of the channel. Several cut banks for road have also suffered from excessive erosion during high discharge, thus washing away cultivated lands.

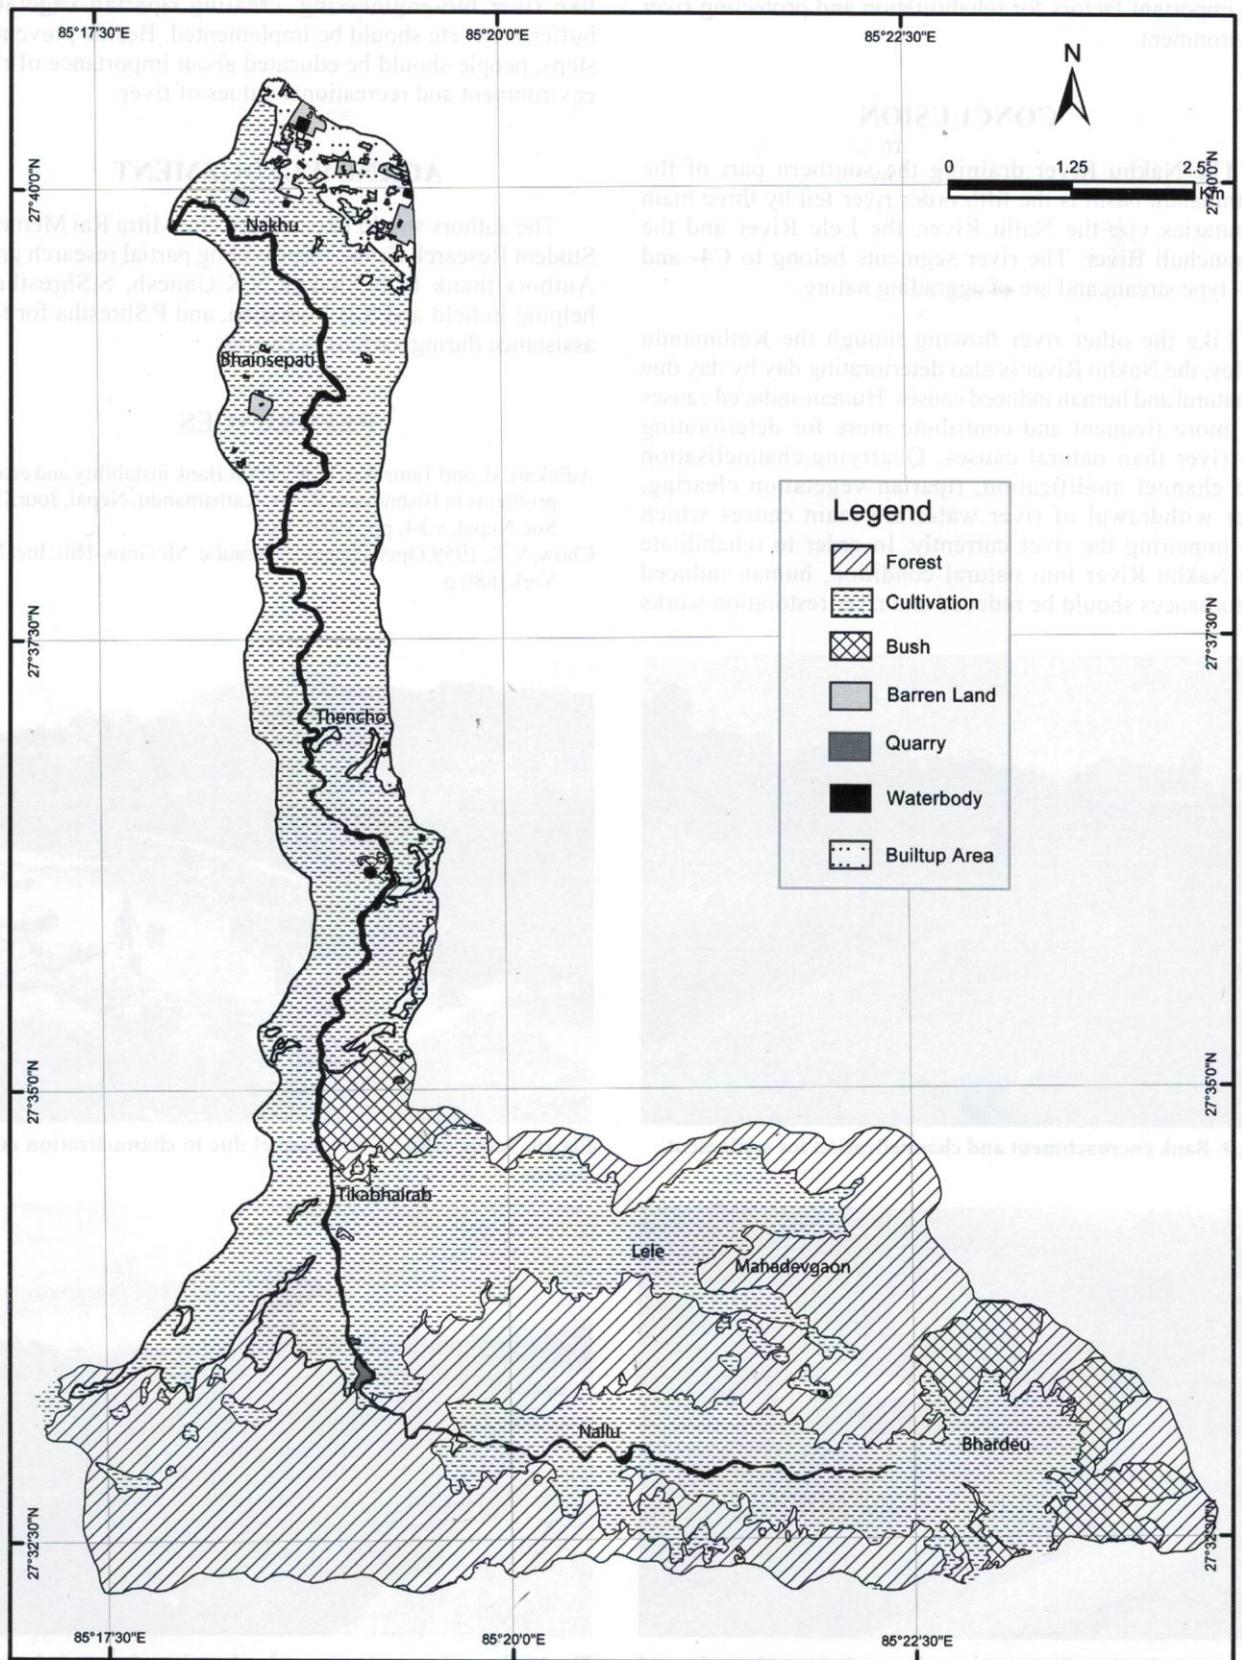
Fig. 13a: Landuse map of Nakhu River watershed (a) based on topo-sheet 1995

With the rapid urbanization in the Kathmandu Valley, scarcity of land for settlement forced people to live in the river banks and flood plains. Bank encroachment for cultivation and settlement increased. The transformation of productive cultivated land to nonproductive settlement also increased (Figs.13a and 13b). Within 14 years, cultivated land has decreased from 30.65% (1995) to 24.9% (2009) and settlement area has increased from 1.3% (1995) to 6.12% (2009) of the watershed area. Though lands of the watershed have been modified to cultivate and other purposes from the past decades, current rates, extents and intensities of landuse changes are far greater than past, driving unprecedented changes in ecosystems and environmental processes in the watershed. Vegetation removal in the watershed leaves soils vulnerable to massive increases in soil erosion by wind and water, especially on steep slopes of quarry area, also releases pollutants to the atmosphere. This not only degrades soil fertility over time, reducing the suitability of land for future agricultural use, but also releases huge quantities of nitrates, phosphorus from fertilizer and sediments to streams and other aquatic ecosystems, causing a different negative impacts such as increased sedimentation and turbidity. In the Nakhu River watershed quarries have increased from 0.04% (1995) to 0.6% (2009) of the total area which have directly reduced the forest area.

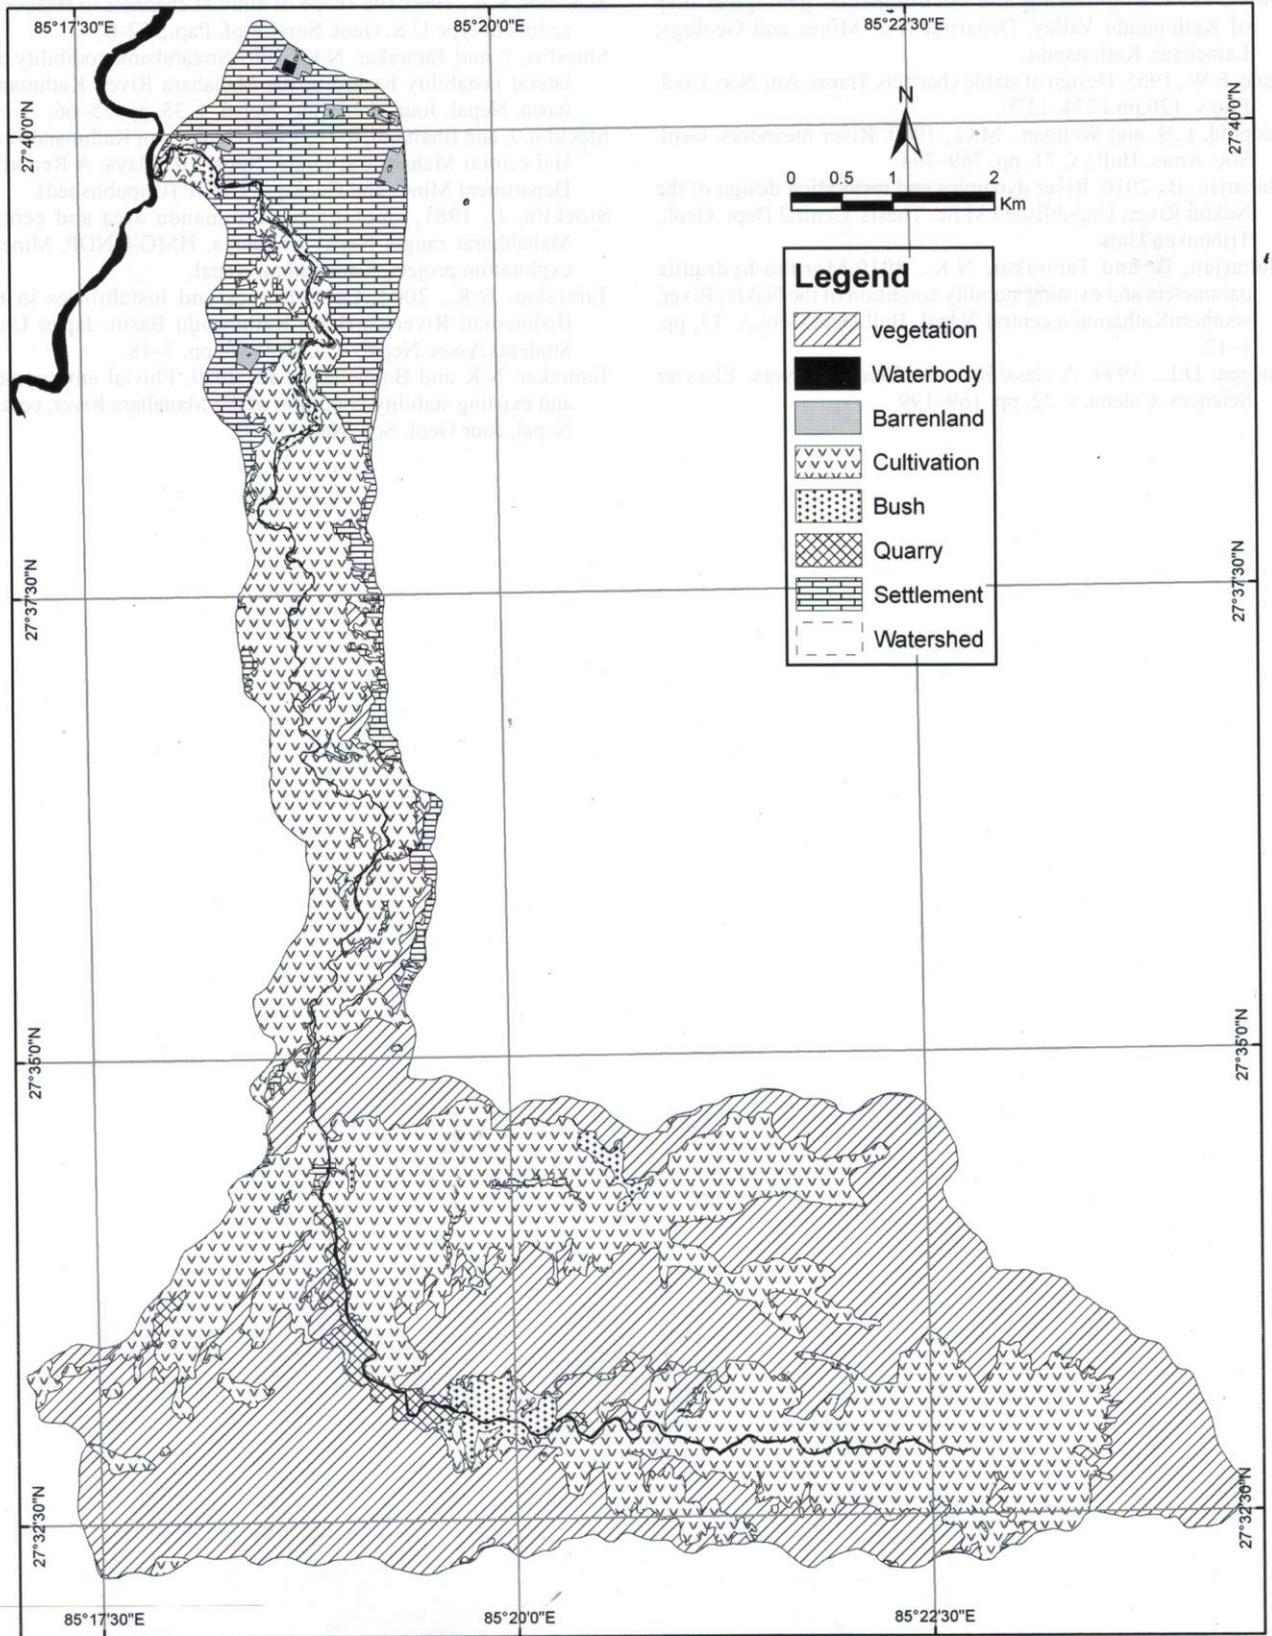
Fig. 13b: Landuse map of Nakhu River watershed (b) Google Earth 2009
