Failure mechanism of large-scale landslide in the central Nepal Himalaya

The geomorphological and geological characteristics of central Nepal reflect the dynamic nature of tectonic and mass movement processes that lead to the occurrence of large-scale landslides (LSLs). The mechanism of the LSL failure process is not well understood due to the different deformation stages controlled by geological structures and causative/triggering factors. Regional tectonic structures and local rock mass characteristics play a vital role in the formation of LSLs. Engineering geological characterization was performed to evaluate the rock/soil properties, and the associated state of danger (cracks, seepage, etc.). The rock mass rating (RMR) and geological strength index (GSI) methods were used to estimate rock mass quality and strength parameters. The estimated strength parameters together with laboratory test data were used to set up a two-dimensional (2D) landslide surface to simulate the failure scenarios. The simulation of landslide models was iterated under different loading conditions by incorporating geological heterogeneities. The results have demonstrated that the movement of the slope was

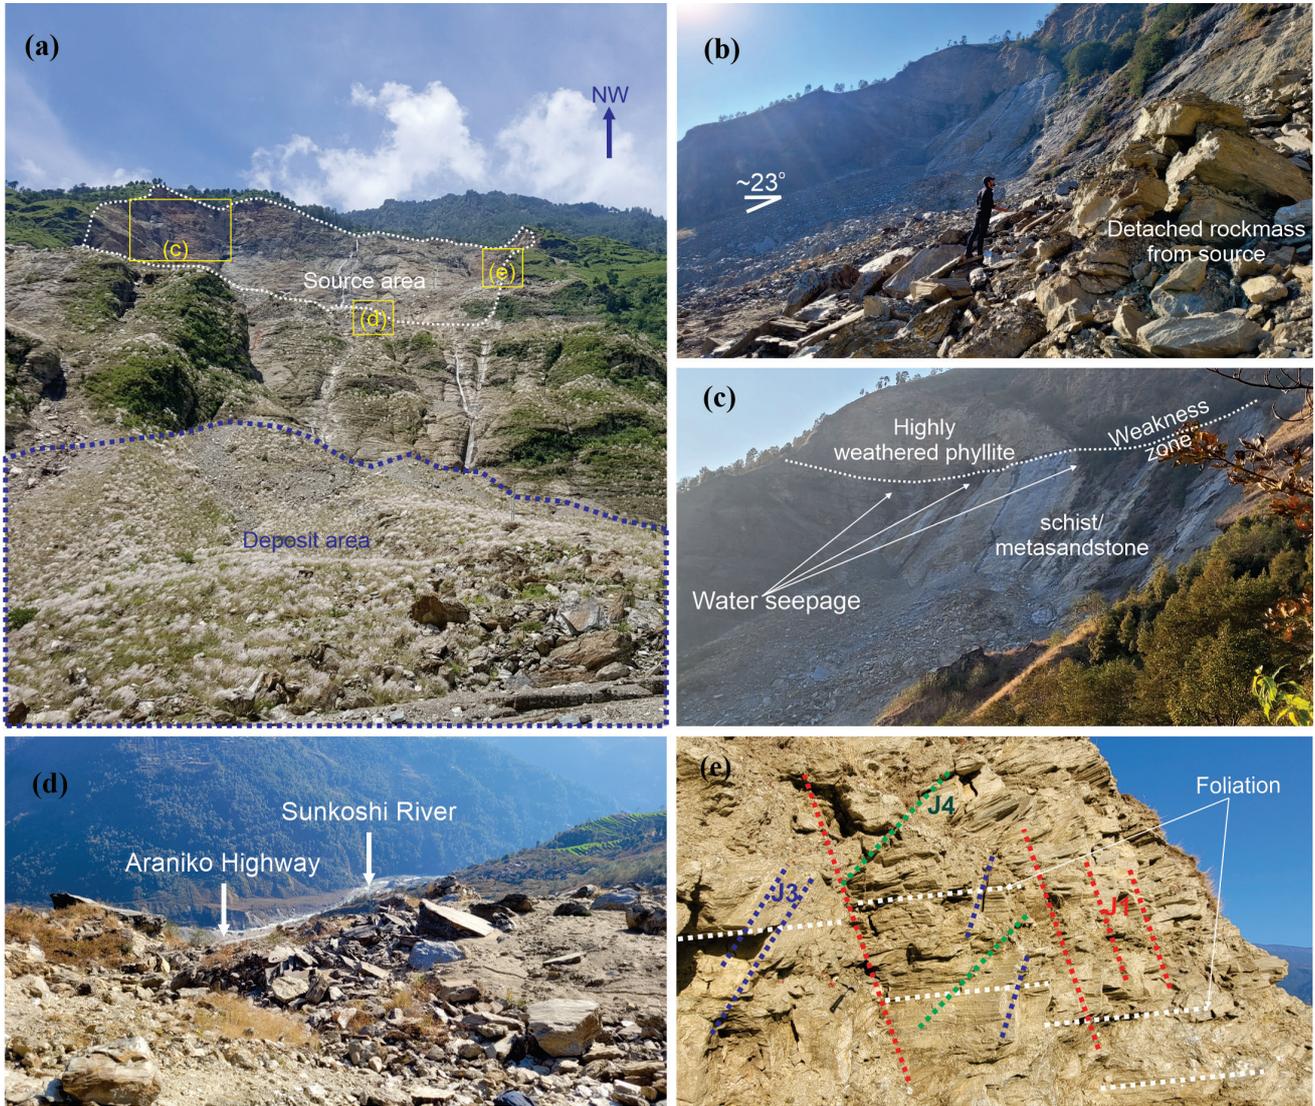
Fig. 4: Field photographs of landslide components (a) main body of landslide, (b) head scarp, (c) landslide rock debris, (d) interstratum boundary and seepage condition, (e) sets of discontinuities present in the landslide flank.

range of $50\text{--}70^\circ$ and another with an orientation range of $335\text{--}352^\circ$ associated with a dip range of $23\text{--}50^\circ$. A highly persistent shear joint is found distinctly parallel to the stress release joint (J_1) along the slope with steeper than slope face. The detached rock boulders having a range of up to 20 m are lying over the upper benching slope of landslides (Fig 4b,c).

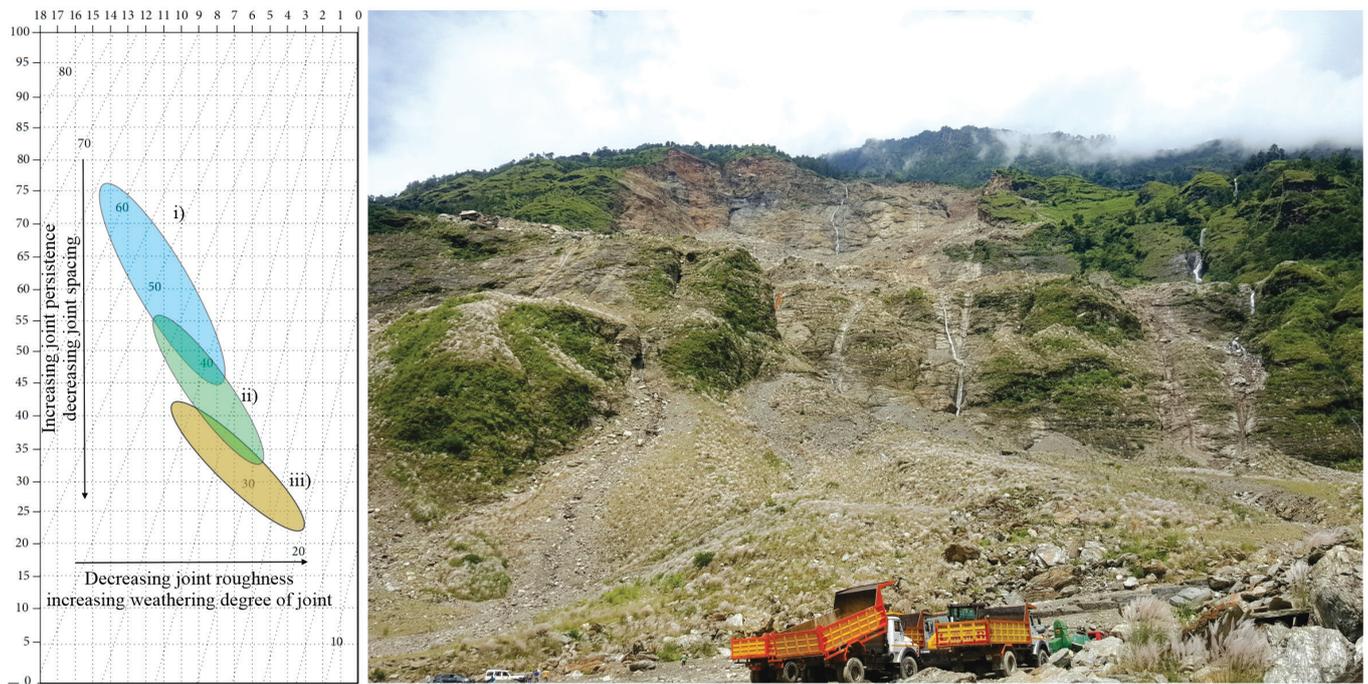
Fig 6: Rock mass quality and the corresponding GSI estimates from different location of landslide (i) main scarp, (ii) sliding surface, (iii) landslide flanks.
