A Study on Squatter Settlements of Kathmandu Using GIS, Aerial Photography, Remote Sensing and Household Survey

Kiran K.C.*, M.Sc. Dissertation Work, 2010, SchEMS, Pokhara University, Nepal
(Programme Officer, NTNC, Nepal, itskrn@gmail.com) and
Dr. Krishna Pahari**, Research Advisor, (National Advisor, UN-WFP, Nepal, krishna.pahari@wfp.org)

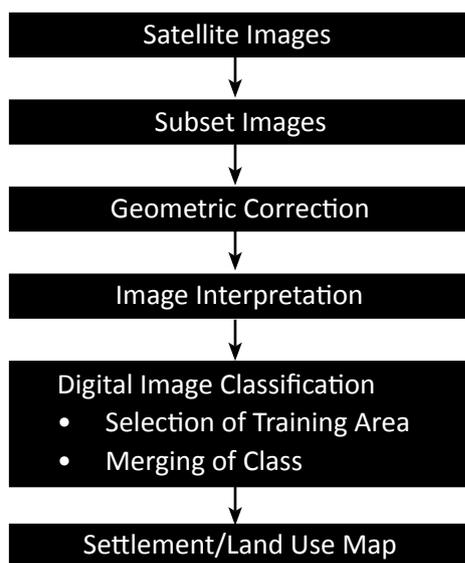
Fig1: Schematic Flow Chart of Satellite Image Study

The schematic flow diagram representing the remote sensing analysis is shown in fig 1. Besides these, topographic map sheets of scale 1:25,000 from Survey Department representing the study area were used and a set of household questionnaire were used for surveying livelihood condition. Advanced tool like GPS and softwares like ERDAS Imagine 9.3, ArcGIS 9.2 were used for spatial analysis and mapping. Statistical analysis of the data from household questionnaire was done with EXCEL and SPSS. The change analysis was done in order to analyze the changes over time. Analyzing different images, growth of the settlement areas, number of household increment, land use change, river line diversion were identified and mapped. Future livelihood conditions have been predicted comparing the survey status.

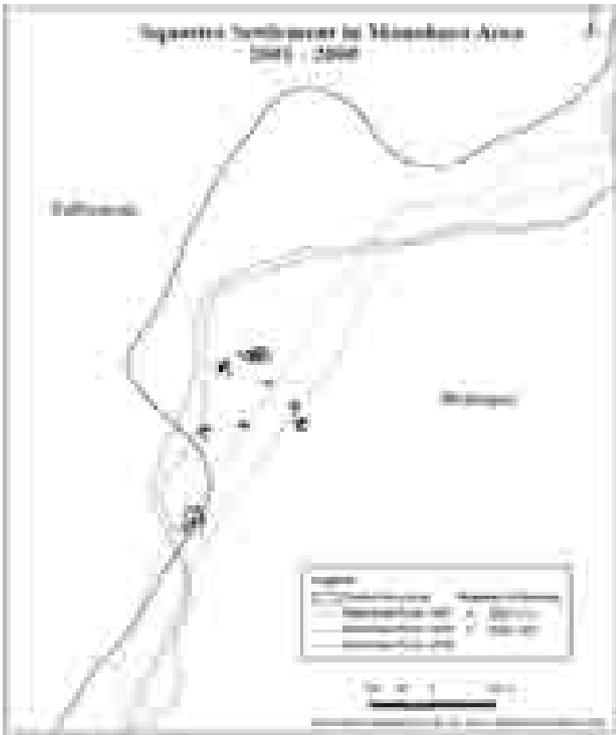
Map. 1. Squatter Settlement in Manohara Area (2001-2005)

The settlements that grew up to 552 in the year 2007 have reached up to 742 till 2009 is seen that the settlements here in Manohara have settled for almost one decade. In maps 1 and 2, a clear picture of river line diversion is also seen from the year 1967 till 2009. It is interesting to know that the 1967 river line that had shifted away from its original course is shifting back towards the squatter settlements that are lying in the same river channel of 1967 and therefore it resembles that the settlements lying in the flood plain are prone to flood hazard causing property loss along with human injuries and deaths.

Through the analysis of the imageries procured, there were no squatter settlements seen in the year 1967 and 1999 in both of the study areas. In the year 2001, a total of 11 households having an estimated population of 77 in the Manohara area and 2 households having an estimated population of 10 were seen in the Thapathali area. The number of households has increased by approximately four times, whereas it has remained constant in the Thapathali area in 2005. It has demonstrated the same trend of rise in 2009 with a total population of 5194. In contrast, the Thapathali squatter area is a recent development as the number of population that was limited to only 23 in 2007 has radically increased up to 1316 in 2009.

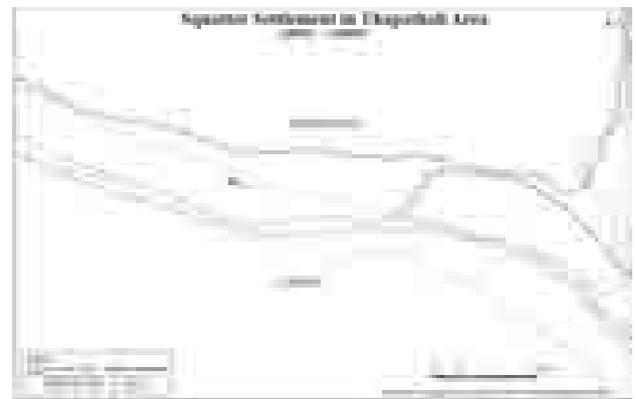
Map. 3. Squatter Settlement in Thapathali Area (2001-2005)

Maps 3 and 4 show the growth of squatter settlements in Thapathali derived from the analysis of series of satellite images same as those used in Manohara area. Map 3 clearly reveals that the squatter settlements started from the year 2001 with only two households were as it is until 2005. These settlements which are currently adjoining to the main road are the oldest settlements lying inside the 1967 river channel. The clear picture of river line diversion from the year 1967 till 2009 is also seen in the figure. The black line resembling district boundary also changes with the change in river line as the district boundary is made in reference to river line.

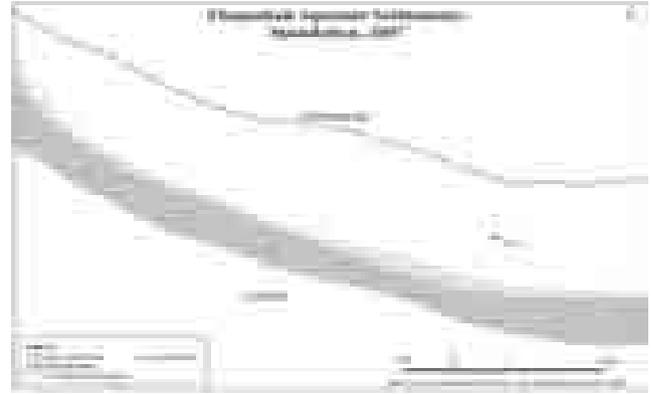
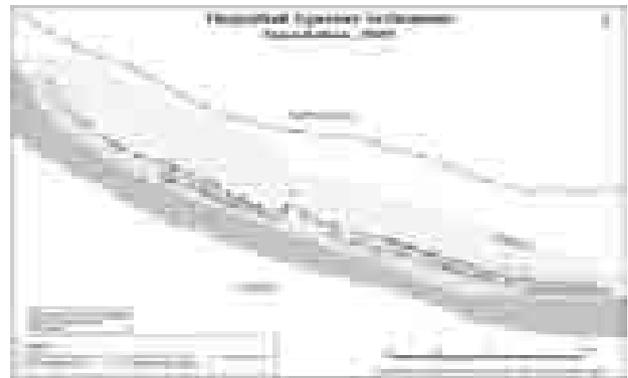
The flood hazard mapping was done for the settlements area (side) on the basis of community knowledge and GPS survey was done for tracking the coordinates. With the help of checklist, the respondents were asked for the previous flood events occurred in the same area. The respondents could remember about the flood events of 2007 and 2009 as presented in the maps. The inundation maps of Manohara ara and Thapathali area are shown from map 13 to 15.

The community-based flood hazard mapping done with the GPS survey has revealed that all the settlements from both of the areas had been inundated in the month of July in 2009. In both areas, the flood event had happened mainly due to the weak embankment and the sand mining activities going on rapidly along the river banks.
