## Geo-hydrological hazards induced by Gorkha Earthquake 2015: A Case of Pharak area, Everest Region, Nepal

**Key words:** Gorkha earthquake, geo-hazards, damages, mitigation and adaptation.

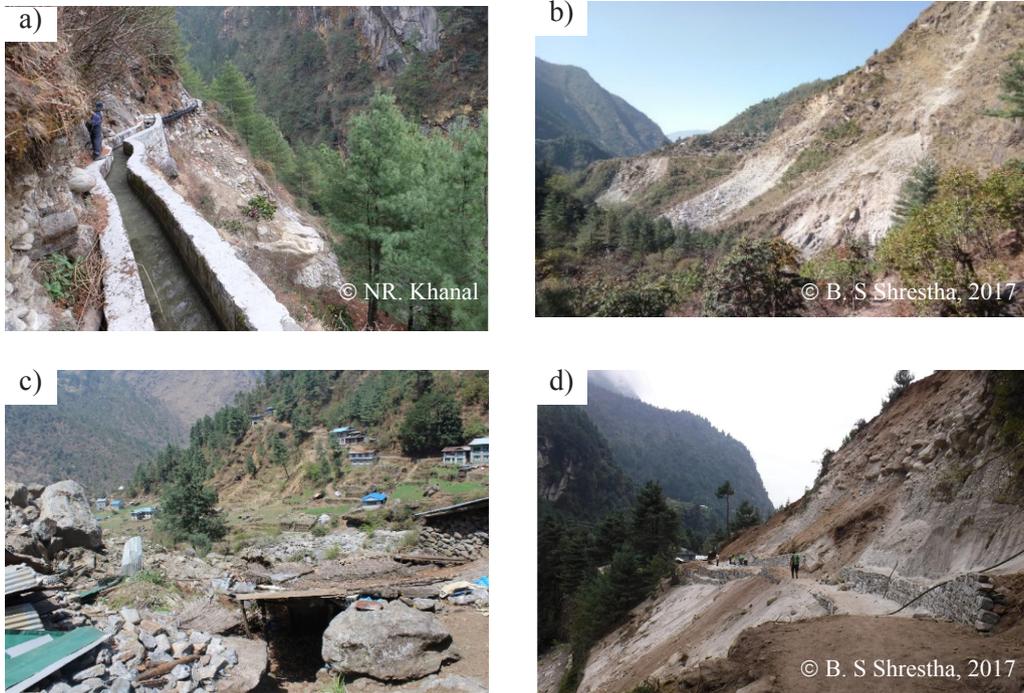
**Figure 4:** Earthquake induced hazards losses and damages in study area. a) Canal damage at Manjo by landslide b) landslide induced at Nackchung village c) Destroyed stone masonry building and collapse crops and cultivated land at Surke village south of Lukla, d) Trail damage by Landslide north of Phakding.

The maximum crops and cultivated land have damaged by landslide. A total of 0.56 hectare *khet* land with 0.28 hectare *bari* land, 3,300 kg potato, 970 kg maize, 670 kg buckwheat and 1480 kg of wheat were destroyed. Rock fall has damaged 0.05 hectare *bari* land and 200 kg potato, 50 kg maize. Similarly, debris flow damaged 0.05 hectare *bari* land with 300 kg of potato (Table 6). Two significant landslides found in Nackchung (Figure 4 b) village west of Lukla and destroyed cultivated land ,shed and trial and these landslides run across the main trail from Lukla to Nackchung down to the river, isolating villagers from the main valley. They had to be flown to Lukla where they stayed for three months while the trail was being repaired (Fort, M., Smadja, J., Khanal, N. R., & Shrestha, B. R., 2019). Another landslide from Phakding landslide (Figure 4 d) right side of the Dudh koshi river has destroyed the major trekking trail (Lukla -Namche). The examples of house damaged and canal damaged are shown in (Figure 4 a and c).

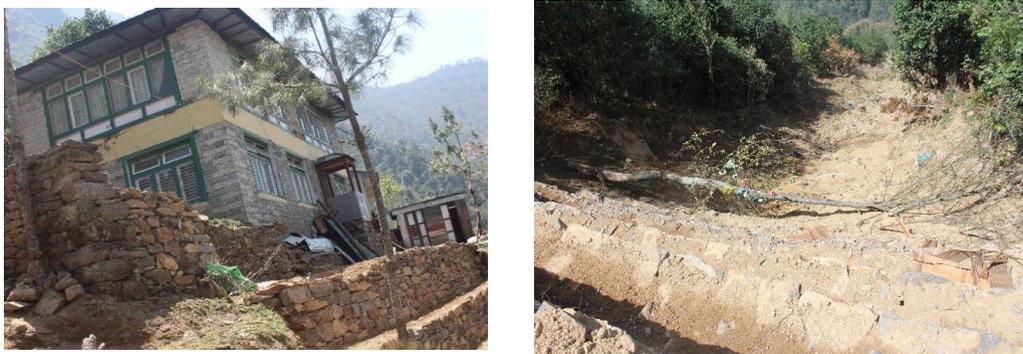
**Figure 5:** Wall constructions to mitigate house and trail at Surke village a) landslide affected house upper part b) wall construction (stone and mud) to control headward extension of landslide.

Local people perceived that geo-hazards like, landslide, rock fall etc. occur in their settlements. Yet, the 2015 Gorkha earthquake had resulted damages and losses in the study area and it damaged trail and bridges. This event had changed the mindset of local people to construct earthquake resisting buildings and other infrastructures too. People think that tree plantation, wall construction and bio-engineering could reduce the effect of landslide, rock fall and debris flow (Figure 5 a and b). Villagers on average felt that a geological hazard would likely occur at their settlements frequently and did not know the mitigation action clearly during a geological hazard. Local people felt that there is no more open spaces and safe land during the disaster period and lacking disaster preparedness. Respondents think that building and other infrastructures should be constructed earthquake resisting
