Performance Evaluation of Historical Masonry Structure

Abstract

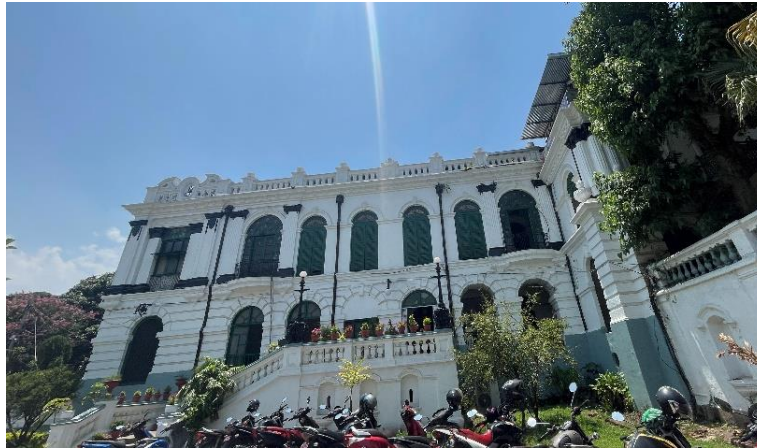
Figure 1: Seto Durbar, Durbar Marga

Seto Durbar, currently operating as Rastriya Banijay Bank, Durbar Marg Branch is the selected site. The architectural plan of the building has been prepared as shown in Figure 6 and Figure 7 A rebound hammer test has been performed on different wall faces. For material characterization, due to unavailability of testing instruments and apparatus, past literature has been reviewed and the paper titled. *Seismic Strengthening of the*

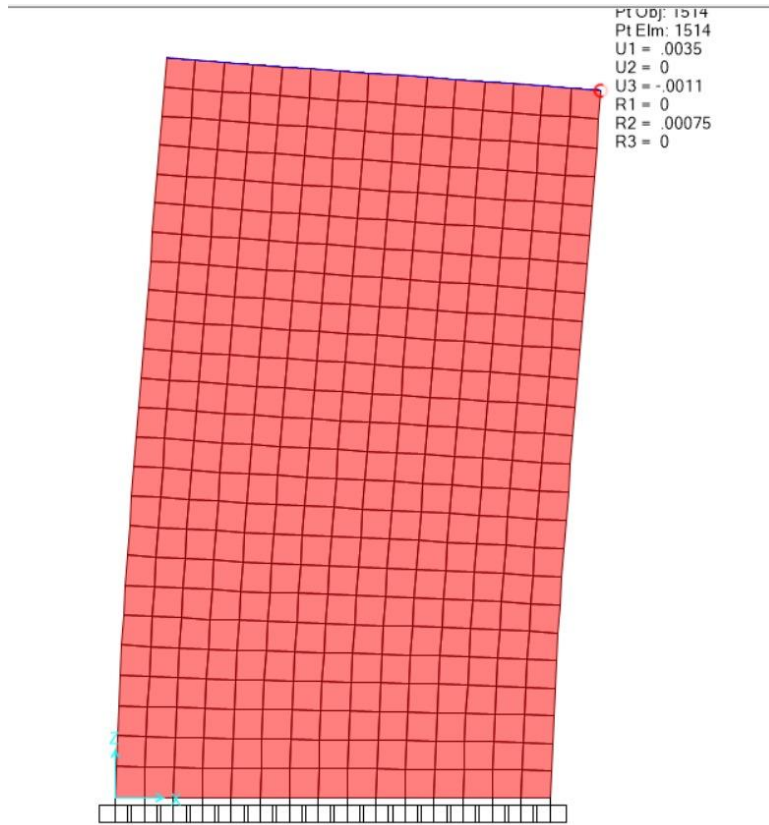
Figure 12. Deflection of wall 2 due to Eqx ultimate

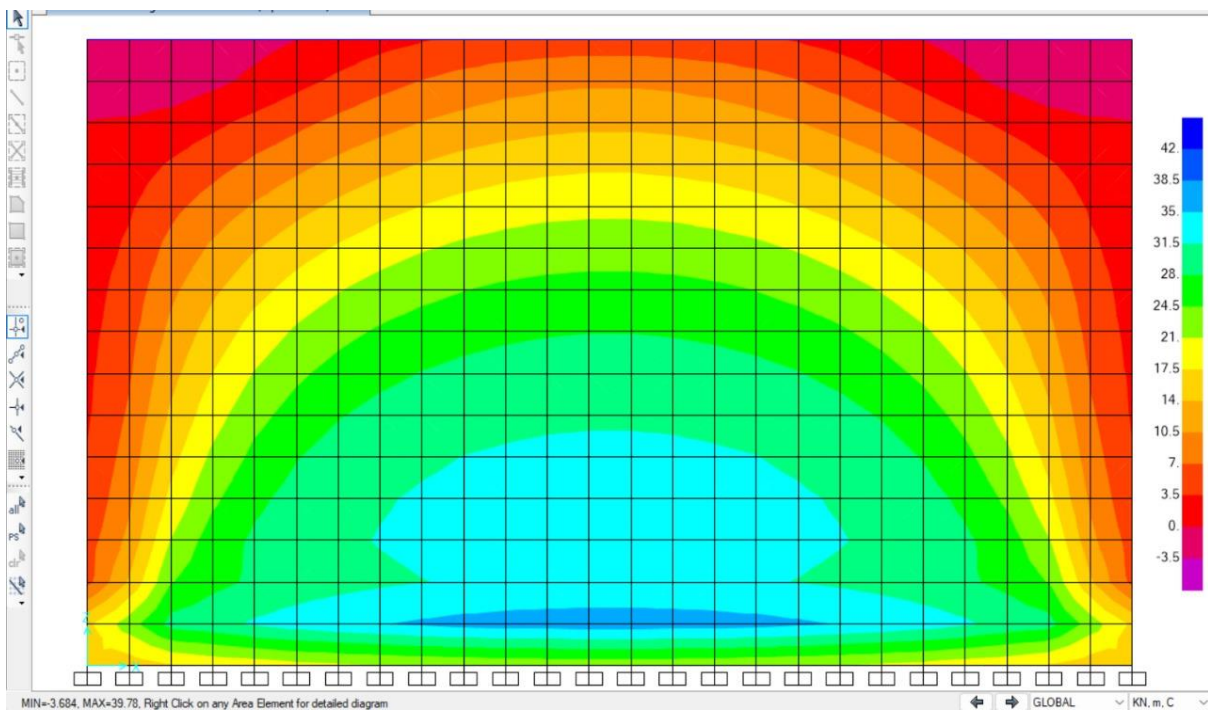
Figure 17. Shear stress on wall 3 due to Eqx ultimate

From the Table 4 and graph the Normal stresses in wall 1, wall 2 and wall 3 are 33.898 kN/m², 86.434 kN/m² and 26.826 kN/m² respectively which is below the permissible compressive stress 250 kN/m² and shear stresses on respective wall are 38.93 kN/m², 66.415 kN/m² and 39.78 kN/m² which is below the permissible shear stress 100.5 kN/m² so retrofitting of the wall panels is not necessary. However numerical modelling of the whole building is yet to be performed.
