Structural Performance of the RC T-Girder Superstructure of Gongabu Bridge under Vehicular Loads

Abstract

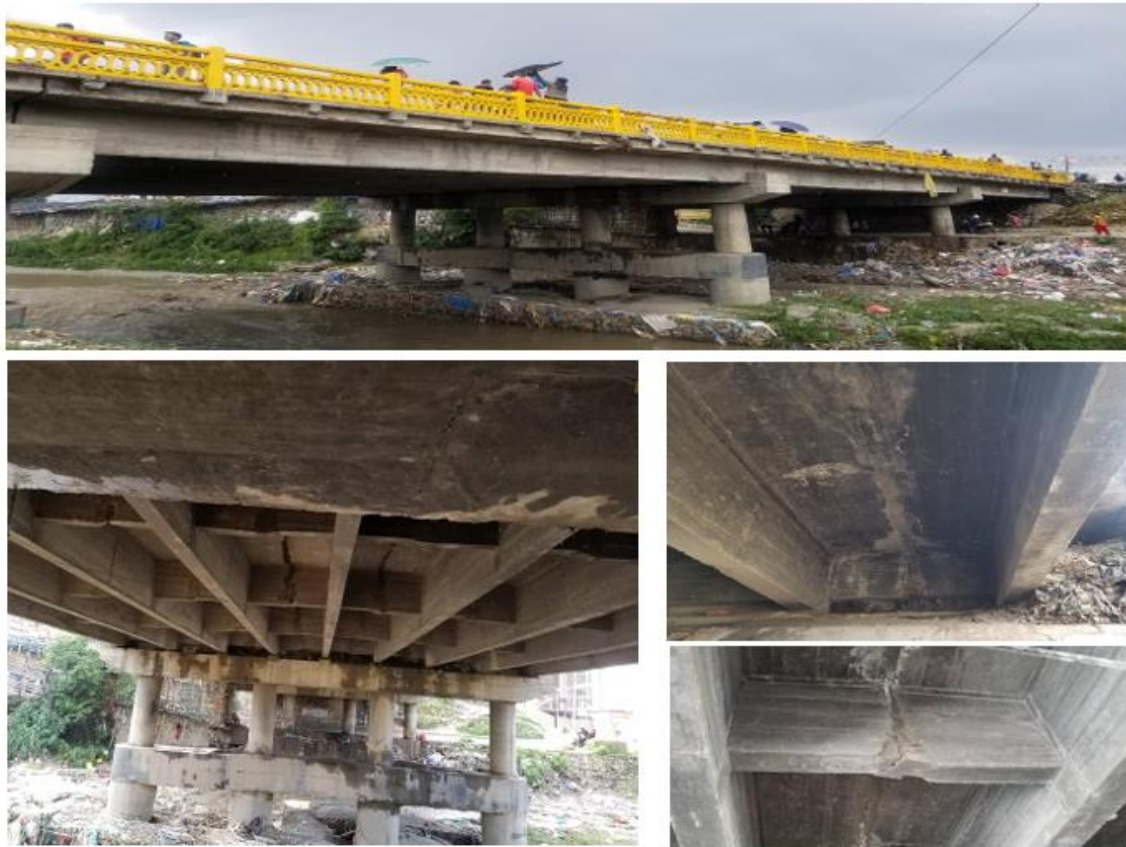
Figure 1. Gongabu Ringroad Bridge

The Gongabu Ringroad Bridge exhibited several structural problems during the visual inspection, as shown in Figure 1. Longitudinal cracks were visible along the bridge deck, which are likely due to weaknesses at the construction joints. These joints often act as points of stress concentration, especially when proper construction practices are not followed. Over time, the continuous impact of heavy traffic loads has made these cracks more severe. Furthermore, signs of scouring were noticed around the pier and pile foundation. Scouring, often caused by flowing water removing soil from around the foundation, can lead to loss of support and increased vulnerability of the structure. These findings indicate that the bridge's structural condition has been affected by both age and environmental factors. The general features of the bridge are provided in Table 1.

Indeed, longitudinal cracks observed during visual inspection, especially in Span 1 and Span 4, correspond with the locations of high deflection and stress concentration. These findings suggest that the bridge is experiencing more strain under vehicle loading than originally designed for, likely due to both increased traffic loads and material aging. It's important to note that while moving loads were considered in the analysis, no explicit dynamic (impact or vibration) loading was modeled.

Based on these observations, it is recommended that targeted retrofitting measures be applied, particularly in Span 4, to reduce deflection and extend service life. Solutions such as externally bonded FRP, steel plate strengthening, or prestressing may be explored. It is also advised to install a Structural Health Monitoring (SHM) system to monitor deflections, crack propagation, and load behavior over time. Lastly, a traffic load reassessment is needed to determine whether current vehicle demands exceed the bridge's original design capacity, and whether future upgrades or replacement should be considered.

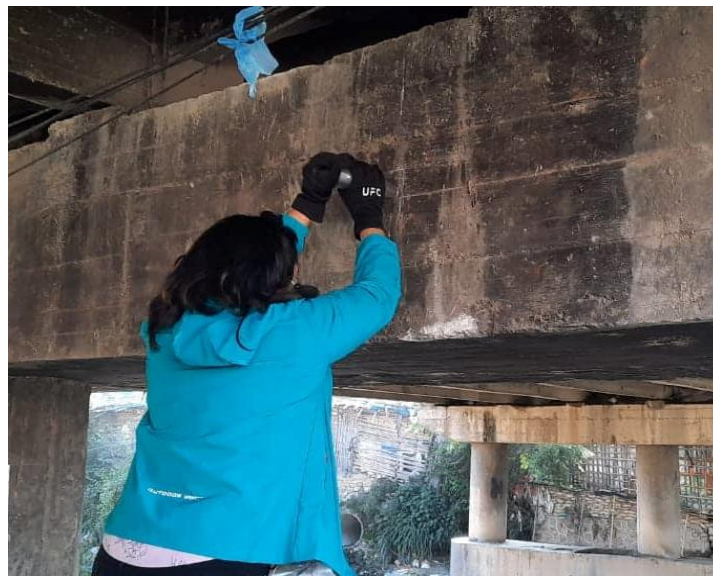
Figure 2. Rebound Hammer Test

The Rebound Hammer Test was performed in accordance with (IS13311(Part2), 1992) to estimate the surface hardness and in-situ compressive strength of concrete in key structural elements of the bridge. The test was conducted on the main girder, cross girder, deck slab, pier head, and pier using a Schmidt Rebound Hammer in a horizontal orientation as shown in Figure 2.

Before testing, all surfaces were cleaned to remove dust, laitance, and loosely adhered particles to ensure accuracy. The testing was carried out using a grid spacing of 25 mm between points, with each impact point kept at least 20 mm away from edges or any surface discontinuities as per standard requirements. At each grid location, multiple

rebound readings were recorded. For each structural component, 20 readings were taken, and to improve result reliability, the five highest and five lowest values were excluded. The mean of the remaining 10 readings was then used to estimate the compressive strength.

Based on the recorded rebound numbers and corresponding standard conversion charts for the Schmidt Hammer Model N/NR, the estimated compressive strengths of the components were as follows and also shown in Table 2: Main Girder: 20 MPa, Cross Girder: 25 MPa, Pier Head: 40 MPa, Pier: 30 MPa and Deck Slab: 35 MPa.
