Geomorphic assessment of morphology of Siwalik origin rivers in Far-west Nepal

*Motilal Ghimire¹ and Puspa Sharma¹

©2024 Journal of Nepal Hydrogeological Association (JNHA), Kathmandu, Nepal

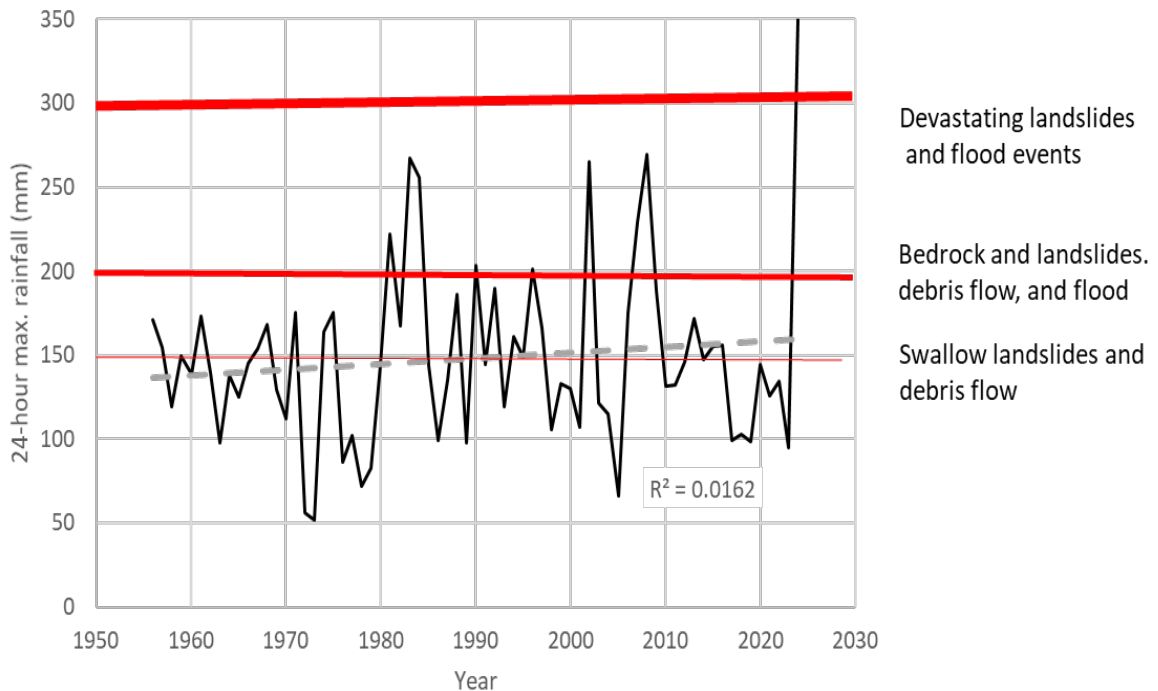
Fig. 4: Historical observation of the 24-hour extreme rainfall events in Dhangadi (DHM, 2020, 2024).

2.3 years, and have shown increasing trend (Fig. 4). Such events can trigger landslides and debris flow in hillslopes. Nine rainfall events with intensity above 200mm/24 hours were recorded, capable of initiating widespread and devastating landslides and debris flow (Fig. 4). In July 7-8 ever recorded (DHM, 2024) extreme rainfall was recorded, i.e., 573.6 mm/24 hour at Hanmannagar. Apart from the rainfall, tectonic upliftment and incision rate are pronounced in creating landslides and erosion. Lavé and Avouac (2000) estimated the uplift rates in the Siwaliks of central Nepal to range between 1-4 mm/year based on the deformation of fluvial terraces. Similarly, erosion rates in the Siwaliks are estimated to be around 2-6 mm/year, varying significantly with monsoon intensity and river dynamics (Bookhagen and Burbank, 2010).

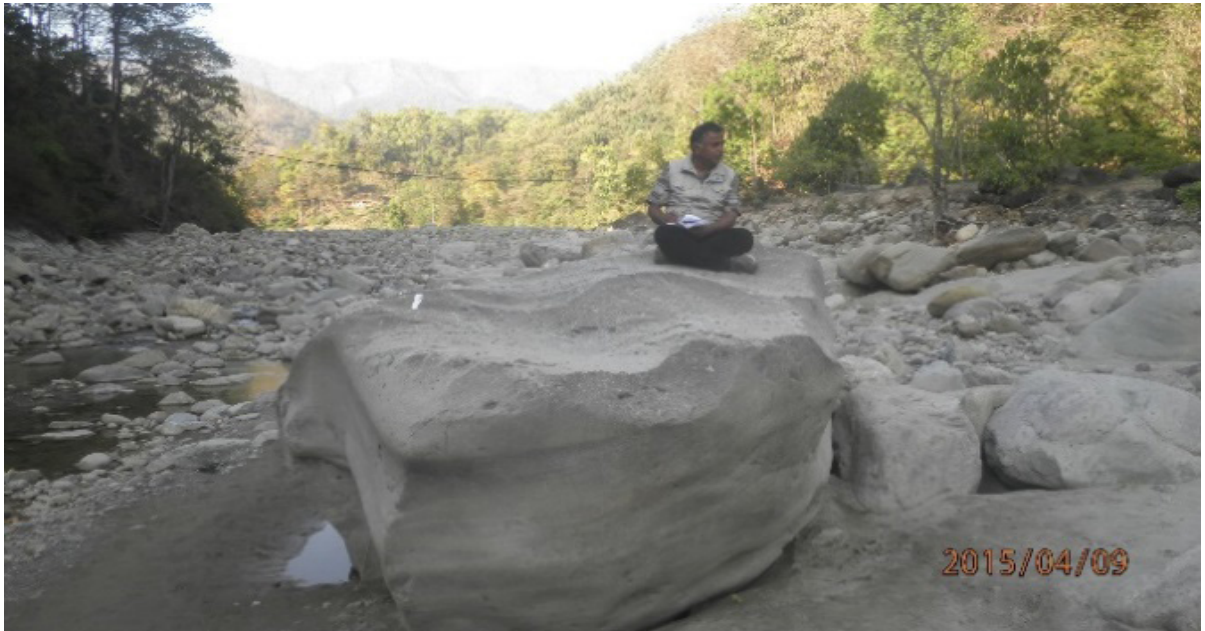
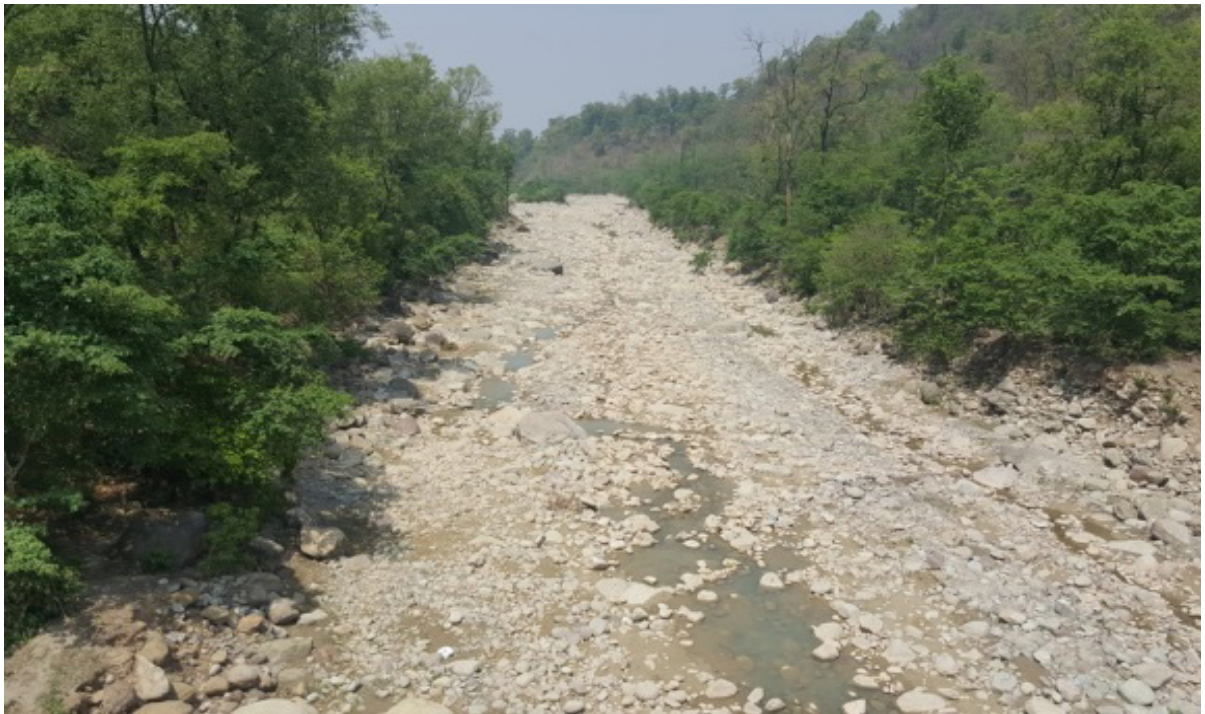
Fig. 7: Boulder, cobble, and gravels near the apex of the fan of Godawari River.

Alluvial fan deposits: This zone comprises alluvial fan deposits, which feature decreasing sediment size from boulders to sand towards south. Riverbeds are wide, shallow, and braided, with unstable island bars. Flashy discharge causes sediment transport during high water levels. The Khutiya River has a significant fan base, while others, like Mohana and Manohara, have smaller fans. Embankment construction requires site assessment due to the risk of channel avulsion (Fig. 6 and 7).

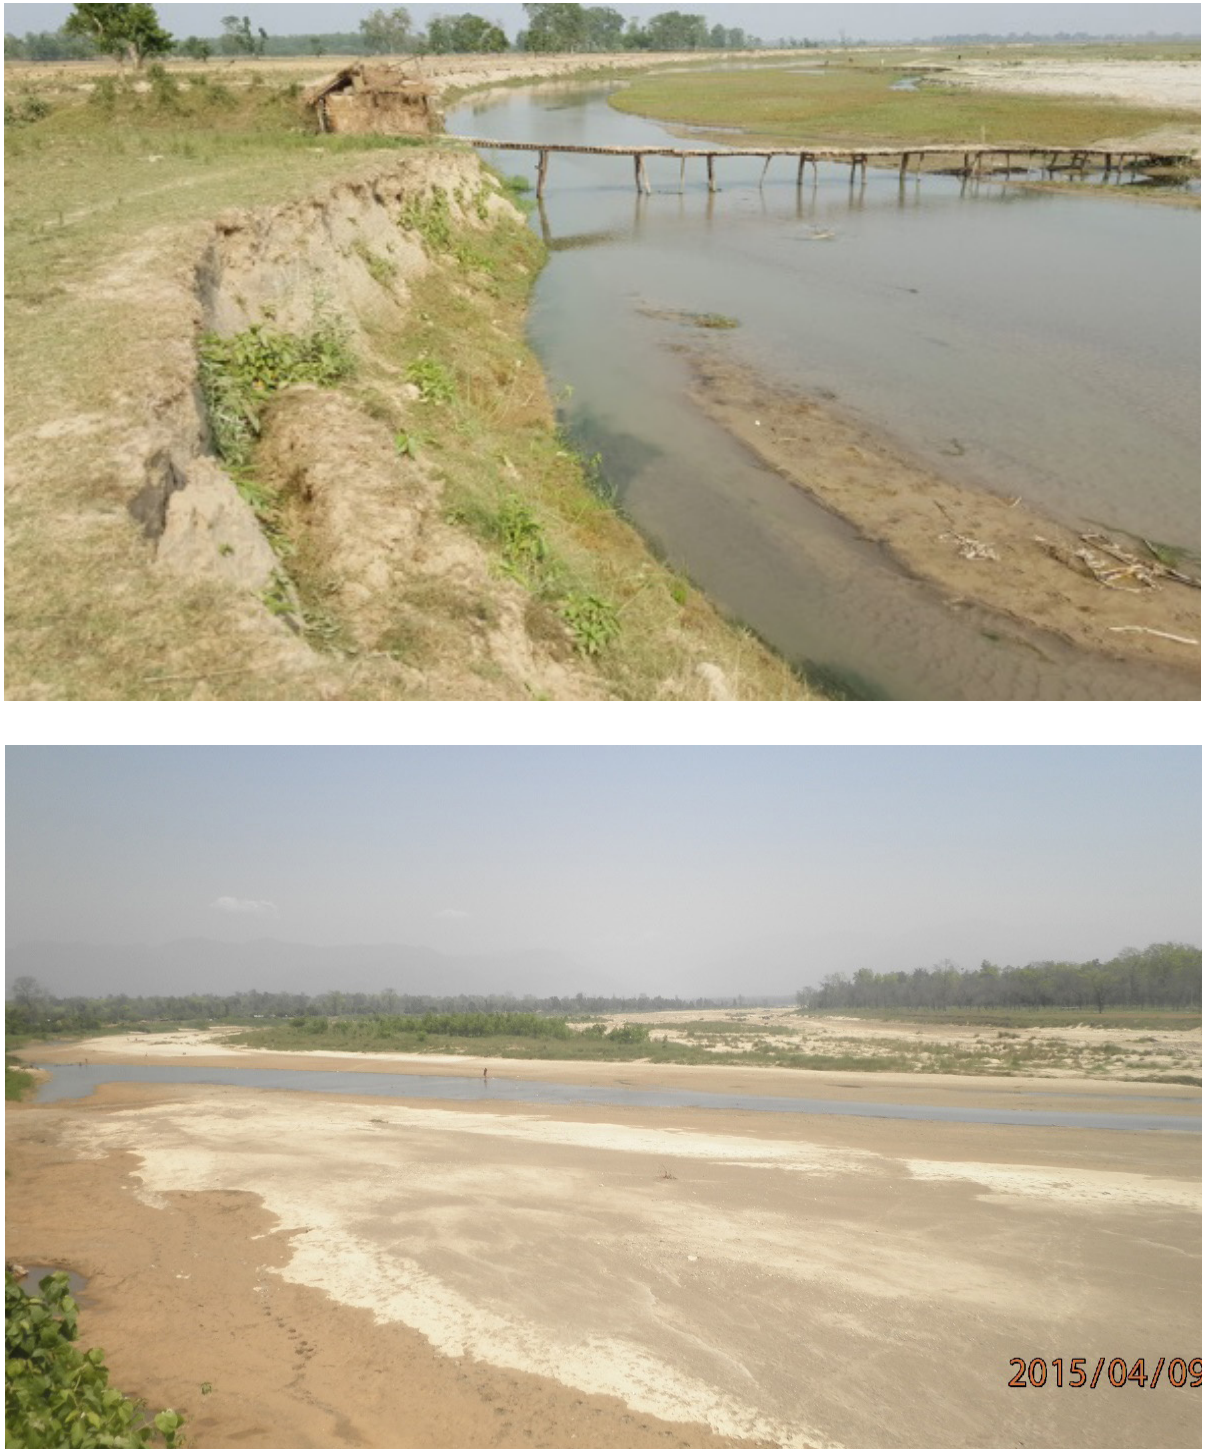
Fig. 8: At 15km downstream from the fan apex. Unlike upstream, the river bed consists mainly of sand, gravel, and silt. Photos on the left show the upstream and right downstream of the Godavari River bridge.

Upper alluvial plain deposits. A transitional zone dominated by gravel and sand deposits, with braided and meandering channel patterns. Evidence of channel avulsions and lateral migration is present. The channel width is intermediate between zones 2 and 4/5 (Fig. 8).

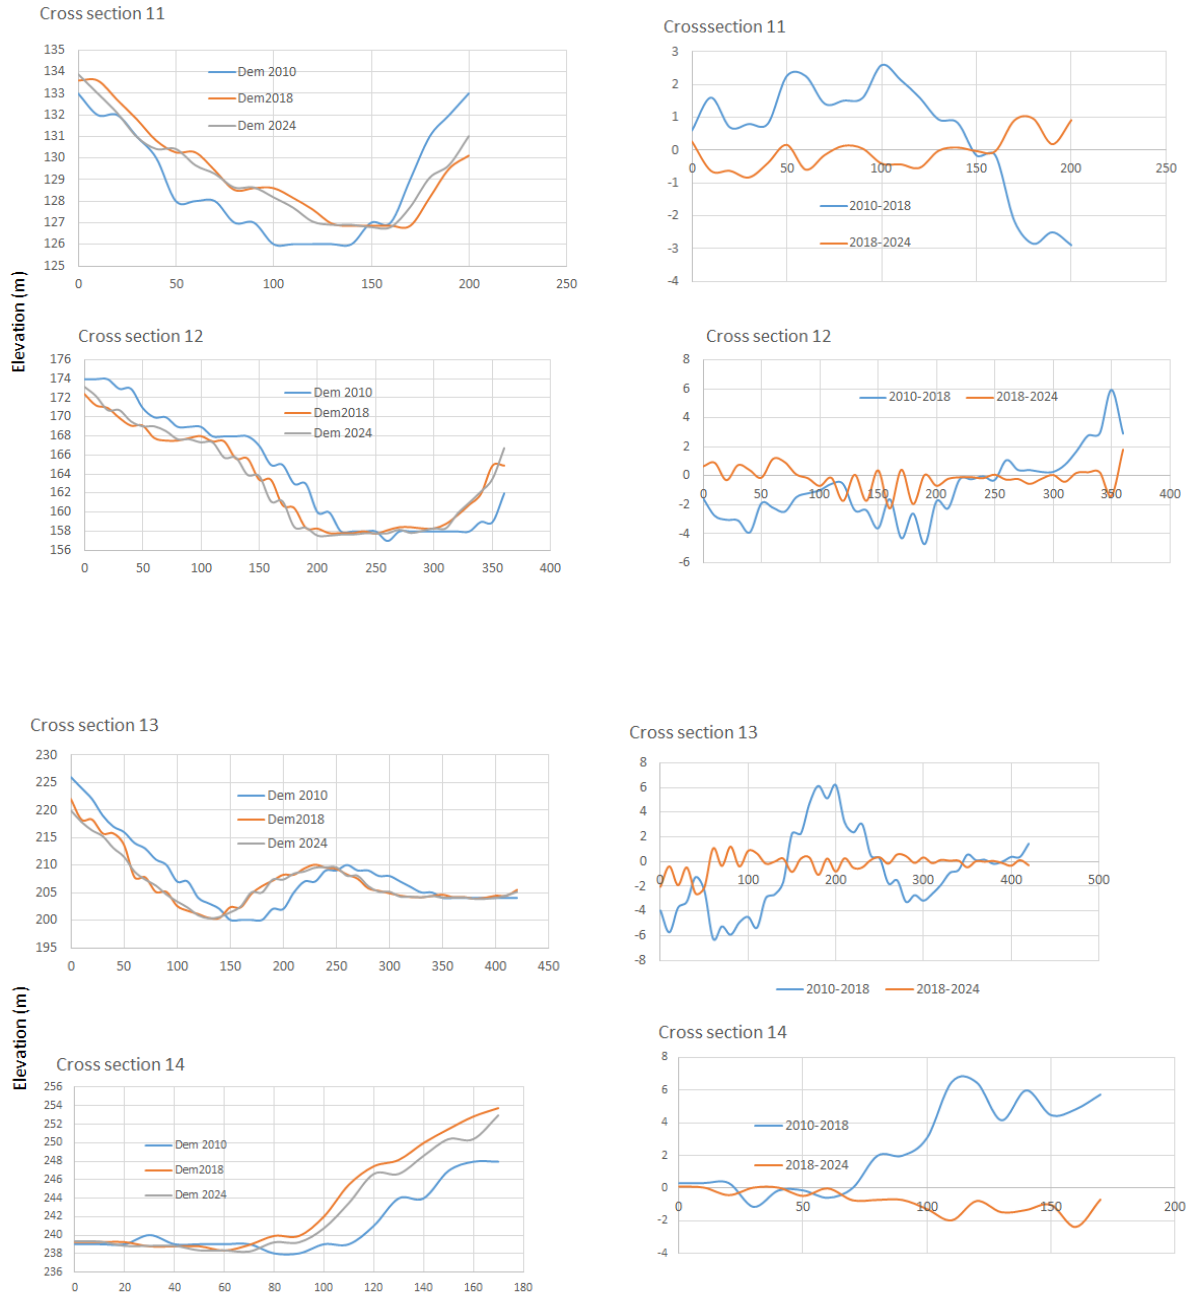
Fig. 10: Cross section forms the river morphology measured at various locations.

Cross-section morphology was examined using DEM derived from the Interferometric synthetic aperture radar (INSAR) data taken by Sentinel-1A in April 2018 and July 2024. The ALOS PALSAR DEM representing 2010 was also used to examine the change in the cross-sectional form of the river morphology (Kryniewska, *et al.*, 2022; Marchetti, 2023). Sentinel-1 images and ALOS PALSAR DEM were also obtained from the Alaska Satellite Facility. The cross-sectional profile at different locations of the Mohana, Godavari and Khutiya Rivers reveals that aggradations and degradation processes are significant in all cross-sections (Table 4 and Fig. 9). However, there is substantial variability in sediment aggradation and degradation across different geomorphic zones (Table 4). Within the river, with the same cross-section, there is also remarkable variability in the river processes (Fig. 9). There was a significant net gain of sediment in m^3/m at CS1 (fan zone), CS4 (Sand, silt and gravel) and CS8 (sand and silt zone). At this location, the net gain of sediments was 93, 1209.9, and 253 m^3/m , respectively. CS2 witnessed the highest net gain (1209.9 m^3/m) in a fan zone, followed by CS10, i.e., 722.6 m^3/m in a fine sand and silt zone. Huge deposition in these

areas (although sediment characteristics differ) could potentially lead to bed-level rise and impact flow patterns.

Significant to substantial sediment loss was observed at CS3 (fan), CS6 (sand, silt, and fine gravel), CS9 (fine sand and silt), and CS12, CS13, and CS14 (fan). CS6, CS9, and CS13 indicate significant sediment loss, which could imply an increase in erosion and sediment transport downstream.
