Assessment of the 2021 debris flow and flood related loss and damage in Melamchi Watershed of Central Nepal

ABSTRACT

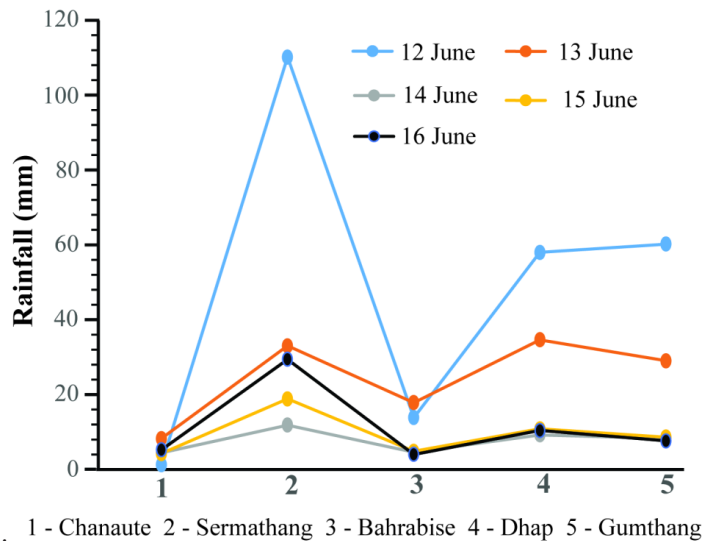
Fig. 2: Rainfall in Sindupalchowk district during June 12-16, 2021.

Administration (NASA), in the Melamchi and Helambu areas, the highest precipitation (168 mm) occurred on June 15, 2021, while the highest daily maximum temperature (20.73°C) was observed on June 9, 2021. The significant rise in temperature possibly contributed to glacier melting, creating the disaster (Source: [NASA, POWER Data Access Viewer](#)).

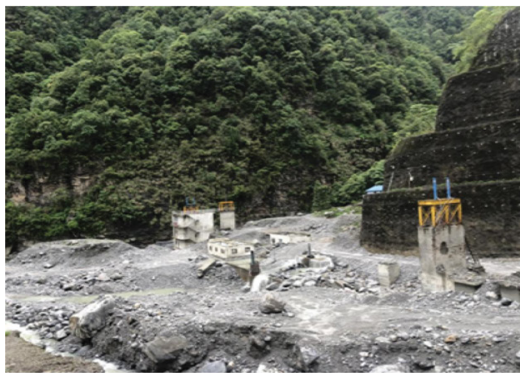
While conducting the analysis of the sample taken from the left bank of the Melamchi Khola near the head works area close to the dam. The followings results were revealed. The sample is from the high flood level debris flow deposits shows the sieve analysis curve for a sample with the following composition. Gravel 41.42%, Sand 57.65% and Silt and Clay 0.93%. Gravel: represented by the steep initial portion of the curve up to about 2 mm, indicating that 41.42% of the sample is gravel. Sand: The curve rises significantly between 0.075 mm and 2 mm, showing that 57.65% of the sample consists of sand. Silt and Clay: The smallest portion of the sample, represented by the smallest particle sizes (0.075 mm and smaller), with only 0.93% passing the sieve. The curve illustrates the cumulative percentage of the particles passing through sieves of decreasing sizes. The points on the curve are marked with percentages, indicating the cumulative passing at specific sieve sizes. This curve is typical for moderately graded soils with a mix of different particle sizes, where sand is the predominant fraction, followed by gravel, and very little silt and clay. (Fig. 4 a and b)

Fig. 4: (a) Flood impacted Melamchi head works area, (b) Particle size distribution of sediment sample (Sample No. 2) collected at the head work area.

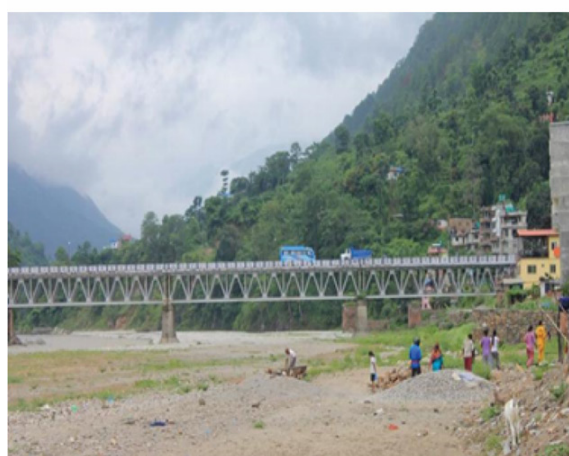
This is the analysis of the sample taken from the right bank of the Melamchi river at two previous fishponds buried sites by the debris flow of Melamchi. The materials were fine (granule to silt and clay) with some light grey quartzite boulders. The figure shows the sieve analysis curve for a sample with the following composition. Gravel 18.17%, Sand 75.65% and Silt and Clay 6.18%. The soil represented by this curve is poorly graded. It shows the significant portion of the particles within a specific size range and a lack of the intermediate size. This typically implies that the soil might not have the desirable properties for the certain engineering applications as it lacks a good mix of the particle's sizes. (Fig. 5 a and b).through sieves of decreasing sizes. The points on the curve are marked with percentages, indicating the cumulative passing at specific sieve sizes. This curve is typical for moderately graded soils with a mix of different particle sizes, where sand is the predominant fraction, followed by gravel, and very little silt and clay. **(Fig. 4a and b)**

Fig. 5: (a) Fish Pond buried site at the Right Bank of Melamchi River above danuwar gaun, (b) Particle size distribution of sediment sample (Sample No. 20) collected at the fish pond buried site above danuwar gaun.

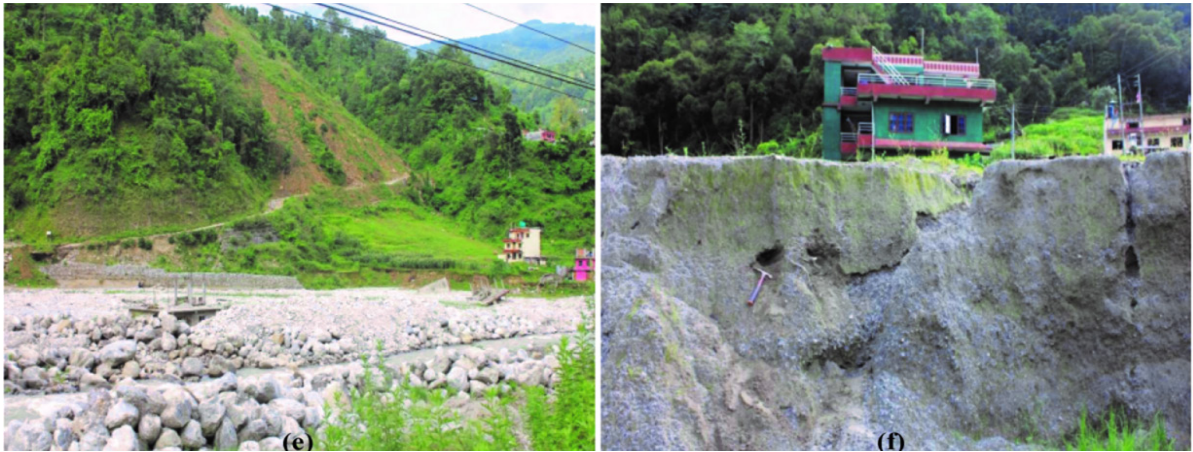
A remanent of the bailey bridge (Rato Pul) brought down from Chanaute was left at 03-56-891 E, 30-85-510 N (elevation, 972 m) on the left bank of the Melamchi River, opposite side of the landslide at Gyalthum. There were rocks in the landslide: dark grey to grey, thin-banded parallel laminated quartzite alternating with garnet (5 mm) schist. The disaster occurred on the 16th of Saun, at night from 11:00 PM to 12:00 AM. The depth of the deposit was 10-12 m. The flow continued for four days at a velocity of 1-2 m/minute (Fig. 9a). At 03-56-589 E, 30-85-298 N, with an elevation of 964 m, at the Melamchi Khola bar, southwest of Gyalthum, a matrix of gravel and liquefied masses was moving slowly for four days at a rate of 50-60 m/hour or 1-2 m/min, creating high dynamic viscosity with a boiling mass of debris. The debris flow must be matrix-supported sandy silt or sandy silty clay (Fig. 9b). At 03-57-175 E, 30-82-354 N, with an elevation of 905 m, at Thulo Khet on the right bank of the Melamchi River, collapsed buildings of pink color,

which was a single-storeyed building (Fig. 9c). At 03-57-878 E, 30-81-686 N, with an elevation of 880 m, it is at the right bank of the Melamchi River at about 100 m long and 50 m wide bar. The bar has banded gneiss and dark grey quartzite. Boulders sizes were 5cm to 1.5 m of different variations i.e boulders to matrix (Fig. 9d).

At 03-58-532 E, 30-80-976 N, Debris flow at 858 m on the Melamchi River's right bank buried two fish ponds with fine material like granule to silt and clay having some light grey quartzite boulders (Fig. 5a). At 03-59-239 E, 30-80-485 N, with an elevation of 841 m, destroyed buildings of Danuwar Gaun were seen, buried up to 4 m, the ceiling of ground floor (Fig. 9e). At 03-59-219 E, 30-80-356 N, Granule sand and silt deposits on the right bank of the Melamchi River formed a crudely stratified 3-meter-high bar near a damaged bridge abutment at 838 m elevation (Fig. 9f).

Fig. 9: Damaged bridge, houses, sand bar observed between Gyalthum and Danuwar gaun. (a) landslide opposite Gyalthum with baily bridge, (b) Melamchi khola bar SW of Gylthum, (c) Collapsed building at left bank of Melamchi river at Thulokhet, (d) Sand bar on top of boulder, (e) Destroyed building of Danuwar Gaun (f) Fine particles deposietd on 3m high bar near damaged bridge abutment.

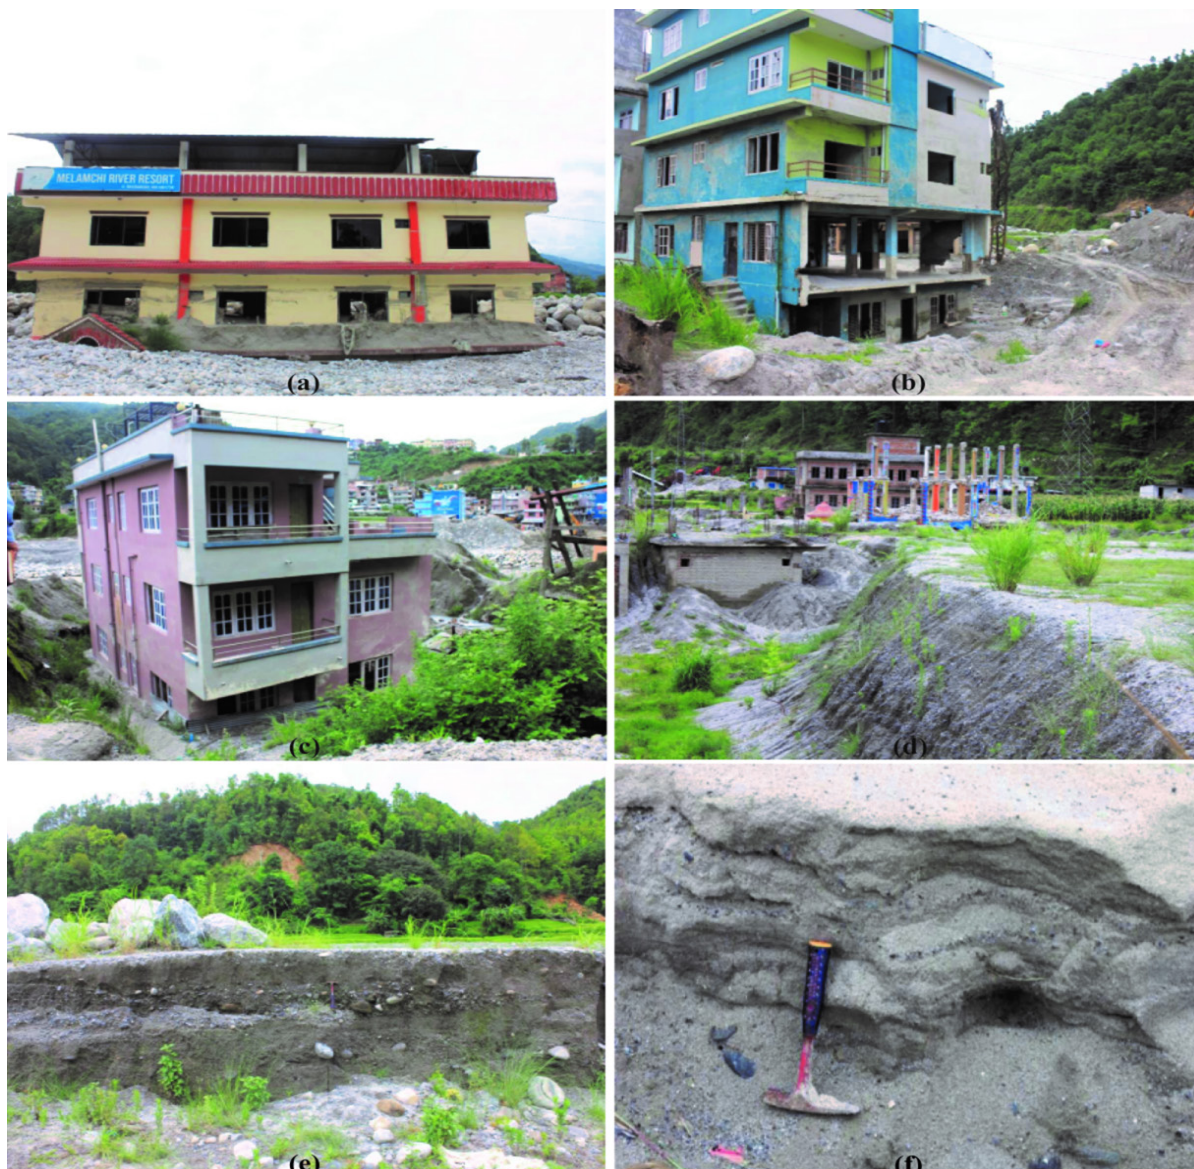
At 03-59-947 E, 30-80-080 N, the Melamchi River Resort at 818 m elevation was buried by debris flow up to 6 meters, covering the ground floor and half of the first floor (Fig. 10a). At 03-60-078 E, 30-79-706N, and 823 m elevation in southern Melamchi, debris flow buried hotel houses up to 3.5 storeys (13 meters deep), leaving a flood mark on green-blue buildings. The debris was mostly silty sand (Fig. 10b). At 03-60-094 E, 30- 79- 557 N and 818 m elevation on the Indrawoti River's left bank, a 15-meter-thick sediment deposit buried a two-story house. The debris flow height exceeded 2 meters, forming a flat area about 600 m long and 150 m wide near a new Bailey bridge construction site (Fig. 10c).

At 03- 59-774 E, 30- 78- 821 N having 806 m elevation on the right bank of a gully near the Armed Police Force, debris flow deposits composed mainly of crudely stratified sand and silt were observed. The thickness of the deposits was about 6 m. According to the respondents, the debris flow took place on the 1st of Asar at 5 PM, and the deposition occurred from 1:00 AM that night and continued almost the whole day on the 2nd of Asar. On the 1st

At 03-59-795 E, 30-76-300 N, with an elevation of 763 m, on the right bank of the Indrawoti River about 500 m upstream from a bridge at Bahune Pati, a crudely stratified sand bed approximately 2 m thick was observed (Fig. 10e). At 03-60-888

E, 30-72-966 N, with an elevation of 732 m near Sipaghat at Eklebesi, Maghitar, on the right bank of the Indrawati River, a light brown sand bar about 30 cm thick was observed (Fig. 10f). At 03-62-589 E, 30-70-751 N, with an elevation of 709 m, at the east end of Sipaghat near a temple and bridge, there was observed an alluvial fan of the Dhad Khola, which was formed by the floodplain deposits of the

2021 Melamchi flood. Similarly, last but not least, at 03-72-463 E, 30-58-846 N, with an elevation of 630 m, on the right bank of the Indrawoti River at the confluence of the Cha Khola, in Dolalghat, the flood covered the ground floor ceiling of the house. The sediments were mainly grey silty sand, and a flood mark was also observed on the Dolalghat bridge (Fig. 6a)

Fig. 10: Buried houses, flood mark, debris flow deposits, sand bar observed below Danuwar gaun and Dolalghat. (a) Buried Melamchi river resort, (b) High flood mark on green blue buildings, (c) Houses buried on two floors on Melamchi bazaar, (d) Debris flow deposits at the transverse from Melamchi to Dolalghat area, (e) Deposits of Crudely stratified sand bed at Bahunepati, (f) 30 cm thick sand bar near Sipaghat at Eklebesi, Magitar
