## The ground based geological assessment of an active landslide: A case study of Jharlang Landslide in Dhading district, Lesser Himalaya, Central Nepal

Jharlang Landslide, also known as "Jharlang Pairo," is a large-scale, ongoing landslide that is situated in the northwest of the Dhading District. This article provides a detailed geological assessment and evaluates the causes, consequences and general mitigation plan of the landslide. The overall study of the landslide was carried out by desk study and field investigation. Field work was carried out to gather pertinent data and information about slope failures. The primary methods of evaluation are knowledge-driven approaches, kinematic analysis, visual inspection, satellite image interpretation, and topographic maps interpretation. The study facilitates comparative analysis through previous studies, satellite images and field observation. The study area is located in the Lesser Himalayan region in Central Nepal. The dominant lithological units in this area are Meta-sandstone, Ulleri Augen Gneiss and phyllite. The constant risk of the landslide to the local people and damage of farmed land and infrastructures is increasing. The a

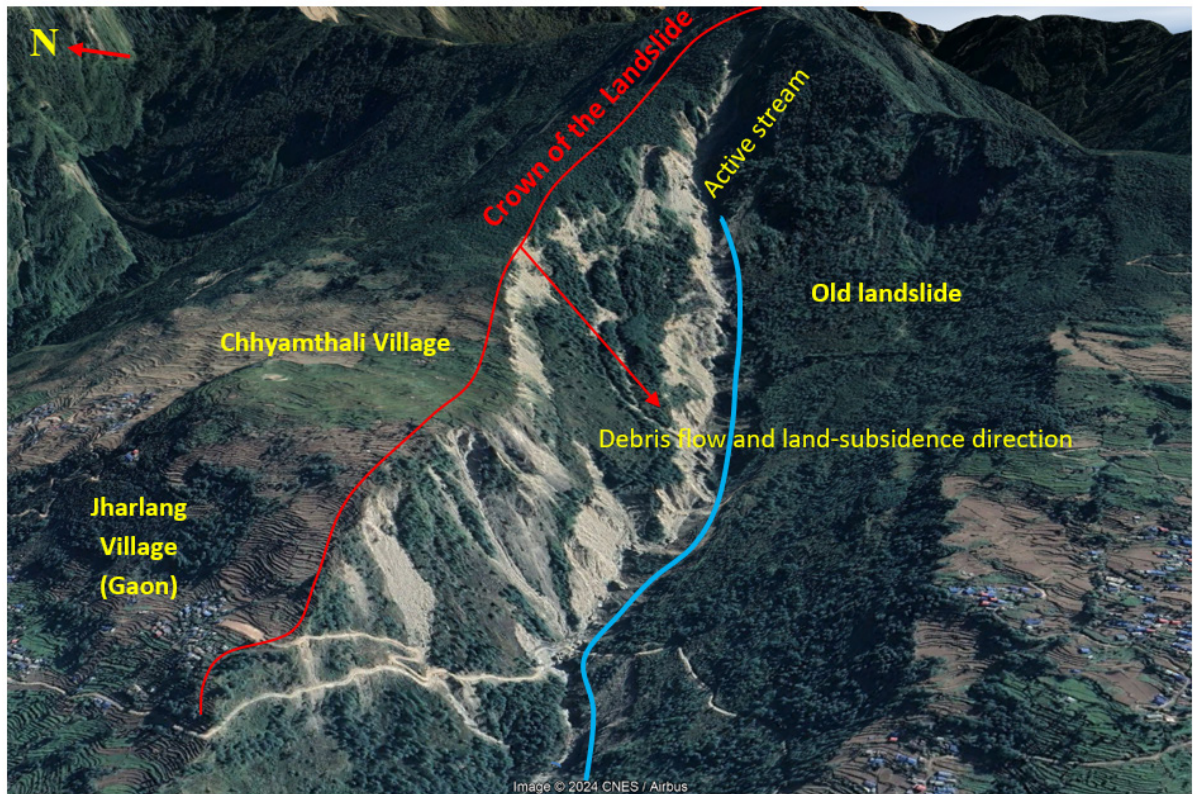
**Fig. 1: Satellite image of Jharlang Landslide and proximity of landslide to nearby villages**  
(Source: Google Earth Pro 2024)

Jharlang Landslide is commonly called 'Jharlang Pairo' (Fig. 1), located in Dhading District in Central Nepal. The landslide is active since 1954 AD and has been threatening to human lives. It is reported that the households near the landslide area have been resettled in the Western part of Nepal. The present study is a field-based geological assessment of the active landslide through visual inspection and observation. In this study, the landslide has been evaluated through geology of the area, lithological composition, hydrogeological interactions, rock and

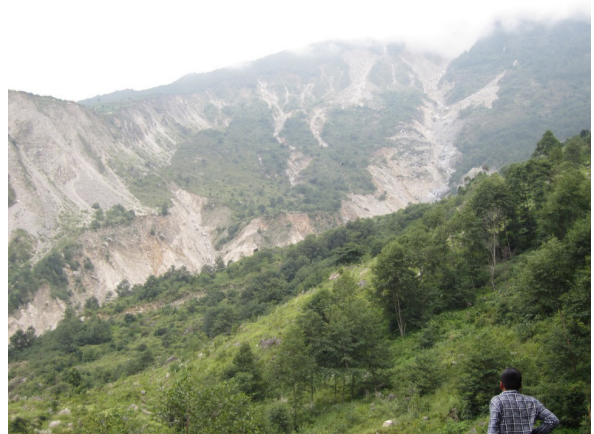
Fig. 5: Wide view of multiple scarps of the Jharlang Landslide

Jharlang Landslide is one of the large and active landslides which is situated in the upper region of the Dhading District in Nepal. The landslide affected area is about 4 sq. km. It is regularly propagating in NE-SW direction. It is one of the renowned landslides in south Asia and has long history of its origination. The mostly affected villages are Chhyamthali, Kalmarn and Jharlang Gaon. Human settlements of these areas are at high risk of the landslide. More than 100 houses in the periphery of this landslide are at high risk. It is being propagating sharply towards the Chhyamthali Village. Most of the slope failures occurred due to intense precipitation and ground water flow during monsoon season, weak rock–mass and lack of bed rock support (Fig. 5). The average annual precipitation around the study area in 2023 published by Department of Hydrology and Meteorology is ranges from 1500-2000 mm (Fig. 6). Main features of the landslide are presented in Table 1.

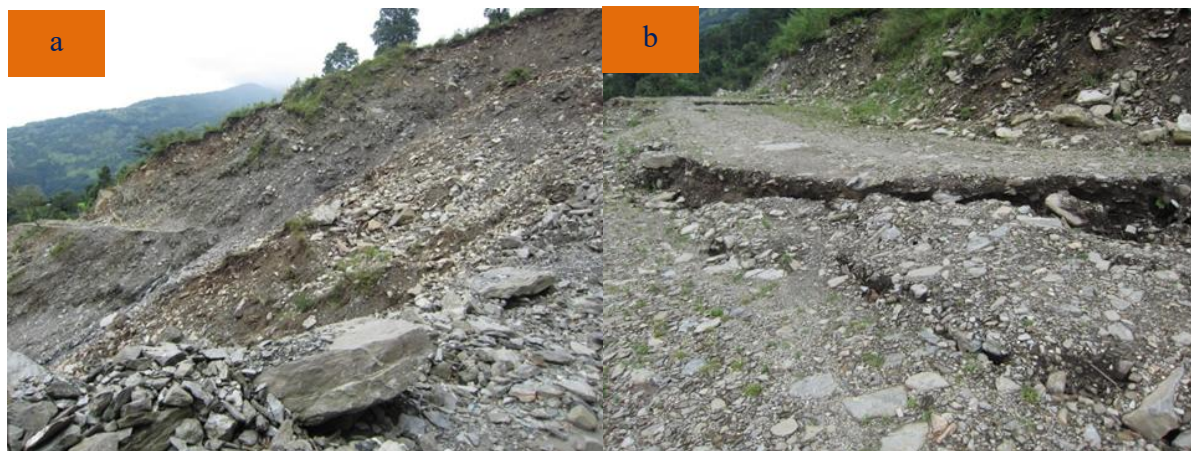
Landslide propagation towards residential areas is one of the main concern depicted by this study. Several prominent tension cracks, sliding and subsidence at crown and middle of the landslide were reported during field observation (Fig. 7). Additionally, tilting of trees, sliding and detachment of soil mass due to percolation of rainwater indicate active movement of the landslide.

**Fig. 7: (a) Slope failures blocking the foot-trail and (b) land subsidence (approximately 20 cm) near the landslide area**

In order to reduce future risk of the landslides, both structural and non-structural measures are recommended. Shallow and deep drainage wells would be the most effective measures to control surface and sub-surface flow of water. Surface runoff is captured by shallow drainage, which guides it away from potentially unstable locations. Bio-engineering could be done at upper and middle parts of the landslide. It will help to stabilize the agricultural lands. Similarly, to protect the cultivated lands, terrace farming is suggested. Other geotechnical in-situ testing, drilling and laboratory investigation of rocks and soil is important for in depth remedy for slope instability. In addition to structural mitigation measures, it is equally important to educate people regarding landslide, conducting public awareness and disseminating experiences to the communities. These are some of the non-structural counter measures to fight against the challenges of the hazard.

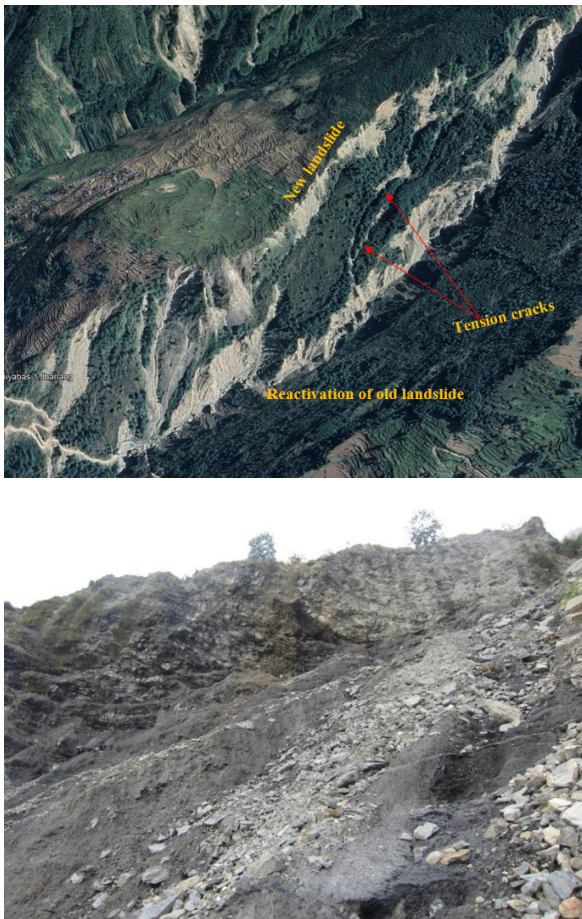
Geologically, the Jharlang Landslide is located in the soft soil over the Ulleri Augen Gneiss, meta-sandstone and Phyllite (K C et al., 2018). Ulleri Augen Gneiss and phyllite are highly weathered whereas meta-sandstone is comparatively intact in the area. The landslide characterizes with rupture curved concavely upward indicates rotational slide (Fig. 8a) as defined by Varnes classification (1978). Field observation clearly shows that the landslide has unsorted and unconsolidated soil materials with limited bedrock support at the lower section of the landslide triggering for the debris flow during oversaturation. Debris deposit consist of unsorted materials of clay, silt, pebbles, cobbles and boulders of which cobbles and boulders are made up of the Augen Gneiss and meta-sandstone with rock fragments. Sliding soil mass with multiple newly generated tension cracks is profoundly distributed. Some boulders are up to 5-10 m in diameter.

During intensive monsoon rainfall in combination with surface runoff and water drain through cracks of slopes oversaturate the soil mass leads to slope failures. It has several slope failures occurred along with sliding blocks of soil mass and accumulation of boulders came at the toe from the upper portion of the landslide. Bedrock exposure is limited in the area. Highly deformed and weathered bed rock of phyllite, metasandstone and Ulleri Augen Gneiss are exposing at the body (center) of the landslide (Fig. 8b). Initially, the slope failures triggered in the uppermost part then seepage, tectonic movements, unplanned cultivation and deforestation give rise to debris flow and slide of the whole soil mass around the area.

Fig. 8: (a) Typical morphology of the landslide illustrating origination of new landslide, reactivation of old landslide and new cracks around the area and (b) Rock exposure at middle section of the landslide.

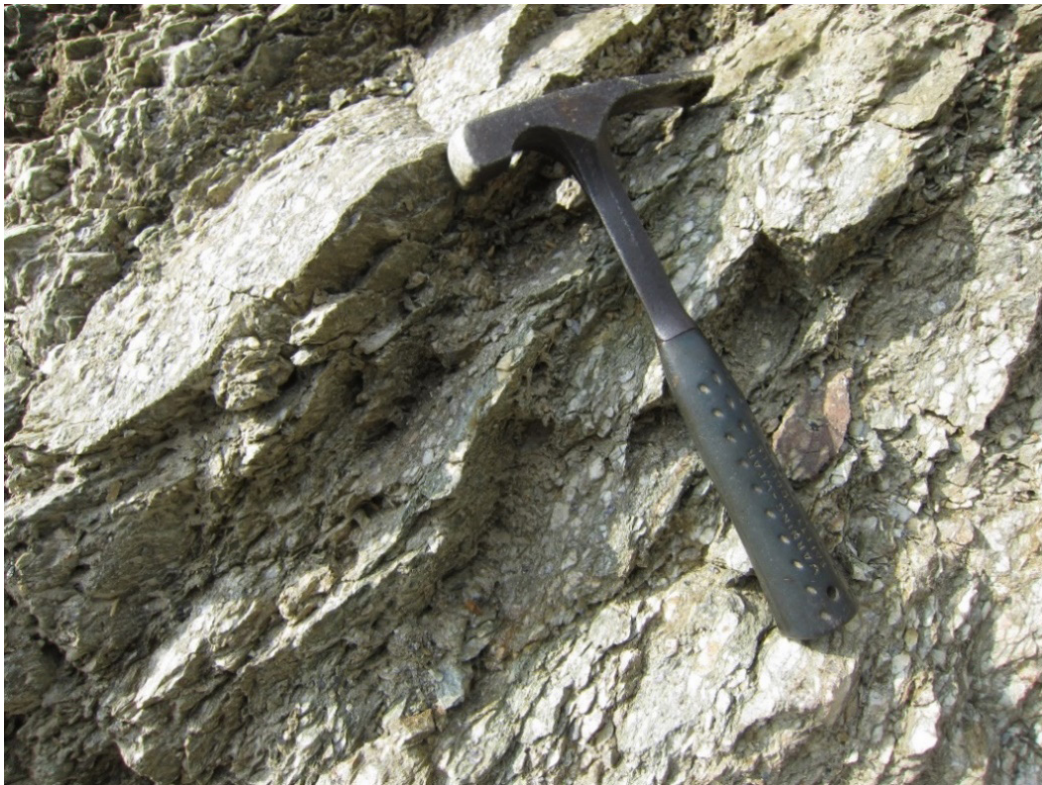
The geology of the area has remarkable cause of the landslide. Geological assessment deals with the study of the lithology, structural features, rock and soil mass condition, orientation of beds, weathering pattern etc. According to Dahal (2012) analysis, fine-grained soil mass, low internal friction angle, abundance of clay minerals, and bedrock hydrogeology are the prominent geological causes of the landslide. Geologically, the landslide area lies in the Kunchha Formation where phyllite, meta-sandstone and Ulleri Augen Gneiss are the major rock types (Fig. 9). Highly deformed and weathered Ulleri Augen Gneiss and phyllite prevails greater susceptibility for the slope failures (Fig. 10). Additionally, the unconsolidated soil materials with limited rock exposure around the area also aid to the slope failures.

Fig. 10: Outcrop view of weathered Ulleri Augen Gneiss and phyllite near the landslide area
