Seismic Assessment of a Masonry Building in Patan, Nepal

Abiskar Acharya^{1,*}, Alok Dahal², Aashutosh Kumar Jha³, Angel Mainali⁴,
Amar Singh Thagunna⁵, Asal Babu Pathak⁶, Rabindra Adhikari⁷

^{1,2,3,4,5,6}Department of Civil Engineering, Institute of Engineering, Thapathali Campus, Tribhuvan University,
Kathmandu, Nepal

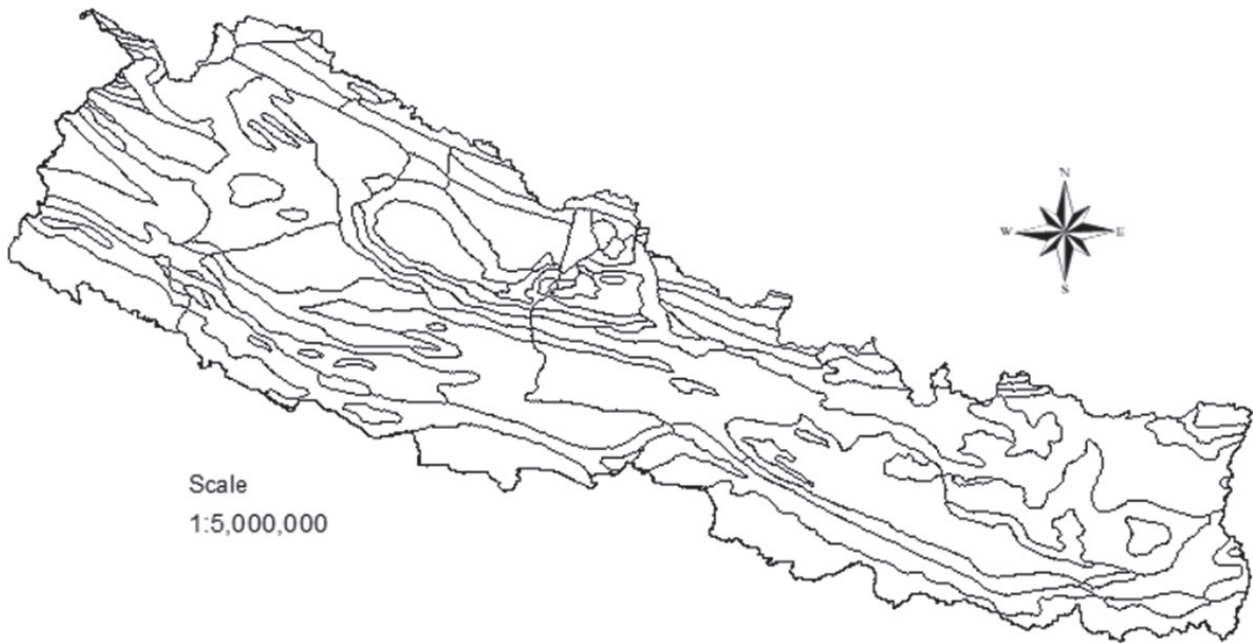
Figure 1: Generalized map illustrating major tectonic fault lines contributing to seismic hazard in Nepal.

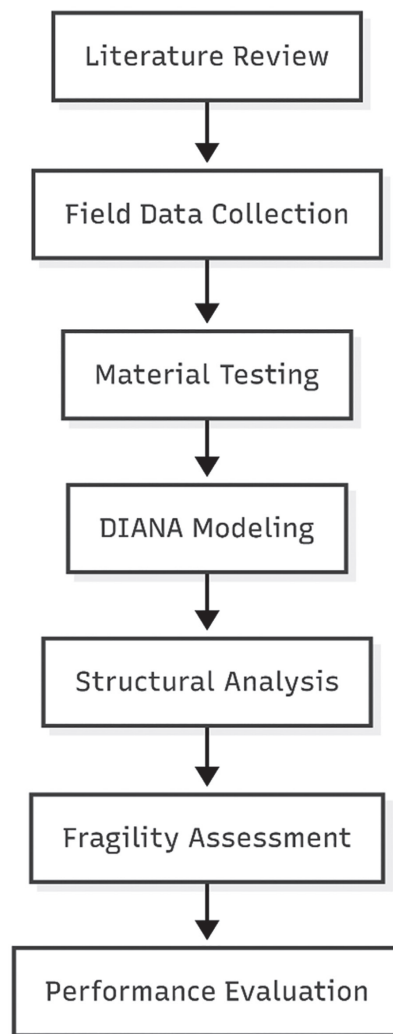
Figure 2: Research methodology workflow

The methodological framework adopted for this study incorporates a combination of field investigations and advanced computational modeling techniques. It comprehensively assesses the seismic performance of a characteristic traditional masonry building in Patan.

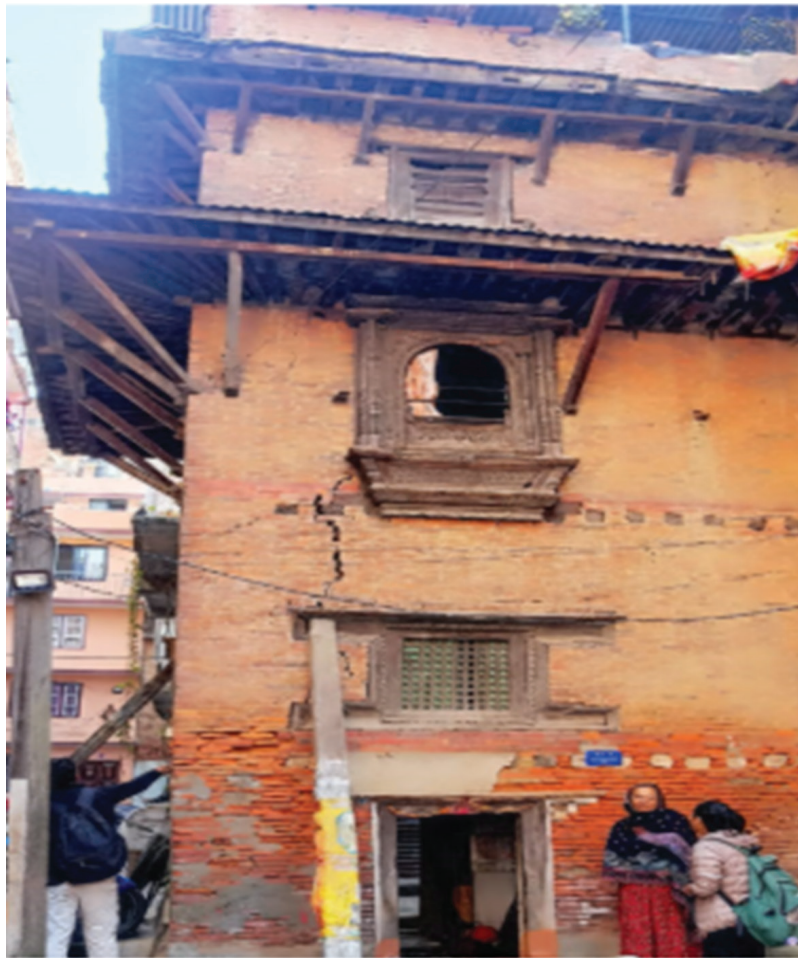
Figure 4: External view of the selected pre-1934 traditional masonry building in Patan.

A field visit was conducted in December 2024 to systematically document the building's structural system, any visible patterns of damage, and to estimate its key dynamic properties. Due to the unavailability of precise damage records from the 1934 earthquake, an understanding of its historical performance was obtained by observing its current condition. Regional damage trends were also documented from subsequent seismic events, such as the 2015 Gorkha earthquake (Furukawa et al., 2017). The building's layout is characterized by exposure on three sides and attachment to an adjacent structure on the fourth. This reflects the typical Patan row housing typology, where buildings frequently share party walls while possessing distinct structural systems on their other elevations. Figure 3 illustrates the geographical location of the study building, and Figure 4 provides an external visual representation.

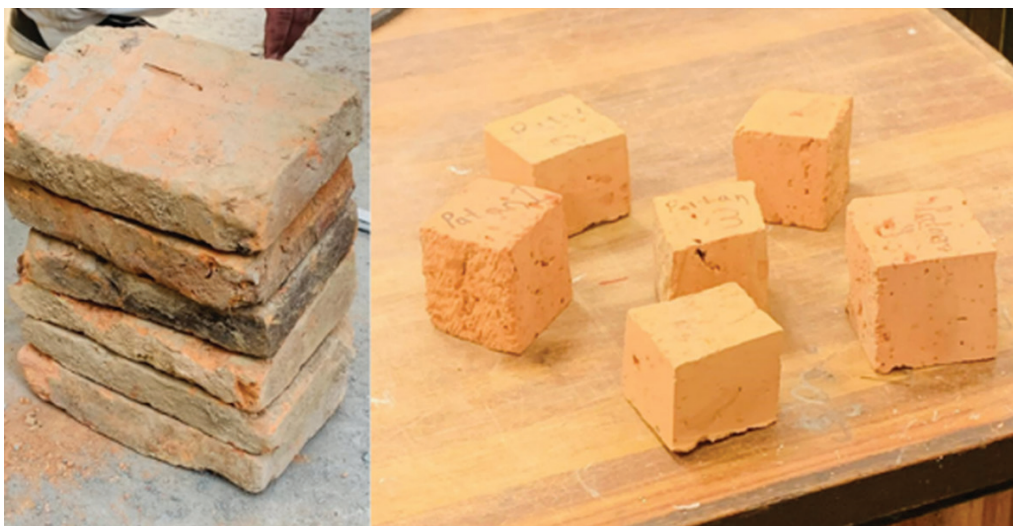
Figure 10: Original brick samples (left, stacked) and prepared 40 mm cube specimens (right) for uniaxial compressive strength testing.

As an integral part of a broader initiative to document the building's construction system, observed damage patterns, and inherent dynamic features, brick samples were procured during the field survey conducted in December 2024. Adhering to established best practices for investigating heritage structures, which emphasize minimizing disruption to the building's fabric (Gautam et al., 2016) a total of six brick samples were meticulously extracted from discrete, unobtrusive sections of the building. These locations included integrity-hidden areas and portions of non-load-bearing walls. The original bricks were found to have consistent dimensions when measured directly, averaging approximately 22.5 cm in length, 11 cm in breadth, and 7.2 cm in thickness. These measurements provide precise, location-specific information regarding the building's original construction materials. Sampling points were carefully selected to be representative of the original building material, with a particular emphasis on the mud-mortar brick masonry walls, which constitute the primary load-bearing components. Areas that might possess historical significance, such as elaborate facades or physically prominent structural elements, were consciously avoided during sampling. The building's configuration, with three sides free-standing and one side abutting a neighboring structure, guided the selection of sampling sites to enable an assessment of potential differences in material exposure and condition. To analyze potential alterations due to reduced exposure, samples were taken from the free-standing sides where environmental degradation processes, such as weathering, could influence material qualities. Concurrently, at least one sample was obtained from the shared party wall. Due to constraints on sample size imposed by heritage conservation guidelines, the procured brick samples were subsequently cut into 40 mm × 40 mm × 40 mm cubes for laboratory testing, as illustrated in Figure 10.

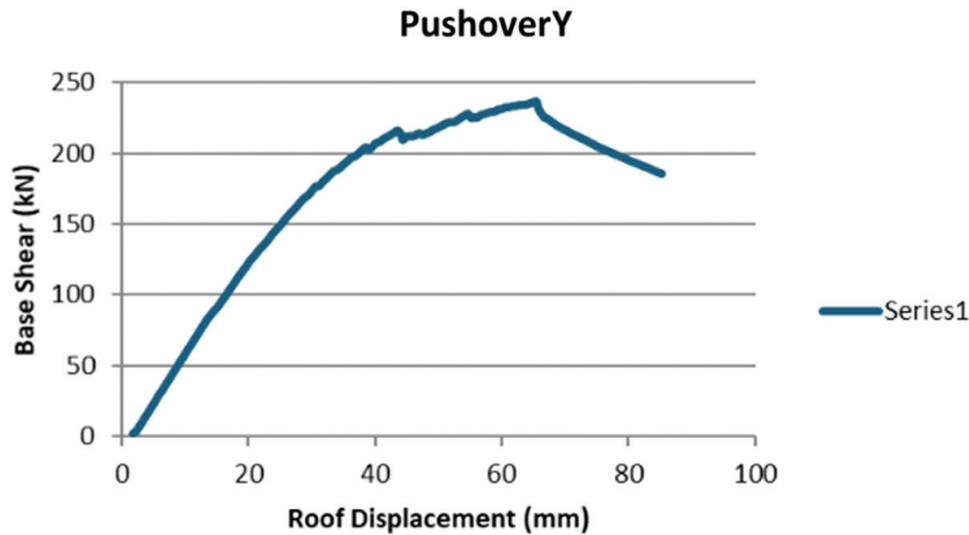
Figure 12: Nonlinear capacity curve for the Y-direction.

The pushover curve depicting the nonlinear capacity in the Y-direction is shown in Figure 12. The curve for the X-direction exhibits a similar general shape but with different characteristic values, as presented later in Figure 14, which includes its bilinear idealization.

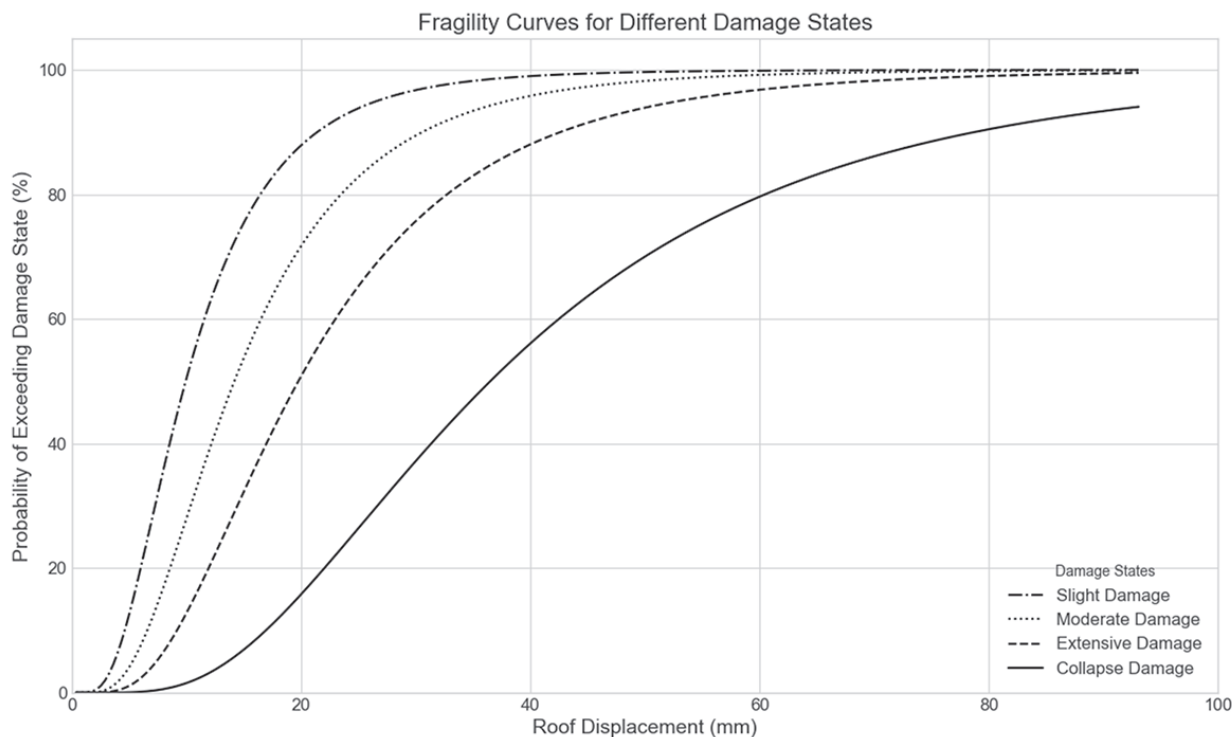
Figure 13: Fragility curves, probability of exceedance vs roof displacement (Δ_{roof}).

(It is noted that the median displacement for collapse derived from the curve appears higher than the deterministic ultimate displacement, u_d , of 36.5 mm obtained from the X-direction pushover analysis. This difference could arise from the statistical methodology employed for fragility derivation, the inclusion of various uncertainties, or potentially the curve representing an averaged or combined directional behavior, or the fitting process of the lognormal distribution.)

- **Probabilistic Performance:** The curves quantify the likelihood of experiencing various levels of damage. For instance, at a roof displacement of 20 mm:

- There is an extremely high probability (~98%) of experiencing at least Slight damage (DS1).
 - There is a high probability (~85%) of experiencing at least Moderate damage (DS2).

- There is a significant probability (~40-50%) of experiencing at least Extensive damage (DS3).
 - There is a lower probability (~10-15%) of reaching or exceeding the Collapse state (DS4).

- **Uncertainty Representation:** The slope of the fragility curves reflects the uncertainty associated with predicting the onset of a particular damage state. Steeper slopes (e.g., for DS1 and DS2) indicate lower dispersion and, consequently, higher confidence in the damage state occurring around the median displacement value. The gentler slope observed for DS4 suggests greater variability or uncertainty in predicting collapse based solely on roof displacement.

- **Damage Progression:** The spacing between the curves visually illustrates the range of displacements over which the various levels of damage are expected to manifest as the deformation demand increases.

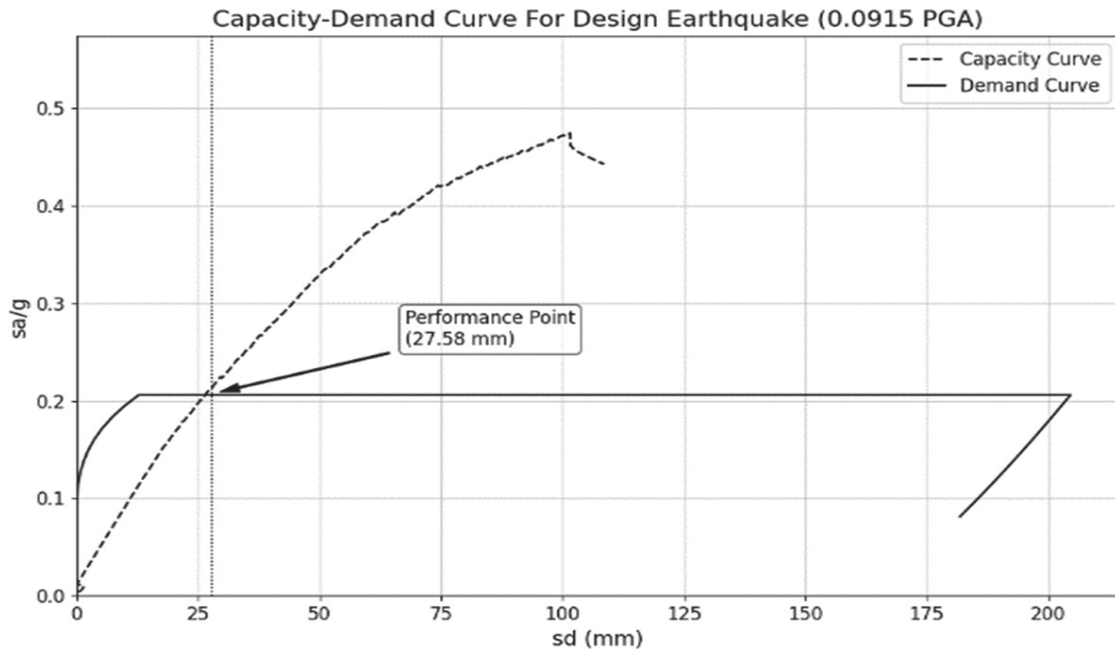
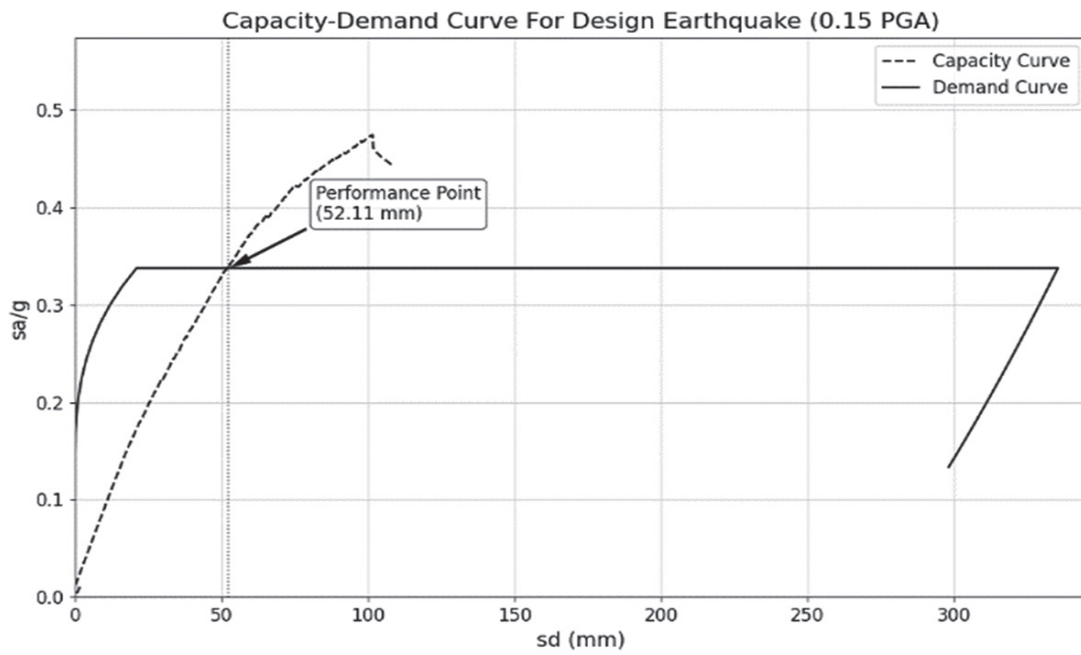
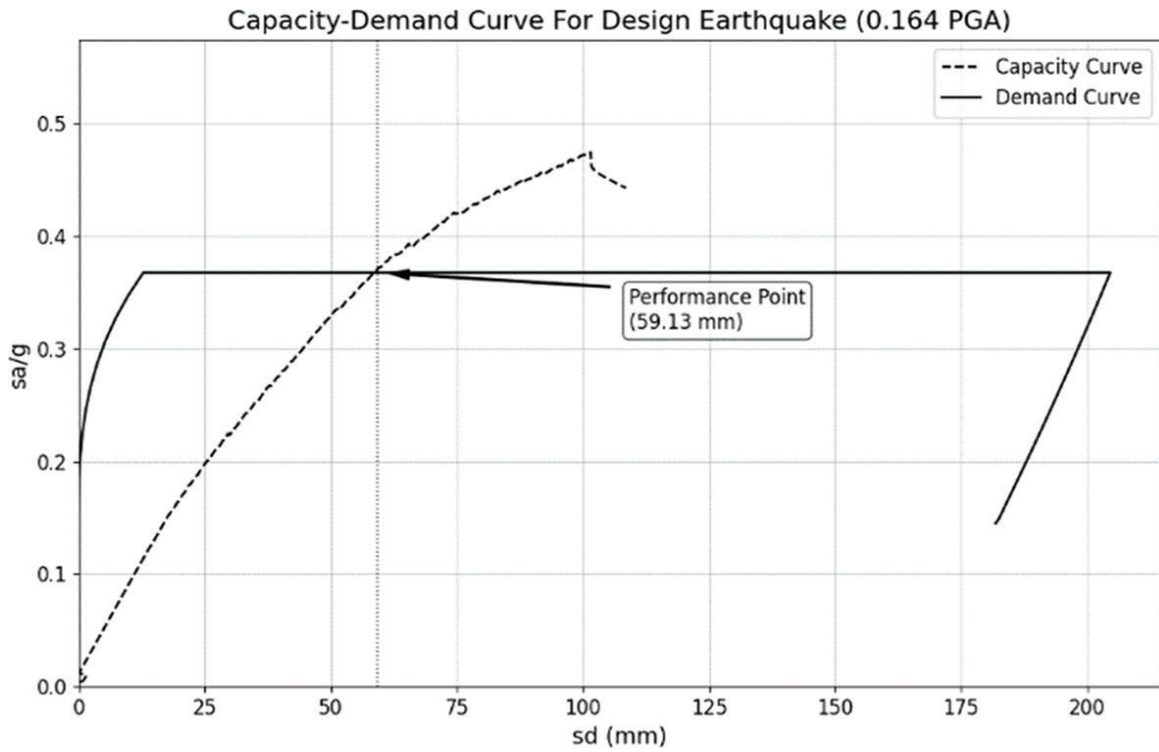
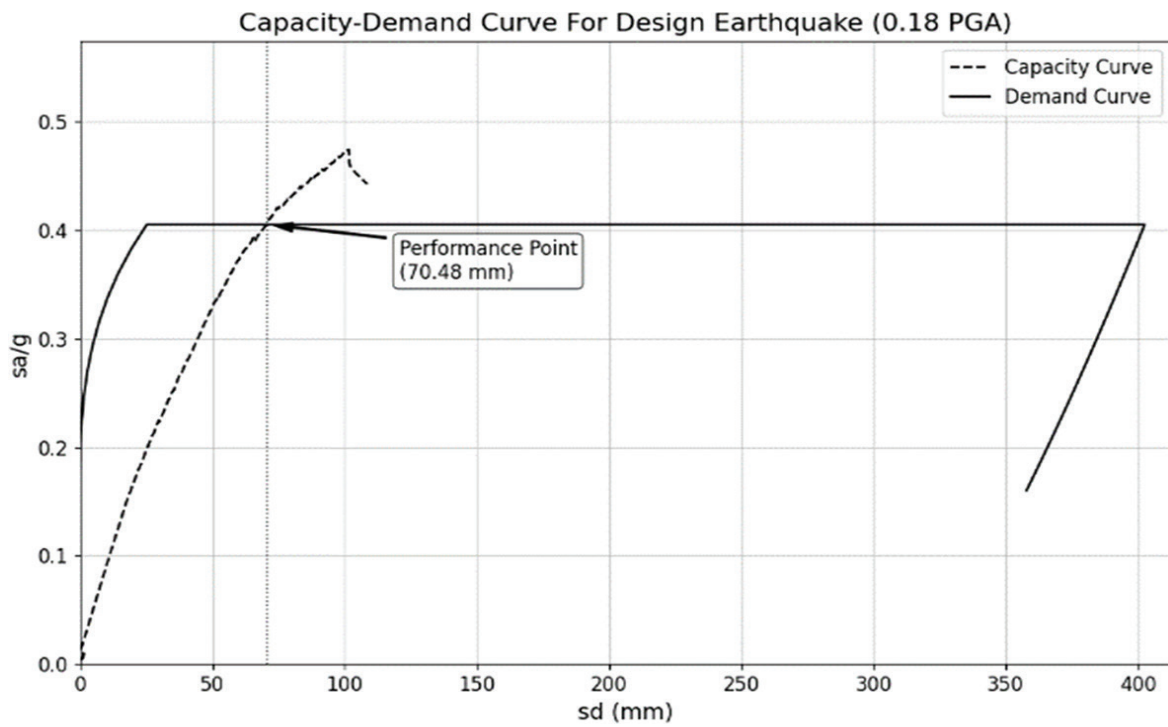
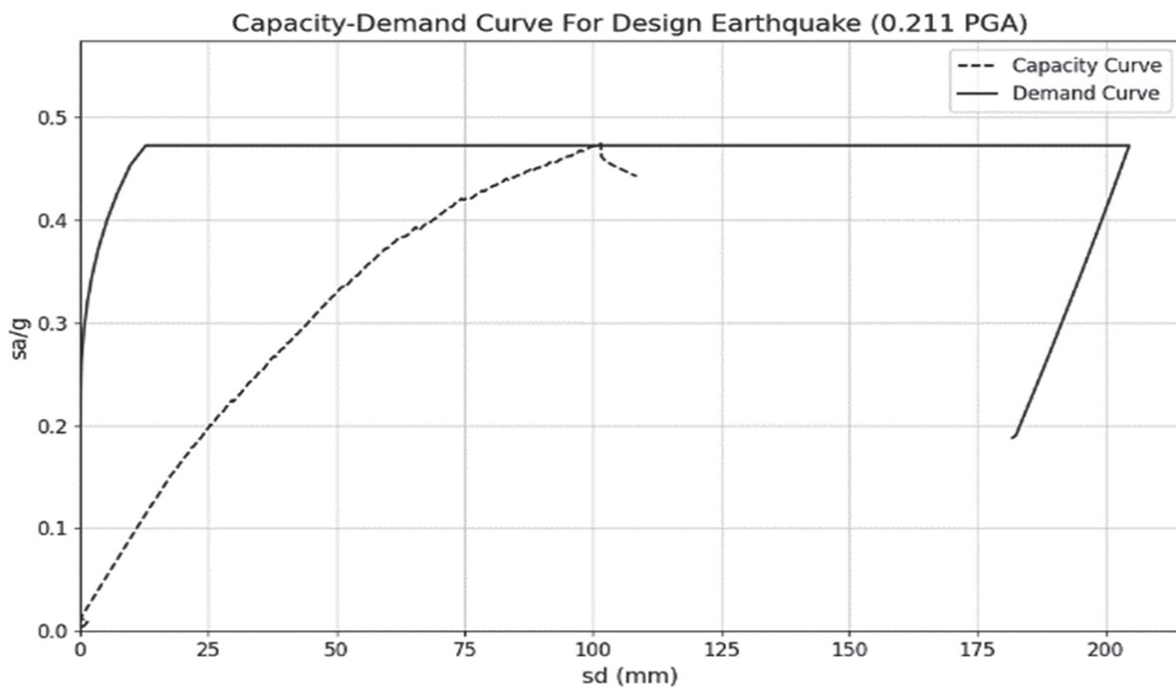
Figure 15: Capacity vs Demand curves for PGA 0.0915g

Figure 16: Capacity vs Demand curves for PGA 0.15g

Figure 17: Capacity vs Demand curves for PGA 0.164g

Figure 18: Capacity vs Demand curves for PGA 0.18g

Figure 19: Capacity vs Demand curves for PGA 0.21g.

Figure 20: Capacity vs Demand curves for PGA 0.211g

The Capacity-Demand curves for the different PGA levels are shown in Figures 14-19 below.

The eigenvalue analysis successfully established the fundamental dynamic identity of the structure, confirming the dominance of the first few modes, which is typical for low-to-medium rise buildings. The pushover analysis provided the essential capacity curve, quantifying the building's resistance as it transitions through elastic and inelastic ranges. The defined performance levels as shown in Table 8 translate these capacities into expected damage thresholds. A critical aspect of this assessment is the comparison of the predicted seismic demand with the capacity thresholds. A direct comparison requires converting the spectral displacement (S_d) from the performance point back to the roof displacement (Δ_{roof}) using the relation $\Delta_{\text{roof}} = \Gamma_{1,\text{roof}} S_d$. With these it was found that at a PGA of 0.0915g, the S_d is 27.525 mm. Similarly, at higher PGAs, the calculated S_d values were found to be large. It was found the roof displacements exceeding the ultimate capacity of $\Delta_u = 36.49$ mm indicated structural collapse. The analysis also revealed that a performance point did not exist for a PGA of 0.211g. This implies that at this level of seismic demand, the structure becomes unstable and collapses before the seismic energy input, as the capacity and demand spectra do not intersect.
