## Dharahara: A Multiple Times Earthquake Demolished Monument, Its Conservation Status

This paper studies the changes that occur during the conservation of earthquake-demolished historical monuments in Nepal, taking “Dharahara” as an example. The tower has suffered extensive damage multiple times due to earthquake occurring in different time periods. Historical monuments respond differently during earthquake depending on the construction technology and materials used. When such monuments are destroyed, alterations in materials and technology are introduced during their reconstruction. The ancient monument Dharahara which was destroyed many times, was examined to understand how it was originally constructed, what materials were used, and what changes have been incorporated in its recent reconstruction. The purpose of this study is to highlight the importance of documenting and preserving Nepal’s unique construction techniques and materials for future generations.

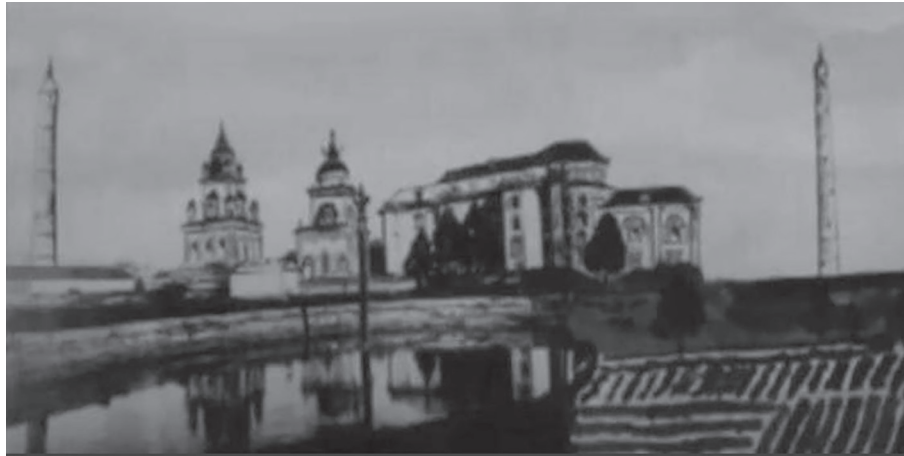
**Figure 1:** The two Dharahara before 1834 A.D. earthquake

The first Dharahara was constructed in 1824 A.D. by the then Prime Minister Bhimsen Thapa for himself at his residence, Janarala Bagh which is located at south-east of Sundhara, near Bhotebahal of Kathmandu. It was an 11 storied tower which got torn into half by 1834 A.D. earthquake. This affected tower completely fell to the ground by the 1934 A.D. earthquake which was never reconstructed and disappeared from the scene.

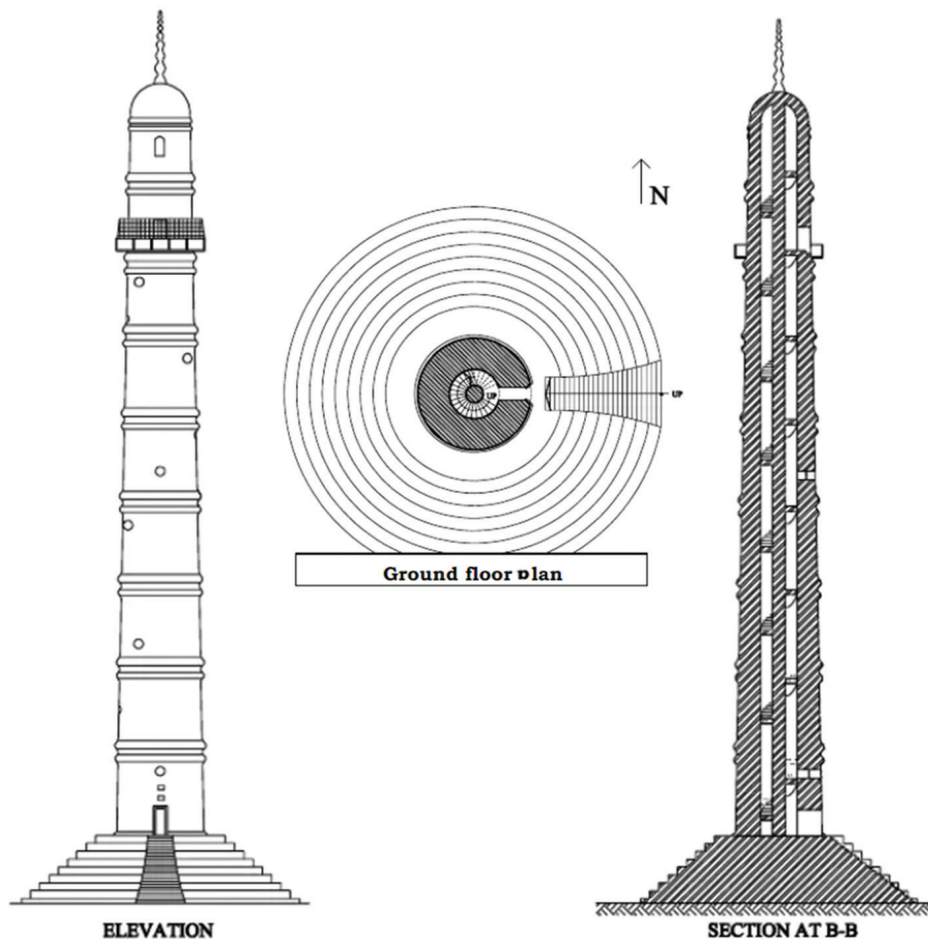
Figure 2: Architectural Drawings of Dharahara<sup>2</sup>

Dharahara, which was built in a postmodern style with significant Mughal and European influences, was a spotless representation of workmanship and culture. It was 250 feet tall and used to stand at 6.1m plinth. The approach to the main entryway consisted of 9 big steps, each measuring 65 cm in tread. These stairs were constructed from stone. Just over the main entry door were two metal inscriptions written in Nepali. These inscriptions included names of individuals, the date of conservation, and other information.

It had a bronze pinnacle at the top. The domical roof was made up of bricks cladding one above the other. The mortar was mainly the lime *surkhi*, black pearls and "*chaku*". There were timber struts and metal rods supporting the wall from the central shaft. The construction technology of the roof structure was different from the traditional construction method of Nepal. The single structural component that supported the whole construction was the central shaft. It was constructed with brick and lime *surkhi* mortar, as well as black pearls and "*chaku*". It had a pendulum-like effect since it was supported by the foundation. The thickness of the wall decreased from 72 inches at the base to 29 inches at the top of the tower. It was made up of brick and mortar of lime *surkhi*, black pearls and "*chaku*" with an external finish of white lime as a paint.

Though the horizontal cornices on the tower's external surfaces gave the impression that there were storeys inside, the internal spiral staircase with its 213 steps led all the way to the top without any landing levels or storeys except for a projecting circular balcony on the 7th floor at the 188th step which was protected by the iron railings. The central shaft of the structure and the load-bearing wall supported the staircase. The diameter of the core and the breadth of the spiral stair were both 3 feet wide. The sectional steel beams, such as the balcony projection and spiral across the core and the outside wall to hold the spiral stair, had been widely employed in the building. The windows provided were circular, and the single door was the main entry door, which was built of timber shutters. The door frame's external stone components were extensively carved with flower designs, geometric forms, and human figures. The wooden shutter was grooved into the wooden frame of the door.

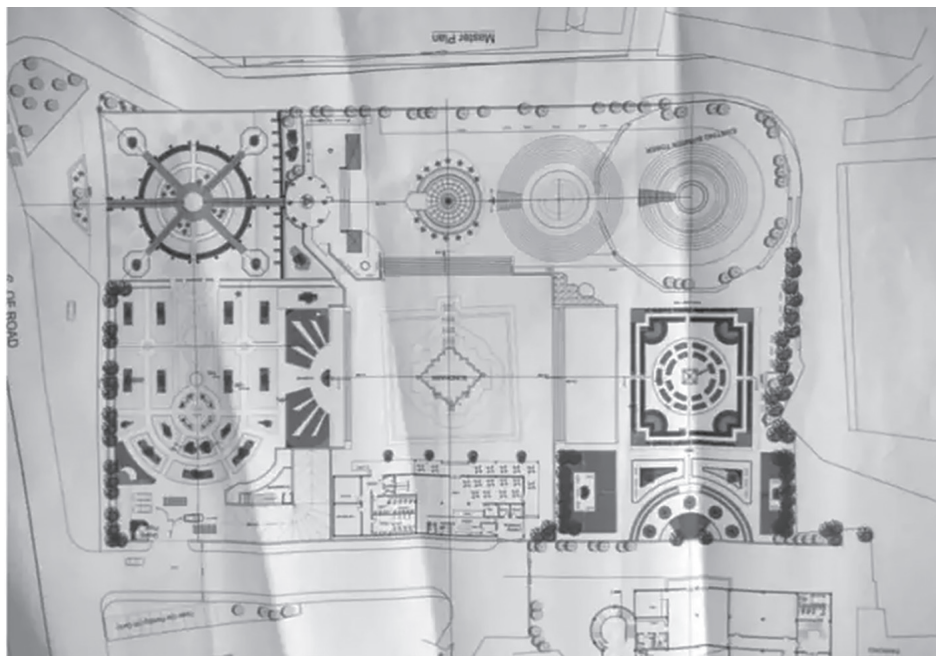
Figure 3: Master Plan of Dharahara3

After the earthquake hit Nepal at 2015 A.D. April 25th, the Dharahara<sup>2</sup> collapsed and the 3rd Dharahara was constructed by Nepal Government through Raman Construction Pvt. Ltd. just besides the remains of the old Dharahara. It was designed by Ar. Bishnu Panthee. The premises of Dharahara was open for the general public since Ashoj 3<sup>rd</sup> 2081 B.S. The construction work had started on the order of the then prime minister Khadga Prasad Oli from October 2018, and it was officially inaugurated on 24 April 2021, just a day before the sixth anniversary of the 2015 A.D. earthquake.

The 3rd Dharahara looks similar to the old one just in appearance, however, it has been equipped with modern amenities. It is 72 m tall and has a 15 m foundation. It is 11-storeys when seen from outside and 21-storeyed from the inside. To make it more accessible, it includes two lifts with underground parking that has the capacity for 350 four-wheelers and 6,000 two-wheelers.

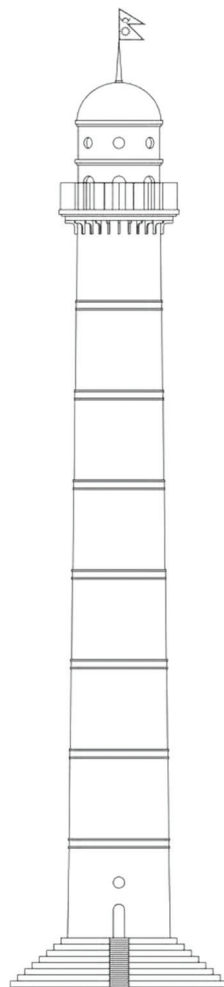
**Figure 4:** Elevation

The construction materials that have been used are cement mortar with masonry for the walls and concrete, sand, aggregate, bricks for the foundation. The construction technology is Reinforced Cement Concrete (RCC) frame structure.

This new Dharahara is earthquake resistant and can sustain up to 8 magnitude earthquakes. It has been made with completely new construction technology due to which it has been criticized by many people and called “jhilke tower”, “seto tower” and claimed that it only fulfills the money-making ambitions but not the historical and cultural significance since it does not have any essence of the original tower. The designer and principal architect had explained that the designs are refined by the passing of time and innovations are made in it.

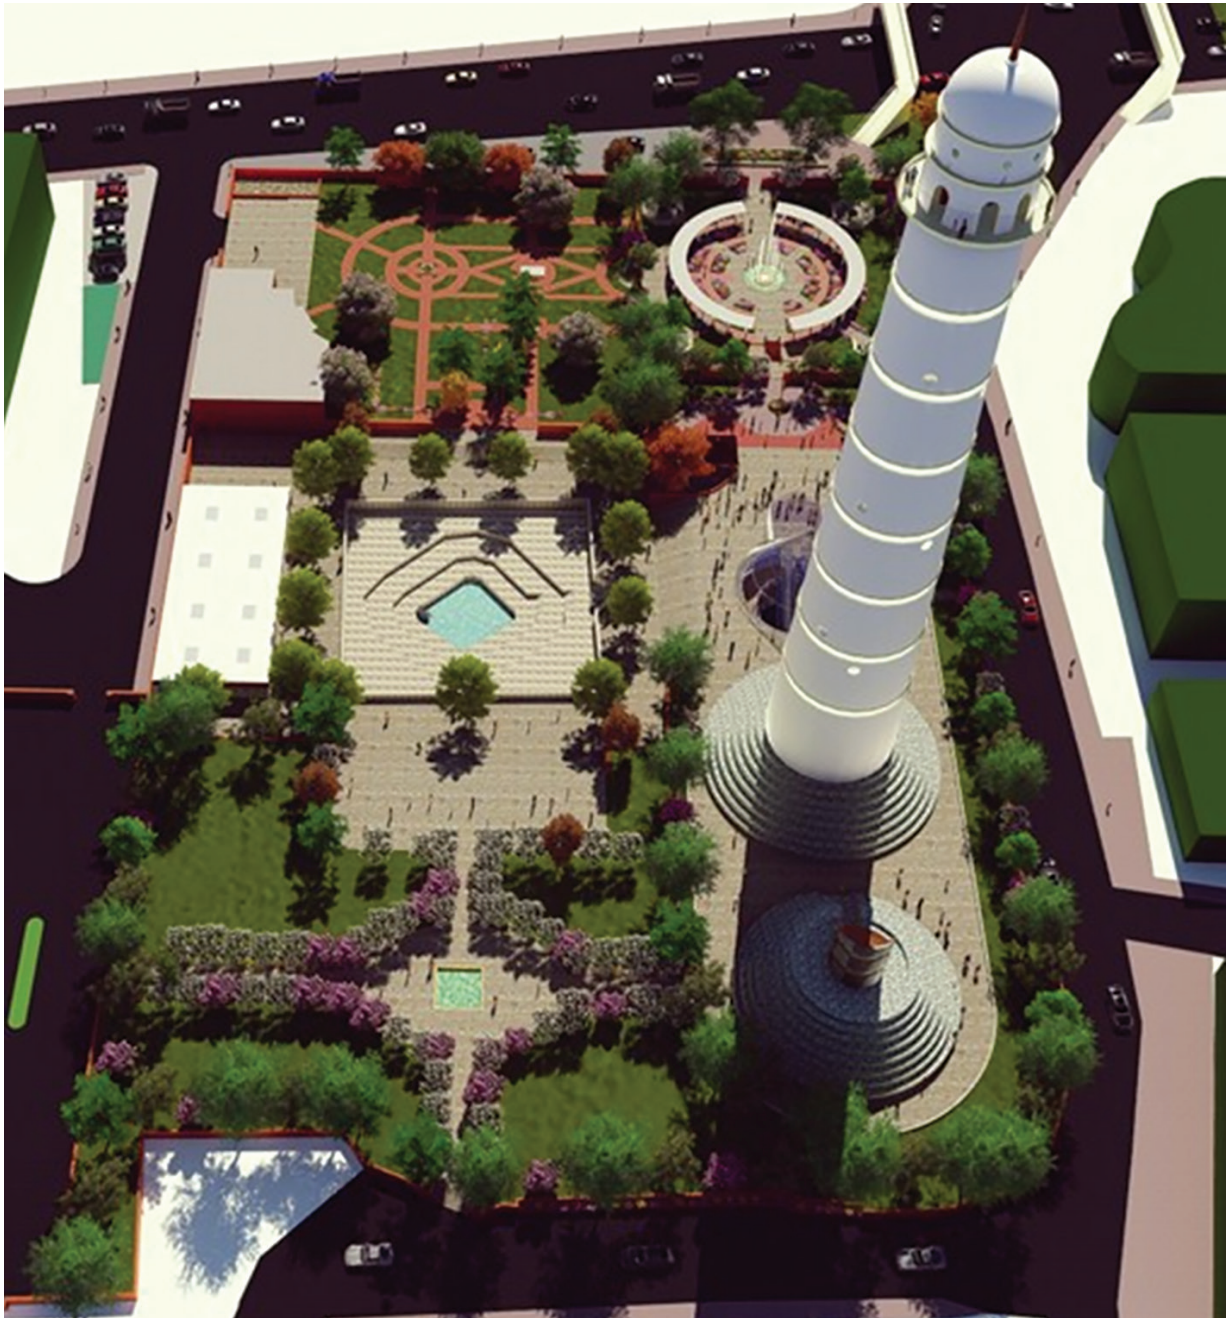
**Figure 5:** The proposed aerial view of Dharahara and its premises
