Perception of Gully Erosion and Conservation Practices in Agulu-Nanka-Oko and Ekwulobia

Abstract: Agulu-Nanka-Oko and Ekwulobia gully erosion is one of the largest of the many gullies in Anambra State. The purpose of this study was to identify and describe the perception of gully erosion and conservation practices in the study area. One hundred (100) questionnaires were purposively administered to local people in the four communities to determine the perceived causes, effects and conservation techniques practised. Household selection was carried out using a proximity-based sampling approach around the major gully sites. Data were collected from primary and secondary sources through the review of related documents, field observations, questionnaire surveys, Focus Group Discussions, and formal and informal interviews. Findings show that most local people recognise and have good awareness of the existence, causes, and impacts of soil erosion. Local people perceived that rainfall, flooding, deforestation, bush burning, sand mining, soil type, lack of drainage channels, and angry gods of the land contributed to gully formation and its effects on the environment and their livelihoods. S

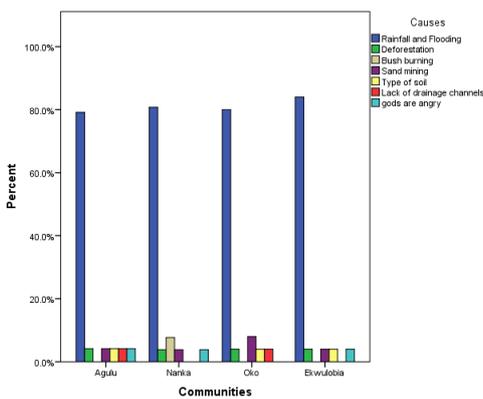
Figure 2: Perceived causes of gully erosion in the study area

Figure 2 shows the local people's perceptions of the causes of gully erosion. These are mainly physical factors, such as climatic elements (especially rainfall), soil type, and human factors, mainly deforestation, bush burning, and sand mining. Other reasons include inadequate drainage channels and spiritual reasons.

Figure 2 reveals that rainfall and flooding are the main causes of gully in Ekwulobia (83%) and the least in Oko and Agulu, with 78% each. Other causes include sand mining, which is more common in Oko (13%) than in the other three areas, with 5% recorded in each of the other

three areas. Bush burning was perceived to cause gully erosion in Nanka (8%) while other areas did not believe that it could trigger erosion. The local people in the four communities expressed concern over deforestation as a cause of erosion, with (6%) recorded in all the locations. Another cause of soil erosion identified by local people was related to the nature of the soil in their community. The local people in Agulu, Oko and Ekwulobia believed in the nature of soil as the cause of erosion (5%) in each of the three areas. The Nanka community disagree (0%) with the type of soil as a cause of erosion. Lack of drainage channel was perceived as the cause of gully erosion in Agulu and Oko areas, with (5%) in each of the two areas, while Nanka and Ekwulobia people did not indicate that lack of drainage channel could trigger gully erosion.

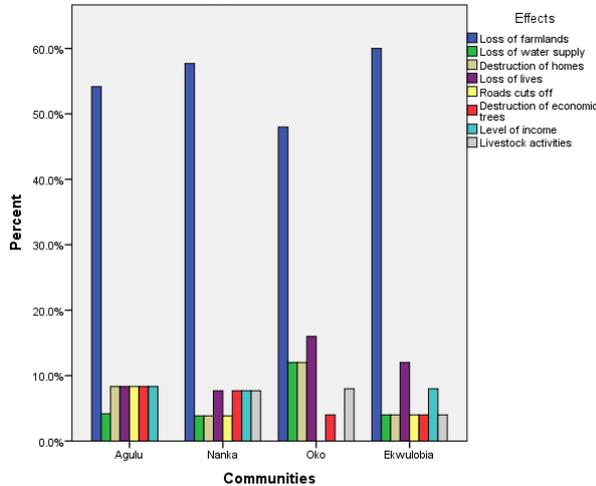
Figure 3: Percentage of the perceived effects of gully erosion and badland on the environment and livelihoods in the study area

Figure 3 shows respondents’ views on the effects of gully erosion on people's livelihoods. The majority of the respondents in the four communities reported that their

livelihoods were seriously affected. It is clear that the effects of gully erosion on the livelihoods of the people in the communities vary (Figure 3). Similarly, all participants of the Focus Group Discussion confirmed that the major effect of gully erosion in their community is the loss of their farmlands. This is clearly shown in figure 5. An indigene of Nanka, Uche okofar lamented. “All my farmlands have disappeared”

The greatest effect of gully erosion in the four communities is the loss of farmland (the highest in the four communities). Others include loss of source of water supply, destruction of homes, loss of lives, roads cut off, destruction of economic trees, reduced level of income and destruction of livestock activities. In the Agulu community, the perceived effects of gully erosion received similar responses, including loss of homes and lives, destruction of economic trees, and reduced income. Similar trends in responses were observed in the Nanka community, with the loss of lives, destruction of economic trees, reduction in income, and destruction of livestock activities, all at the same level across the area. The local people indicated that lives have been lost in their various communities while others are forced to relocate to other

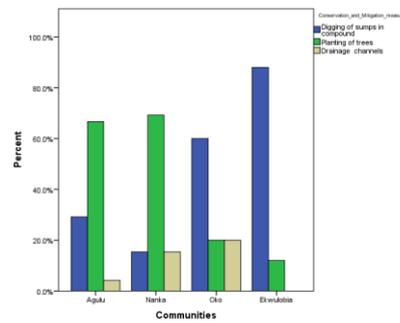
Figure 4: Some Attempted Soil Conservation Practices in the four communities

Direct observation coupled with FGD and interviews with local households in the four communities indicated that there were some initiatives and intervention in the past to control erosion, but still not effective. Figure 4 shows soil conservation measures adopted by the local people such as digging of sumps in compound which has the highest practice in Ekwulobia (90%) and least in Nanka (15%) other techniques include planting of trees, with high indication in Nanka (70%) and Agulu (68%). It was very low in other two areas. Forming drainage channel was very popular in Oko (20%) and Nanka (14%). There was almost non practice of drainage channel in Ekwulobia (0%). The differences in the variation of techniques could be attributed to choice and perception of the local people in controlling gully erosion.

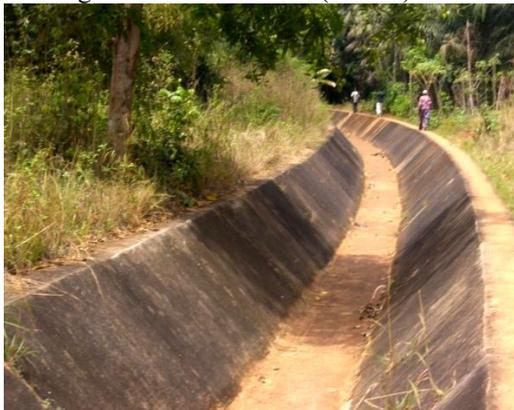
Plate 1: A section of the concrete drain channel around the head of the Ududonka gully, Agulu, constructed in 1970s from Nanka through Oko
Source: Researcher's field survey, 2024

Table 3 presents the historical background on erosion control measures in Agulu-Nanka-Oko and Ekwulobia communities. Afforestation has had a qualified success as a prevention measure. It has nevertheless remained the primary means of assessing the onset of gullies in the vast areas underlain by highly erodible geologic formations (plate 4). The cashew plant *Anacardium occidentale*, by virtue of being a fast-growing medium-sized tree with a luxuriant canopy and broad leaves, has been the arboreal species of choice for prevention purposes (Plate 3). The tree usually has low branches and effectively breaks the force of a raindrop. It hardly allows undergrowth of other plants, even grass, such that a dense cashew forest still has wide open spaces on the ground below the luxuriant canopy. In the early 1960s, the Eastern Nigeria Regional Government established a cashew nut canning factory. The enlightenment campaign was ineffective due to the inadequacy of agricultural extension services and rural farmers' distrust of new methods. Drainage channels constructed in the 70's had little success (Plate 1). Other erosion control measures employed by the local people include using gullies as refuse dumps and placing sandbags on the road surface (Plate 2).
