Drone and Electrical Resistivity Tomography (ERT) survey assisted slope instability risk assessment: A case study of Phyllitic landslide in Lesser Himalayas of Nepal

Abstract

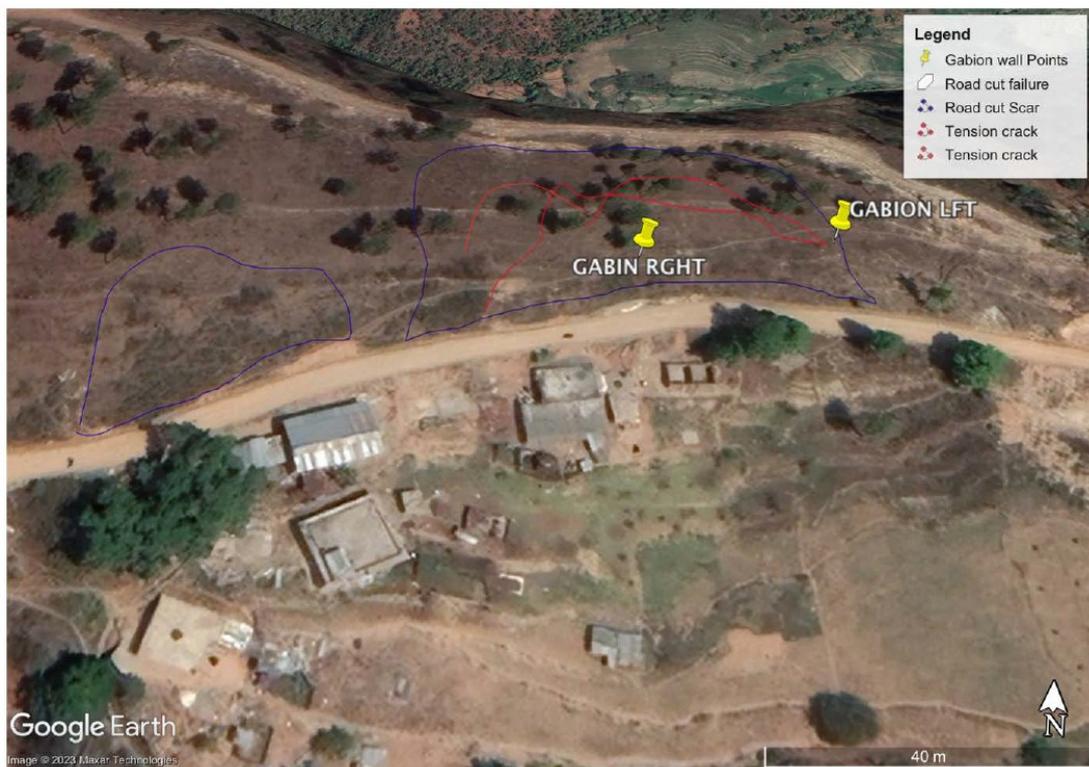
Figure 1: Figure shows the aerial photograph of the study area

Nuwakot district also suffered from the earthquake triggered landslide and earthquake-induced hazard map has been prepared though the proposed site was not vulnerable during that period (Dangi et al., 2019; Joshi et al., 2017). The aerial photographs of the area from 2021 AD suggest that the area is relatively stable and landslide events are recent. The image shown in Figure 1 indicates that there is an existing road section that was constructed around 1995 AD and had remained relatively stable over time. The problem was encountered during the road extension which involves the toe cutting of previously steadied slope, resulted in the roadside slope failure in the year of 2021 AD. Furthermore, the gabion structure was constructed in 2022 AD, further excavation during the trenching of the foundation lead to failure of the soil mass in the form of landslide.

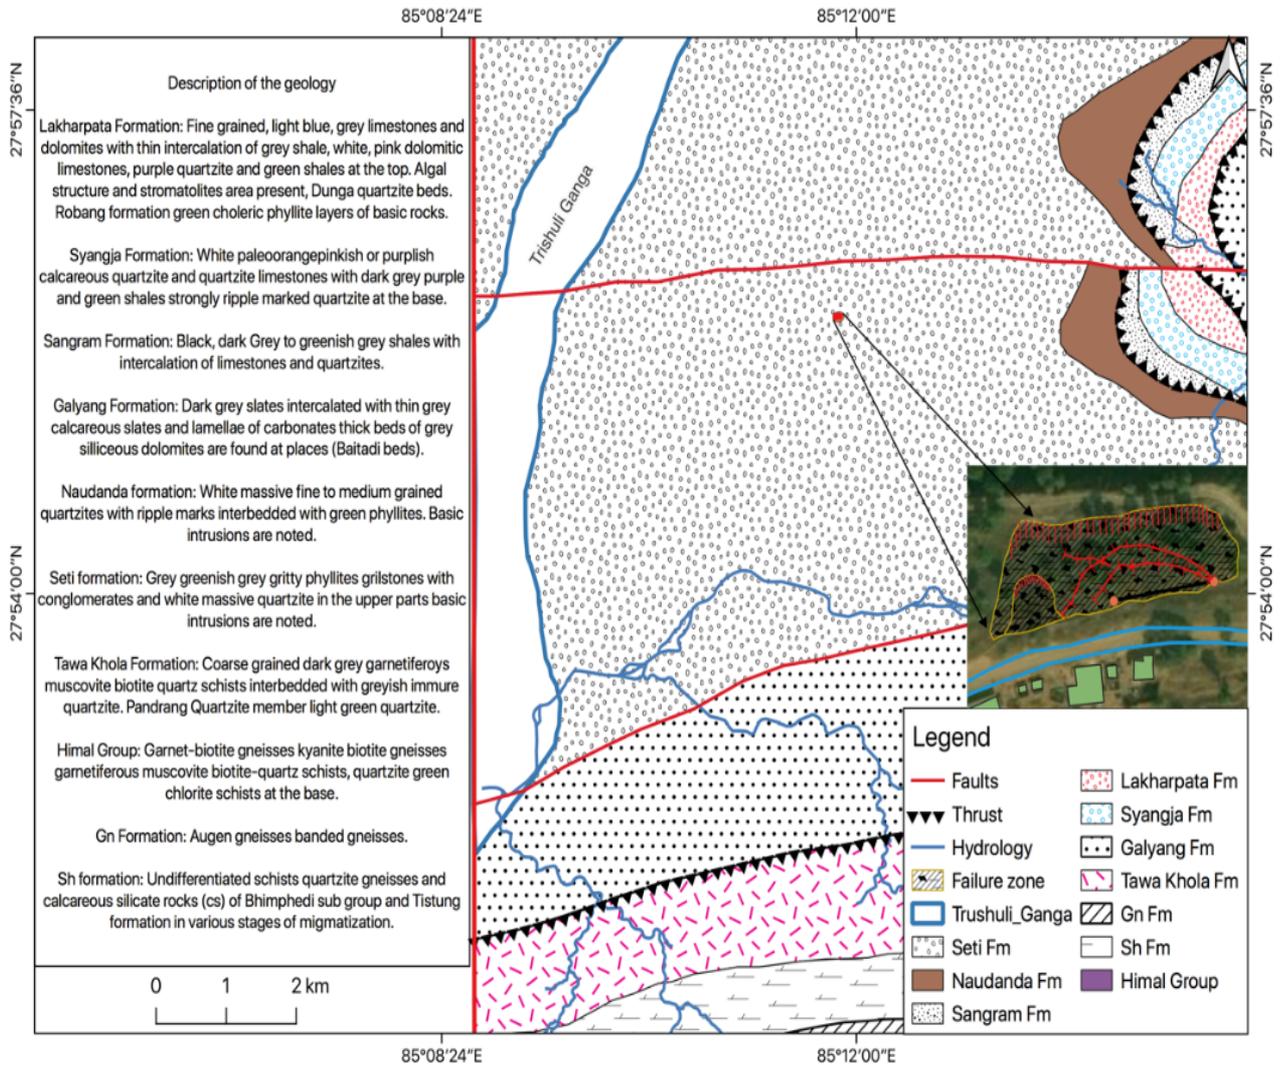
Figure 3: The geological map of the study area (inventory on the zoom)

The study area lies within the Upper Pre-Carabean to late Paleozoic era, especially in the Seti formation (English et al., 2000). The lithology of the area consists of Grey greenish grey gritty phyllites gritstones with conglomerates with partly intruded

massive white quartzite in upper part. The following figure highlights the regional geology of the area (Figure 3).

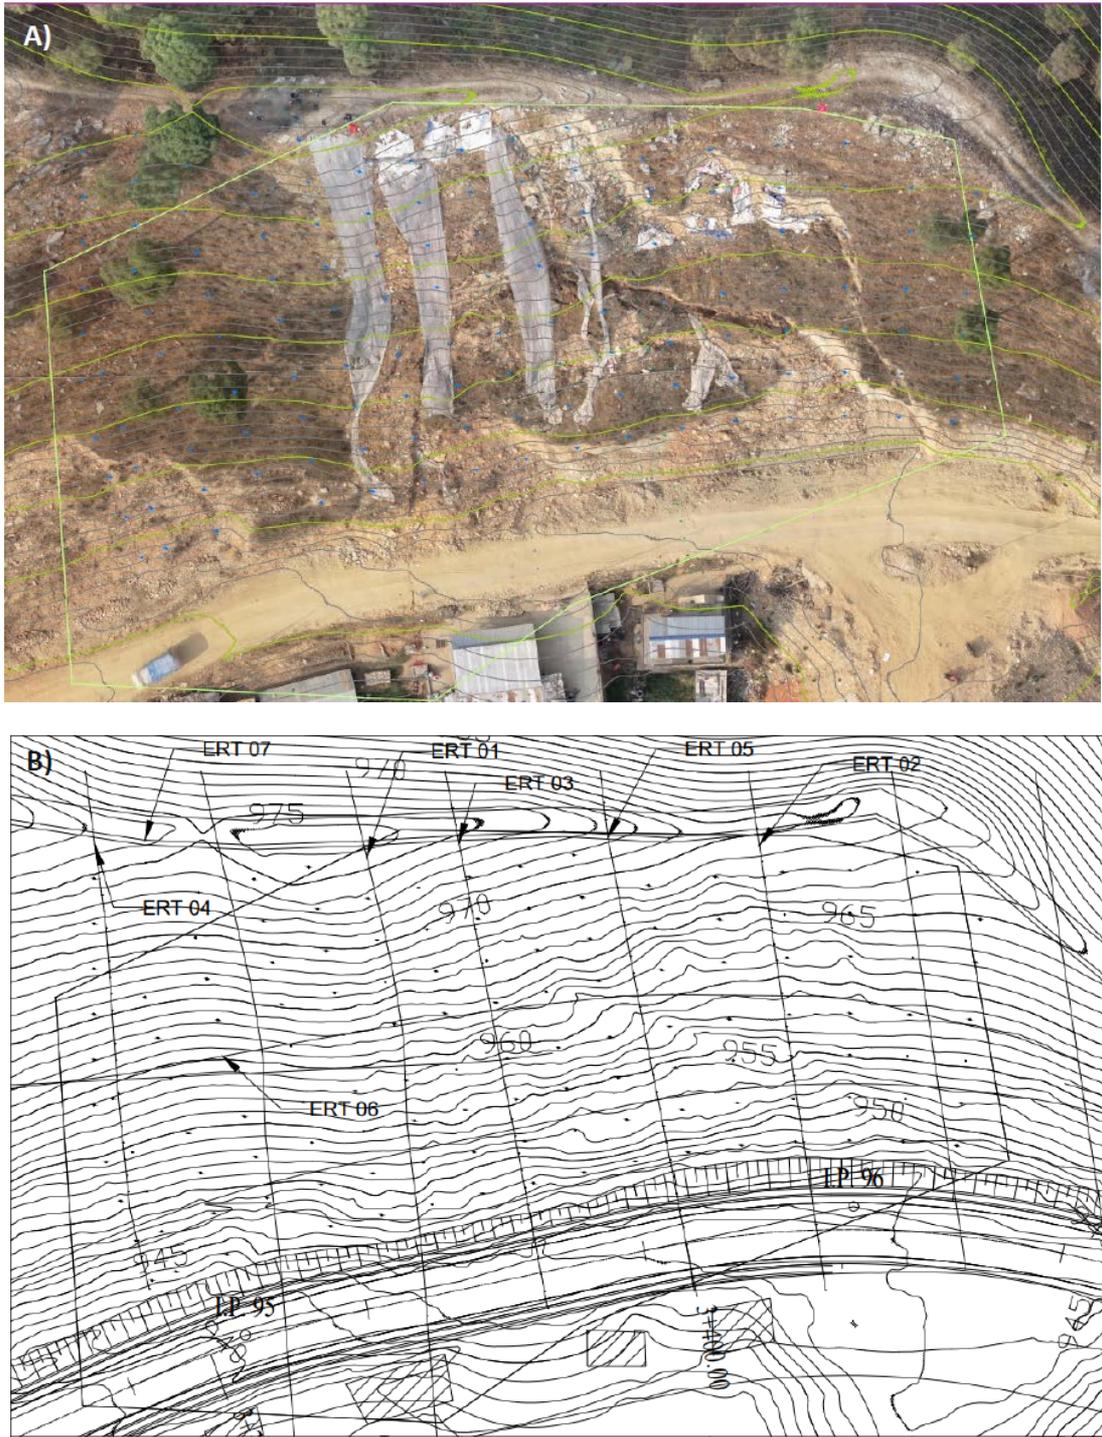
Figure 4: A) Orthophoto of landslide and B) contour map aligned with the designed road.

The unmanned aerial vehicle (UAV) is utilized for the monitoring of the landslide and produce high-resolution digital elevation models (DEM), orthophotos, and aerial photos based density point clouds obtained from structure-from-motion (Eker et al., 2018; Tian et al., 2020). The UAV captured images that were processed in Pix4Dmapper and obtained Ortho-photo and Digital Terrain Model (DTM) having a resolution of 0.3 meters (30 cm). The houses observed in the Ortho-photo were digitized and the linear features such as the drainage and debris flow channel were delineated. The contour of the terrain was prepared from the DTM accordingly the cross-sectional profile of the terrain was constructed, and road alignment was overlaid.

Field investigation and orthophoto interpretation revealed the presence of tension cracks and distinct lines of movement across the slope. The terrain slope varies between 32° and 42°, with a maximum elevation difference of approximately 37 m. The road is located on the south-facing ridge of the hill, where the slope has become unstable due to the absence of persistent groundwater conditions, whereas the north-facing slope remains relatively stable, as shown in Figure 4.

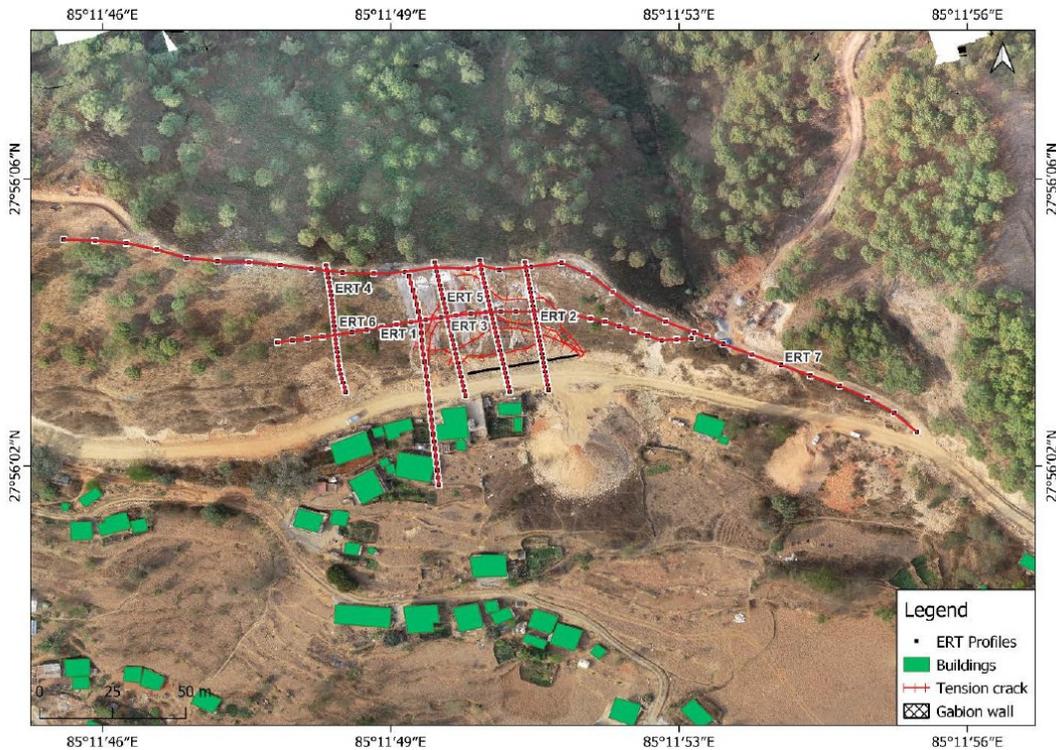
Figure 5: ERT profiles conducted in the study area.

Sigdel & Adhikari, 2020). The ERT survey was conducted with WJJD-4 Resistivity/IP equipment. The District Map, GPS, Drone, Photographic Camera, Brunton Compass, and Geological Hammer were used during the data collection. Due to the undulated site conditions, topographic correction has been adopted for the ERT profiling. Field data were gathered to obtain a continuous coverage of the sub-surface along the line of investigation which illustrates different resistivity zones due to presence of different lithological types (Figure 5).

The detail of the ERT profile that has been taken for the analysis has been presented which illustrates the general background of the ERT survey (Table 1)

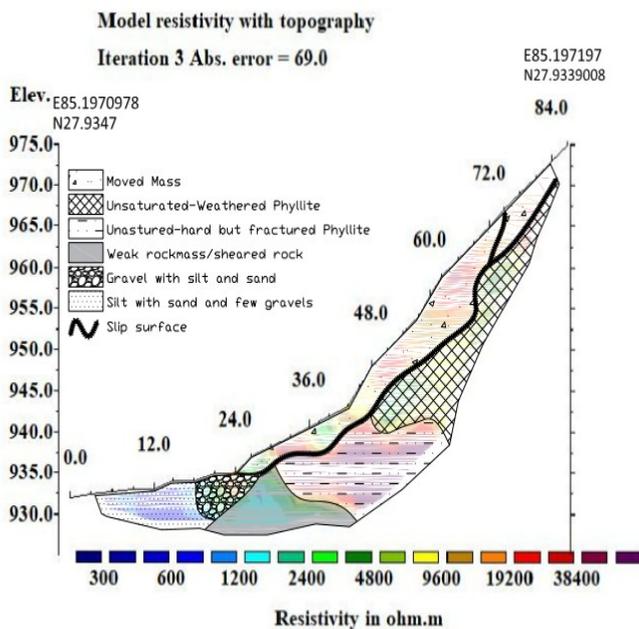
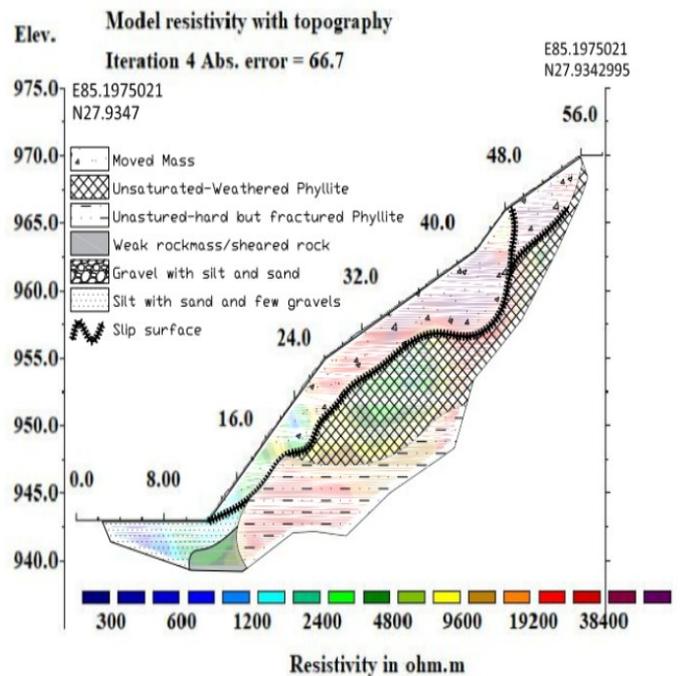
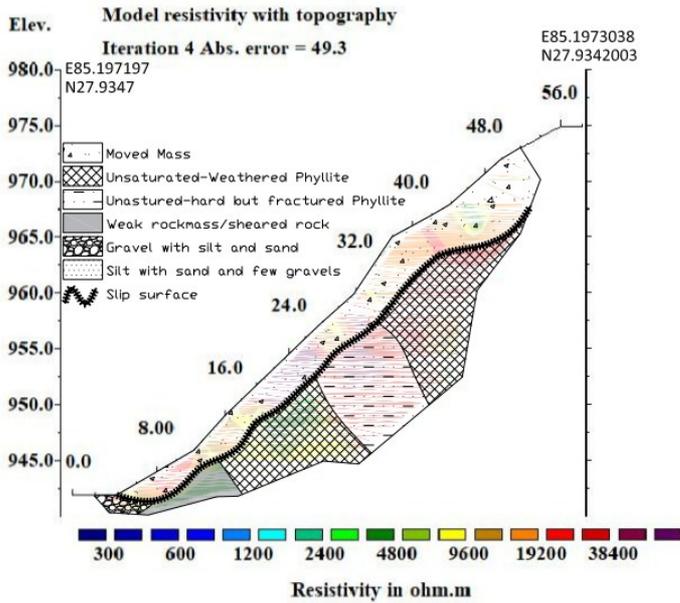
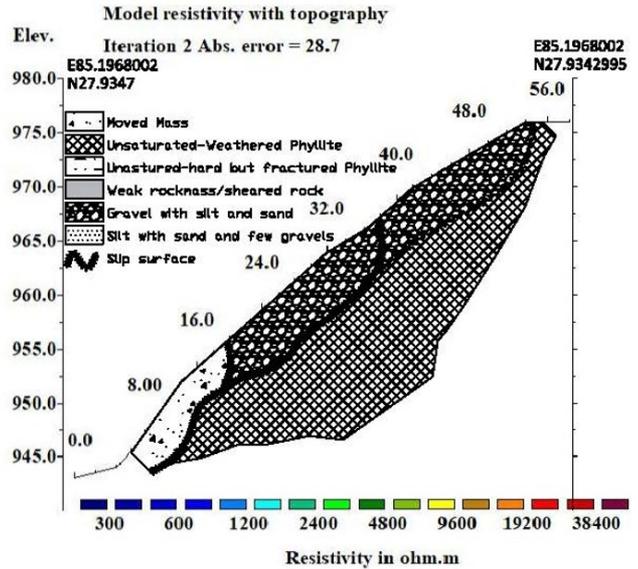
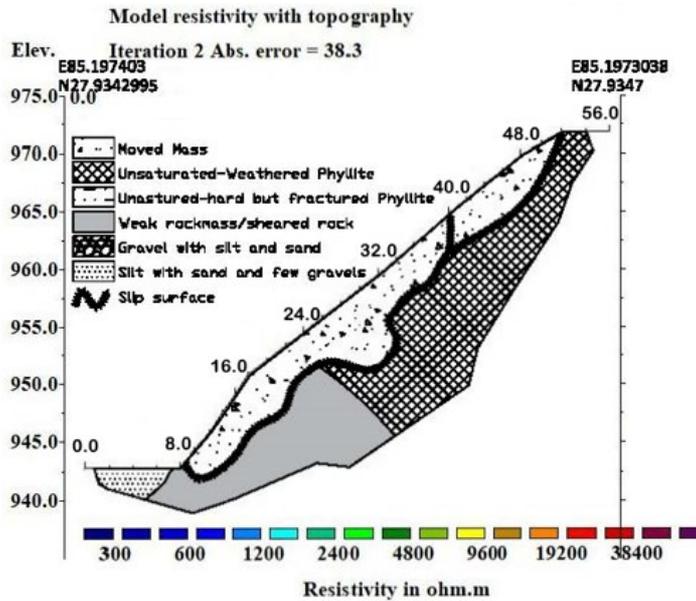
Figure 6: a) ERT profile 1 b) ERT profile 2 c) ERT profile 3 d) ERT profile 4, and e) ERT profile 5 of the study area with slip depth interpretation.

The very low resistivity zone <1200 Ohm-m which represents silt with sand and less gravel. The low resistivity zone 1200 to 2400 Ohm-m which represents weak rock mass or sheared rock. The moderate resistivity zone 2400 to 9600 Ohm-m represents unsaturated weathered rock. The high resistivity zone 2400 to 38400 Ohm-m denotes the moved mass (unsaturated silt-fine sand with gravels and gravels with silt-sand), and very high resistivity zone >38400 Ohm-m denotes unsaturated hard to fractured rock. The similar results were presented in the previous research conducted in Ngozumpa glacier of Nepal (Thompson et al., 2017). The detail sub-surface condition and slip surface estimation has been presented below (Figure 6).

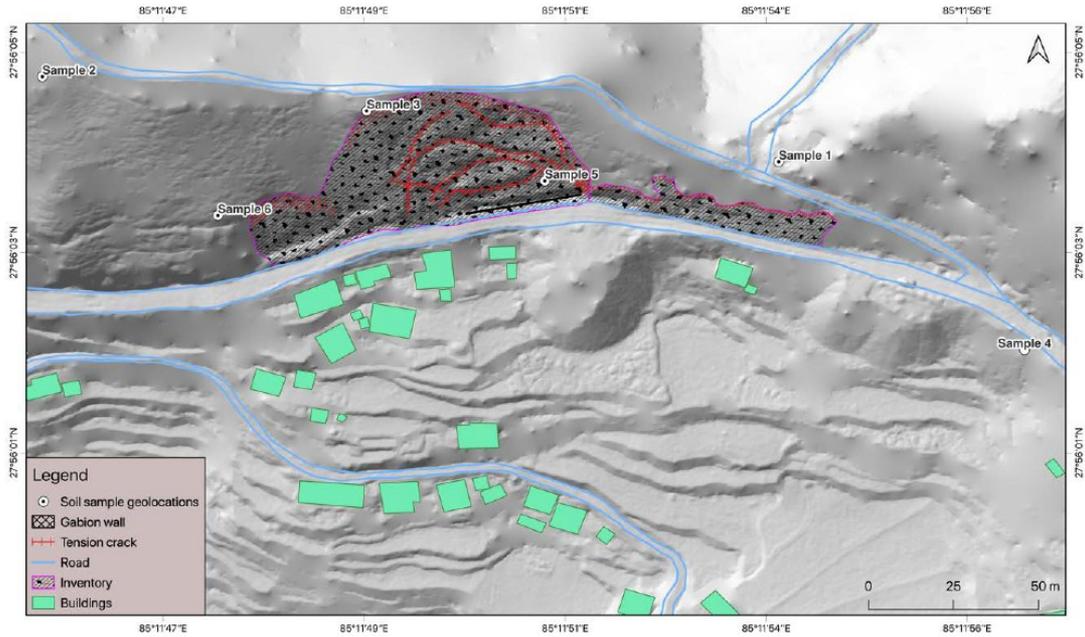
Figure 7: Inventory map (with hill-shade overlay) shows the location of soil samples collected.

soil were determined from fieldwork and laboratory analysis. Geotechnical properties of the soil samples collected from the following locations have been derived from the laboratory testing (Figure 7).

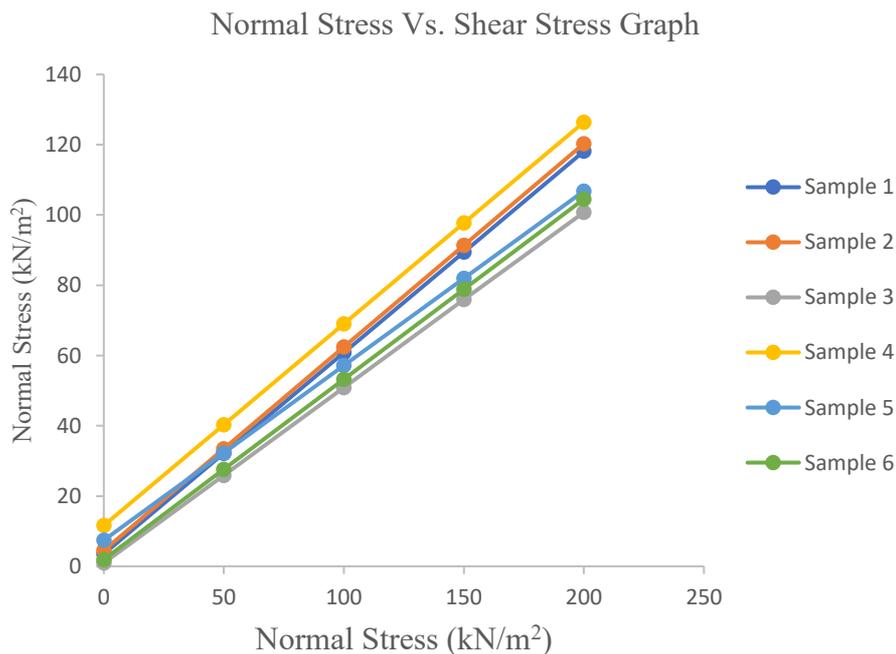
Figure 8: Normal stress vs. Shear stress curve for 6 different locations.

Direct Shear test was carried out on 6 number of soil sample samples retrieved from different locations. The graph between normal and shear stress has been plotted (Figure 8). The friction angle value indicates that the friction angle of sandy soil decreases with increase in confining pressure, thus implying a circular soil failure envelope. The typical sandy soil has negligible shear strength at zero confining stress which can generally be modelled with a cohesion value of zero (Sigdel & Adhikari, 2020).

The cohesion (c) and angle of internal friction (ϕ°) of the soil was found in the range of 1.0 to 11.60 kN/m² and 26.5° to 30° respectively which can be tabulated in the following table 6.

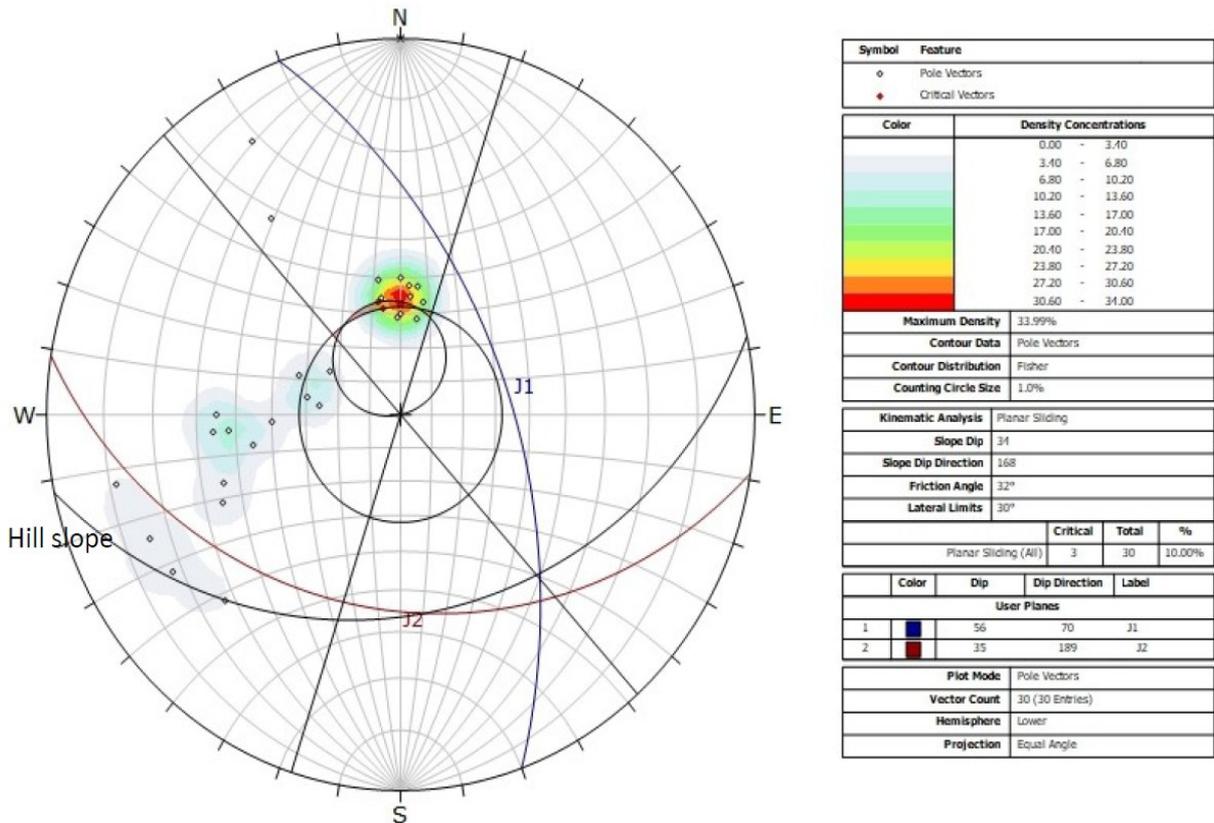
Figure 9: Rock slope stability analysis

The DIPs software has been adopted to estimate the rock slope stability which employs the graphical approach for the analysis. It analyses the stability of the slopes with complex geometries that include multiple dip direction and variable dip angles. The software also incorporates different methods, including limit equilibrium and kinematic analysis, to determine the factors influencing slope stability (Rahman et al., 2023). Limit equilibrium analysis assumes the equilibrium between the driving and resisting forces acting on a slope. On the other hand, kinematic analysis is useful for identifying potential failure modes and their associated geometries. The analysis of 30 vectors for the Phyllite rock in the area shows that the area has low possibility of plane failures. The hill slope is placed concordant to the bedrock dip. However, the steeper terrain is not in the daylight for the failure, indicated that the slope failure is mainly

due to the toe excavation and the failure material is overlaying soil and detached rock blocks (Figure 9).

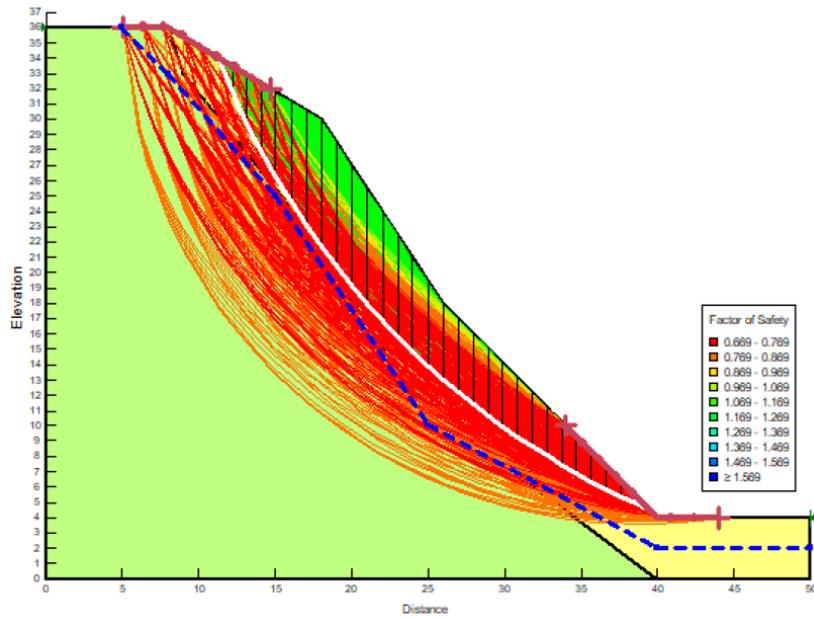
Figure 10: Limit Equilibrium Analysis (FoS) of the slope profile based on Geo-studio.

The slope stability was assessed using the Geo-Studio Software (Package SLOPE/W) and Slice2 software that works on limit equilibrium model (LEM) for which laboratory analyzed geotechnical parameters obtained from the laboratory testing and topographical parameters obtained from high resolution Digital Terrain Model (~30 cm) were used. The Geo-studio and Slope2 software packages have been widely accepted software for the slope stability analysis using Bishops' method for the estimation of factor of safety (Geo-Studio, 2012; Salmasi et al., 2019; Su et al., 2022). The stability model was implemented for the soil profile (Figure 10, and Figure 11) depicted that the slope is unstable which has FoS less than 1 (Geo-studio FoS=0.668, and Slice FoS=0.679).

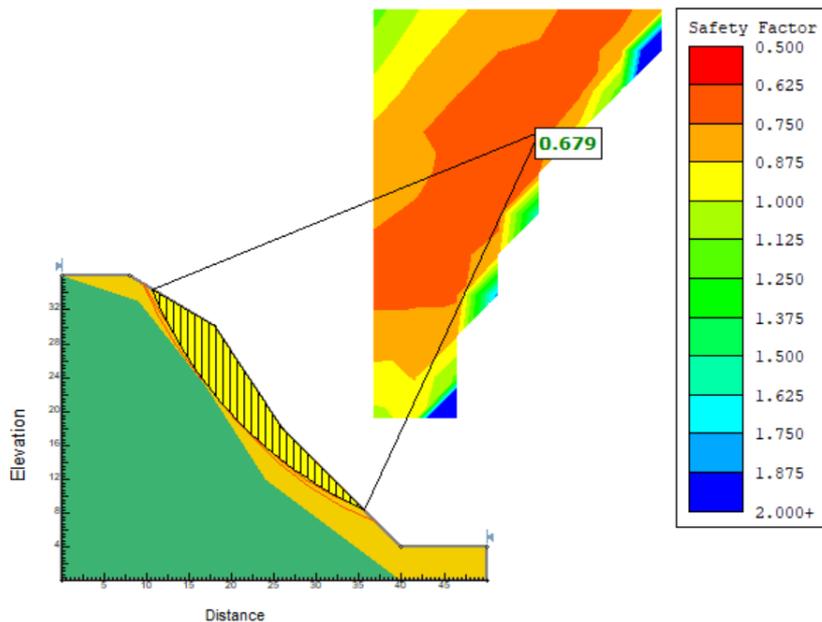
Figure 11: Limit Equilibrium Analysis (FoS) of the slope profile based on Slice2.

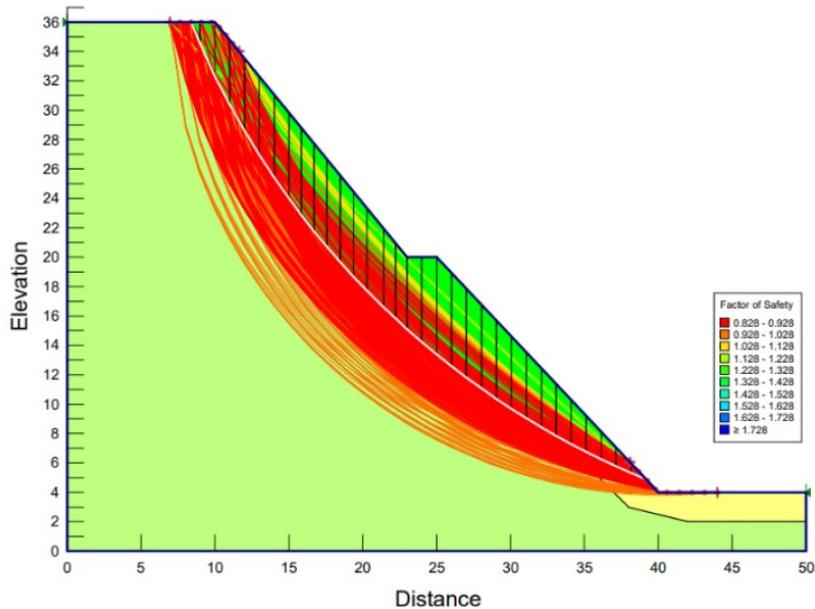
Figure 12: Limit Equilibrium Analysis (FoS) of the slope profile based on Geo-studio.

To achieve the roadside slope stable, firstly a model was constructed by removing the loose materials on the slope (i. e. removing the surcharge load) and checked the FoS with a 2-meters bench in the middle of the slope without anchor bolt. The model depicted FoS which is still lower than 1 indicates that the slope is still unstable (Geo-studio FoS=0.828, and Slide2 FoS=0.832).

- a. Removal of loose earth material: It is suggested to remove the loose earth material from slope which results in the reduction of the surcharge load thereby increasing the FoS. The modelling also indicated that the removing of the loose earth material increases the FoS from 0.68 to 0.82.

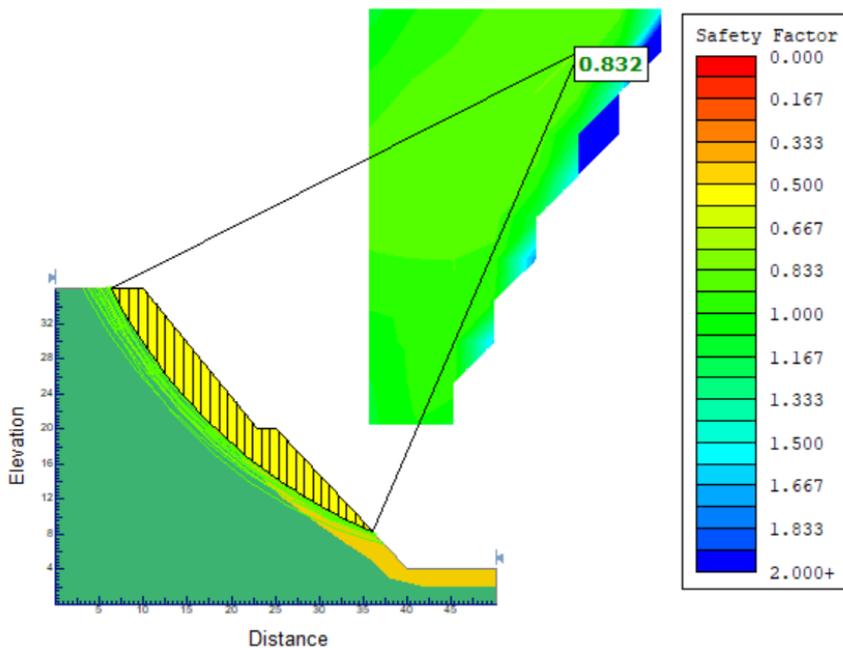
Figure 13: Limit Equilibrium Analysis (FoS) of the slope profile based on Slice2.

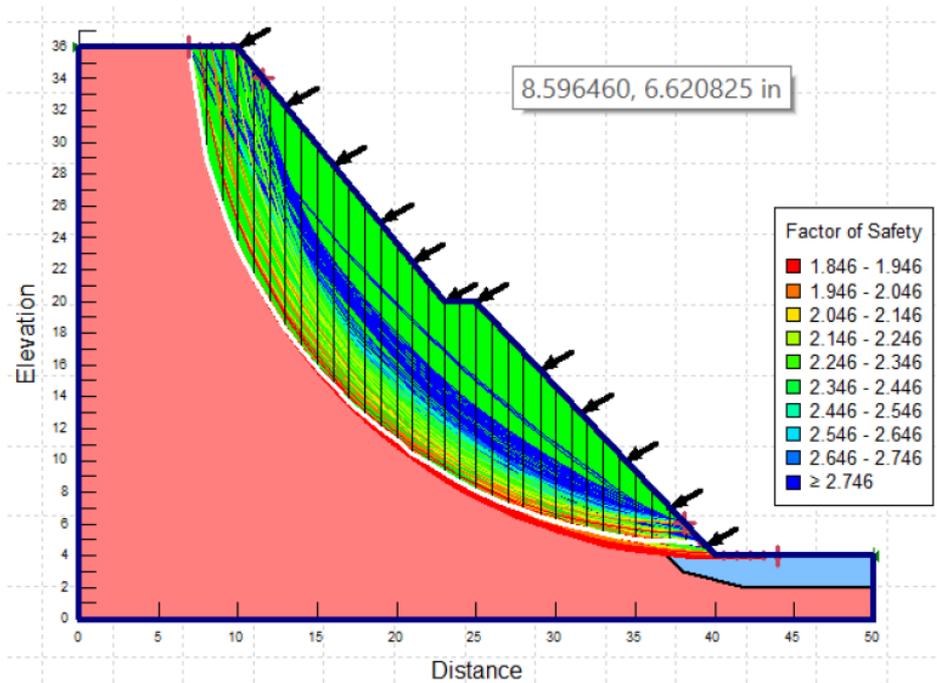
Figure 14: FoS Model with the point load of 150 kN/m².

The above models clearly indicated the requirement of the Anchorage. Finally, a Geo-studio-based model was set for the reinforced concrete shear wall (Height=1.8 m, and Length=81 m), concrete crib (Size= 0.3m×0.3 m, and total length=1843m), and anchor bolts (Size= 25 mm diameter, bond length=3 m, and numbers=182) for 150kN/m² point load. The appropriate design-based stability analysis indicates that the slope became stable (FoS=1.84) (Figure 14).

- b. Construction of RCC shear wall: Steel Reinforced Cement Concrete (RCC) shear wall is proposed along the hillside or the toe of the slope parallel to the roadside drainage. The share wall is 81-meter in length and 1.8-meter high along with the height of the foundation. A shallow shear wall has been proposed to reduce the cost and to support the concrete crib to be built on the hill slope.

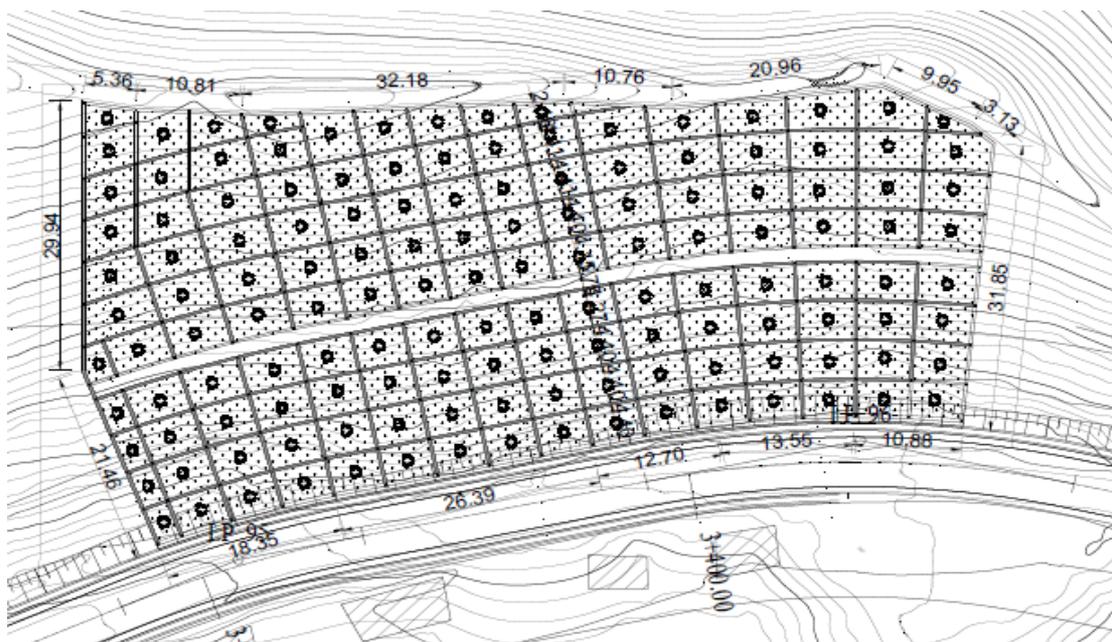
Figure 15: Plan for landslide structure

- c. Construction of concrete crib and anchors: The slope to be protected is long and the slope varies from 33-40 degrees below which settlement is located. Field Observation, modelling and design work depicted that the concrete crib along with the rock bolt is the best option in terms of cost, stability, and sustainability.

- d. Vegetation: The restoration of the natural environment and ecology can be achieved by applying vegetation in the free space available between the cribs of the slope protection system.
