River channel dynamics and flooding: A case of motorable bridge collapse due to abrupt flood in Chhabdi Khola, Tanahun, Nepal

Madhav Adhikari*, Bharat Prasad Bhandari

Central Department of Environmental Science, Tribhuvan University, Kirtipur, Kathmandu, Nepal

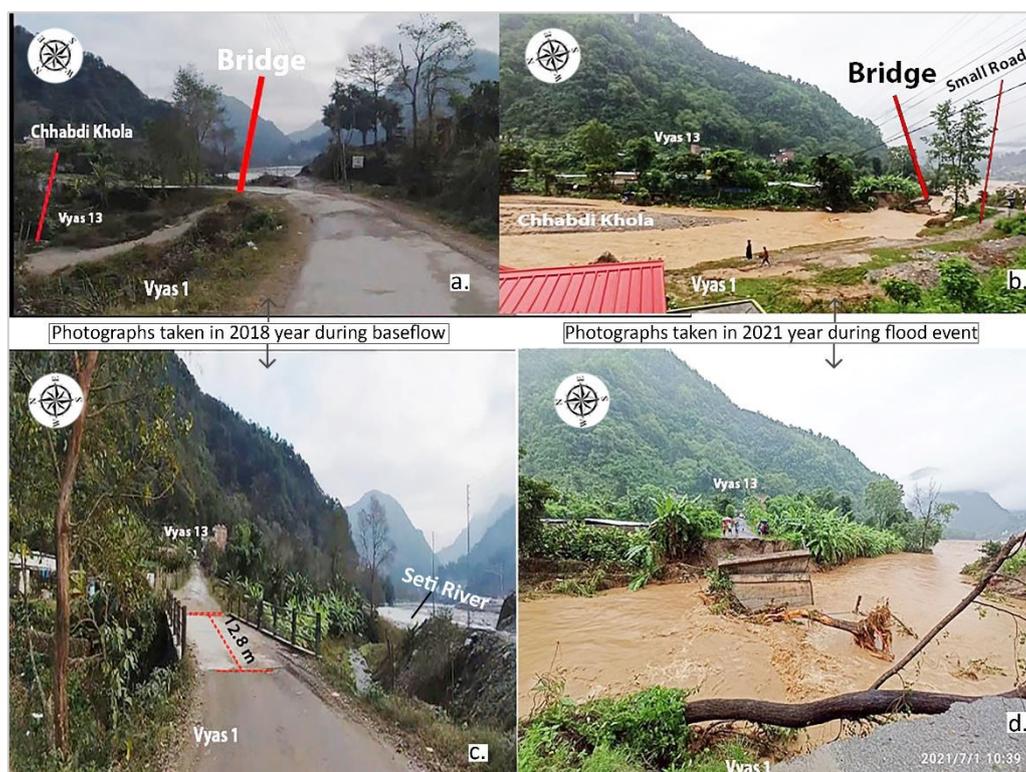
The Chhabdi Dovan Bridge collapsed in the year 2021 following a flooding event in the Chhabdi catchment area, an unprecedented occurrence according to local community reports. The bridge's current state can be seen in Fig. 14, with debris and materials scattered around the collapsed structure due to the flood aftermath. Fig. 14 provides a visual overview of the bridge's historical and current conditions, which served as a crucial link between Vyas Municipality's wards 1 and 13, as well as its surrounding environment.

Figure 14 Comparing before and after condition of Bridge area due to flood; a: Bridge condition assessment of Chhabdi Khola Dovan linking Vyas 1 and Vyas 13 under low-flow conditions b: Bridge infrastructure loss and roadway damage in aftermath of the flood event c: Bridge dimensions indicated by red dotted line and showing location of Seti River area which is mainstem for Chhabdi Khola d: Condition of Chhabdi Dovan Bridge's structural integrity following its submersion by the Chhabdi Khola flood and subsequent debris accumulation (Note: The photographs featured in Fig. 14 to Fig. 17 were captured by the author.).

The bridge has an average width of 17.47 meters, but at study site 28, the stream widens to 28.8 meters near the bridge inlet, as shown in Fig. 14. The figure shows the stream flowing narrowly through the bridge, highlighting the insufficiency of the bridge's dimensions, especially its height and length, to accommodate the stream's width and ensure unobstructed flow.

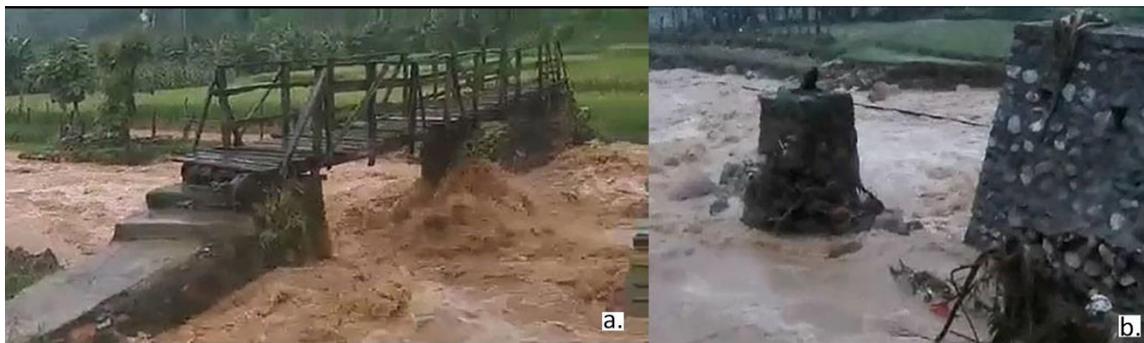
On the same day, an analogous event transpired in the vicinity of the Chhabdi Barah temple, located approximately 5 kilometers northeast of Chhabdi Khola Dovan, which is within the periphery of study site number 25. This incident entailed the complete dislodging of a crucial wooden bridge, supported by concrete-based pillars, utilized for local transit, as a consequence of an exceptional rainfall-induced deluge. The ramifications of this deluge extended to the detriment of agricultural lands, croplands, and grasslands, as evidenced in Fig. 15.

Figure 15 Chhabdi flood impact in the upstream area near Chhabdi Barah temple in site 25; a: Photograph showing the bridge pillar scouring during the flood b: Photograph showing complete sweeping away of the same bridge after the flood.

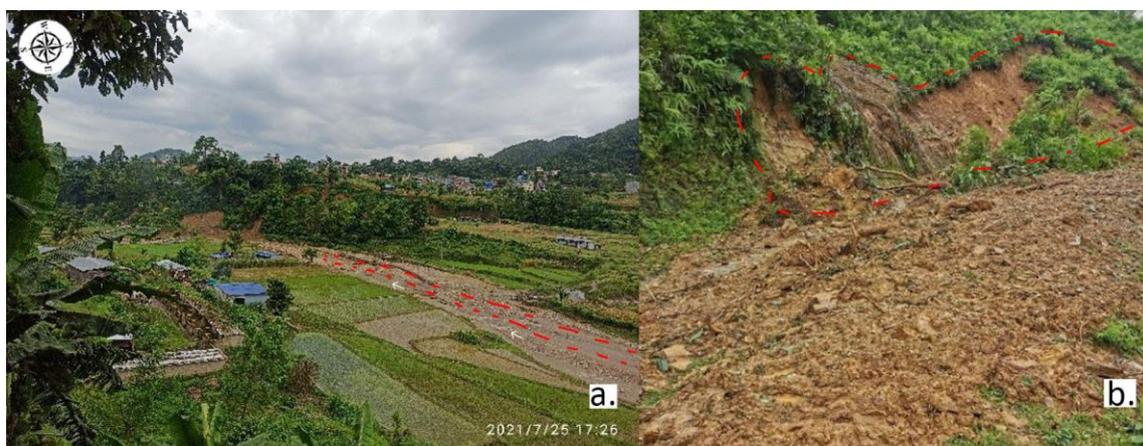
agricultural and livestock sectors. Furthermore, it led to soil erosion and landslides, compounding the risks to human life, hindering transportation and communication systems, and further exacerbating damage to buildings and infrastructure, as illustrated in Fig. 16.

Figure 16 Post-flood condition in Chhabdi Khola; a: Expansion in both banks of Chhabdi Khola affecting agricultural area; highlighted by the red line indicating the original Chhabdi Khola path b: Landslide as indicated by red line and soil erosion resulted from extreme rainfall. (Photo taken after 24 days of the flood).

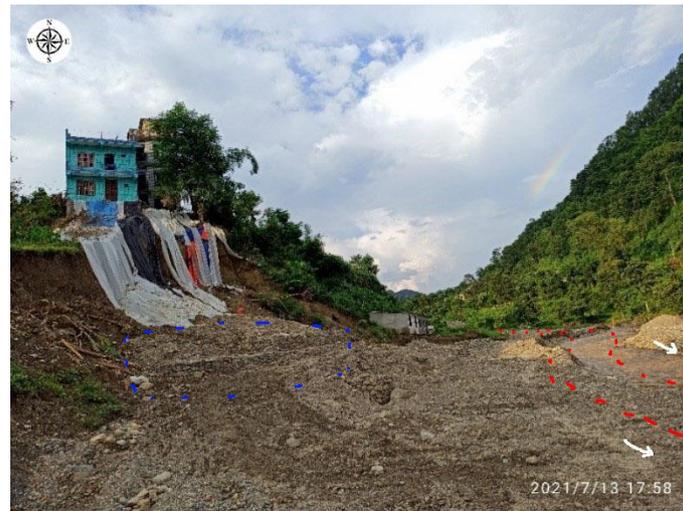
The Chhabdi Khola area faced numerous challenges following a destructive flood event. This led to significant property losses, including farmland, homes, and livestock. Erosion of soil put many houses at risk, and the fast-flowing floodwaters further exacerbated the situation. Fig. 17 illustrates one such at-risk building near the downstream area.

Figure 17 Building being exposed to vulnerable due to Chhabdi flood; red line indicating the original Chhabdi Khola path and blue line encircles the immediate structural mitigation (gabion wall) applied after flood event to minimize risk for building.
