Special Issue "Research & Practice", 15 June 2021, pp. 12-25

Assessment of Natural Hazard in the Himalayas: A Case Study of the Seti River Flash Flood 2012

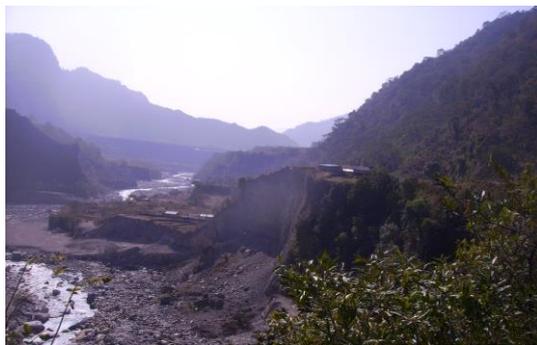
[Photo 1]. Upper part of Pokhara valley, near Talunge

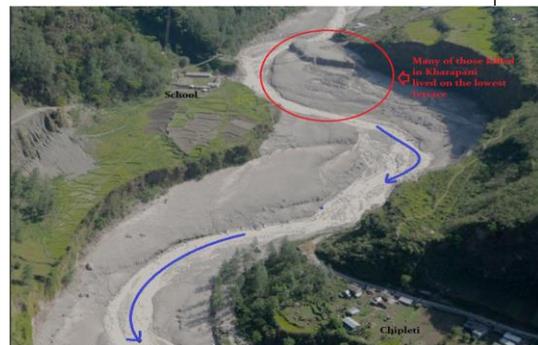
[Photo 2]. Devastated Kharapani (Tatopani) Area

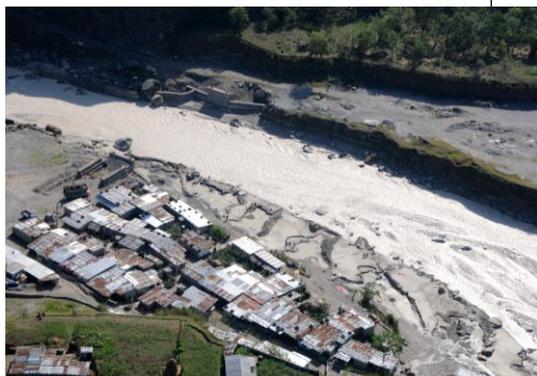
[Photo 3]: Highly vulnerable houses (Masina Bagar of Hemja) within 50m Seti River course.

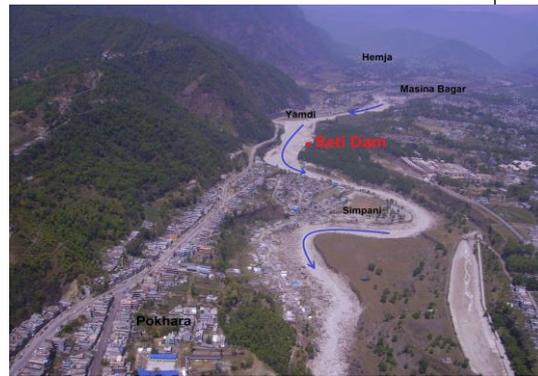
[Photo 4]: Seti Dam and vulnerable settlement within 50m of Seti River course.

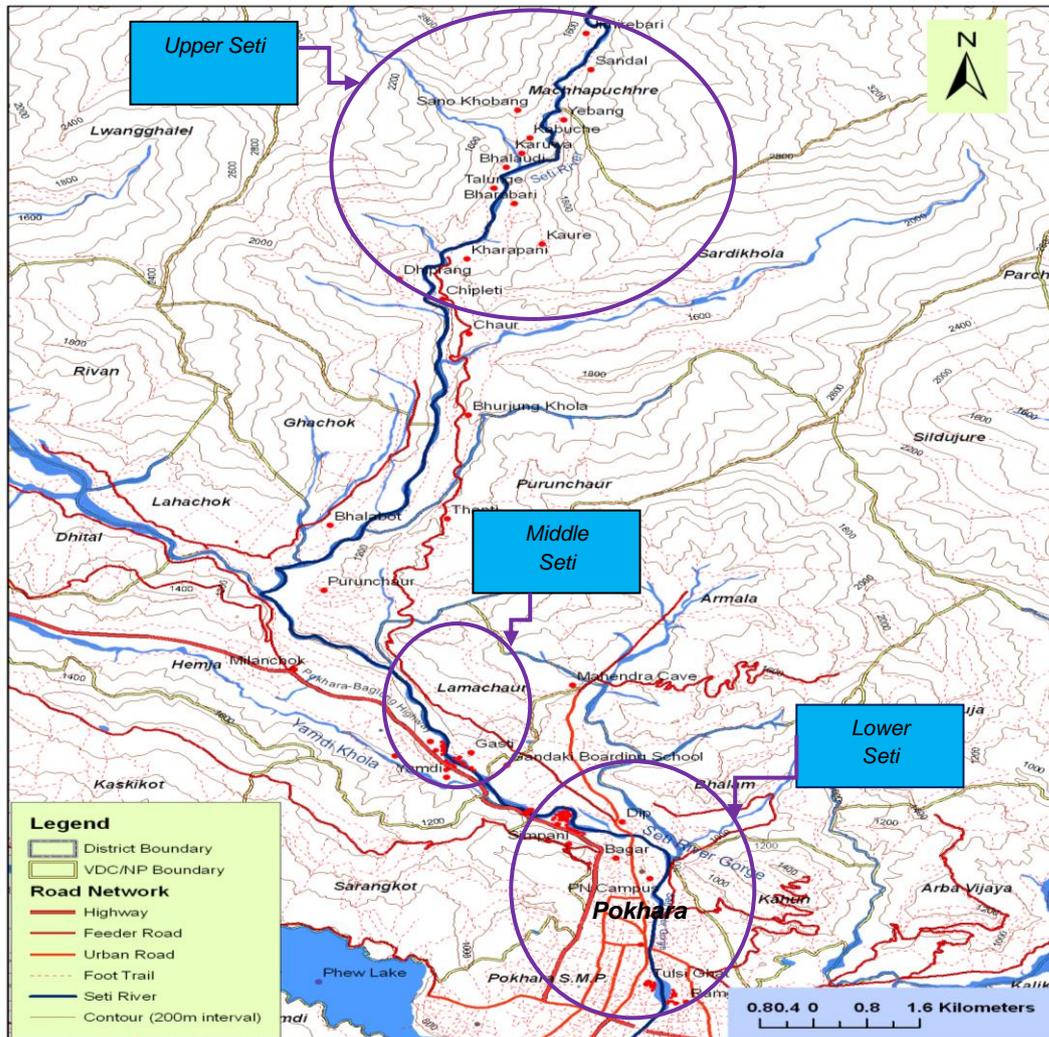
Figure 2
Location of major affected area of Seti river course

The overall affected area covers household settlements from the Seti River courses, particularly from Ramghat of Pokhara Metropolitan City to Jimirebari of Machhapuche Rural Municipality. The Seti River Flood Disaster Area (SRFDA) covers Machhapuchre, Sardikhola, Ghachowk, Lahachowk, Puranchaur, Lamachaur, Hemja and some areas of Pokhara Metropolitan City. According to the population census 2011, the total population of SRFDA is 289358 residing within 76,556 households. Out of the total households, only 810 (1.06%) households fall within the 50-meter margin from the Seti River. Out of total marginal households, only 163 (20%) households were purposively selected for finding characteristic features of population and settlement. For simplicity, the marginal area from Ramghat to Jimirebari were-designated as Seti River Corridor (SRC) and divided into three sections viz. Upper Seti, Middle Seti, and Lower Seti. The area above Kharapani is named as Upper Seti, [Photo:1&2] Kaskeri to Kharapani as Middle Seti [Photo:3] and Ramghat to Kaskeri as Lower Seti, [Photo:4] respectively.

These divisions represent the spatial variation in the socio-economic profile of the population (Table 2 & Fig.2).

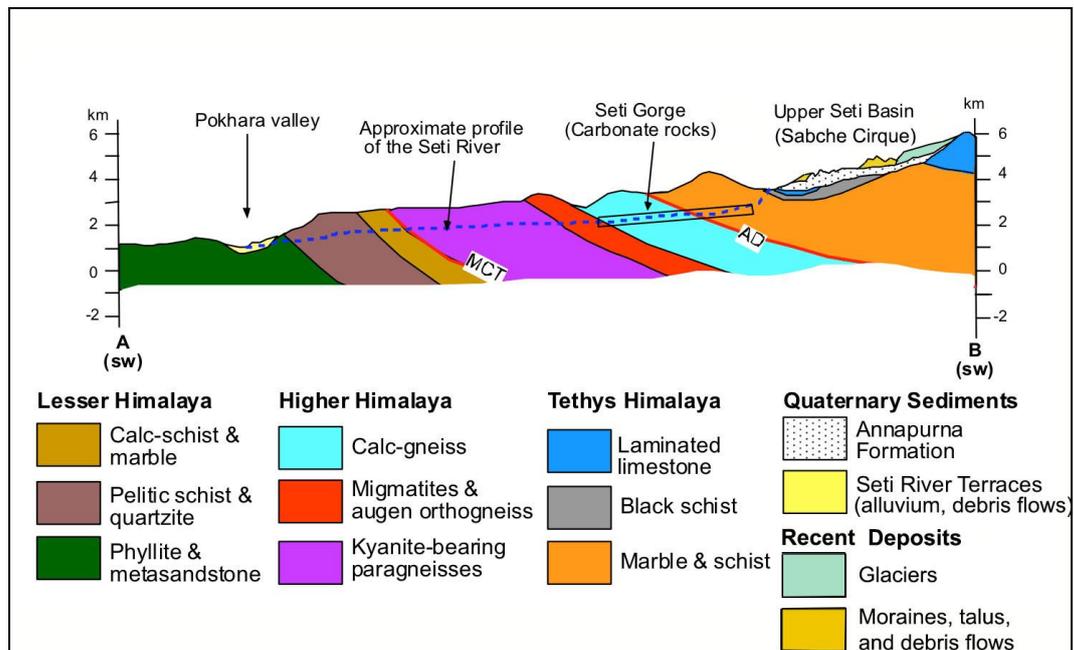
Figure 3
Simplified, Schematic Geological Cross-Section across the Pokhara Valley

According to the regional geological map and cross-section of the Seti River Basin that cover the area north of Pokhara (Kargelet al., 2013), the lithology of the area was separated into several mappable units based on distinctions of lithology, presence or absence of fossils, sediment consolidation, and the position within the overall rock sequence. The lithological boundaries observed along the accessible routes were extended to the inaccessible areas based on the orientation of the beds and foliation (strike and dip). The bedrock of the area can be divided into three tectonic units, i.e., the Lesser Himalaya, Higher Himalaya, and the Tethys Himalaya separated by major regional faults, namely, the Main Central Thrust (MCT) and Annapurna Detachment (AD). The unconsolidated materials are much younger and include the Annapurna formation (calcareous silts, sands and gravels) and recent glaciers, moraines, debris flows and alluvial gravels. As we have described below, the 2012 disaster has a strong involvement from the deep Seti River gorge and the high, steep peaks of the Annapurna Range; these are erosional features developed in the rocks of the Tethys Himalaya and Higher Himalaya.

The Karst topography is formed in easily soluble rocks such as carbonates (limestone and dolomites) and evaporates (gypsum and salt). It is evident from the present geological mapping that about a 7 km stretch of the Seti River flows across the carbonate rocks (marbles, calc-schists, and calc-gneisses) (Fig. 3). These rocks are mainly composed of calcite (CaCO₃). The Karst topography is very common in the Pokhara valley in the carbonate cemented terraces. Mahendra Cave, Chamere Cave and Gupteshor Cave are some examples. Therefore, underground channels and caves may also be present in the Seti River gorge. This would increase the volume available to store water when the gorge is dammed and hence increase the potential flood volumes when the dam is broken.

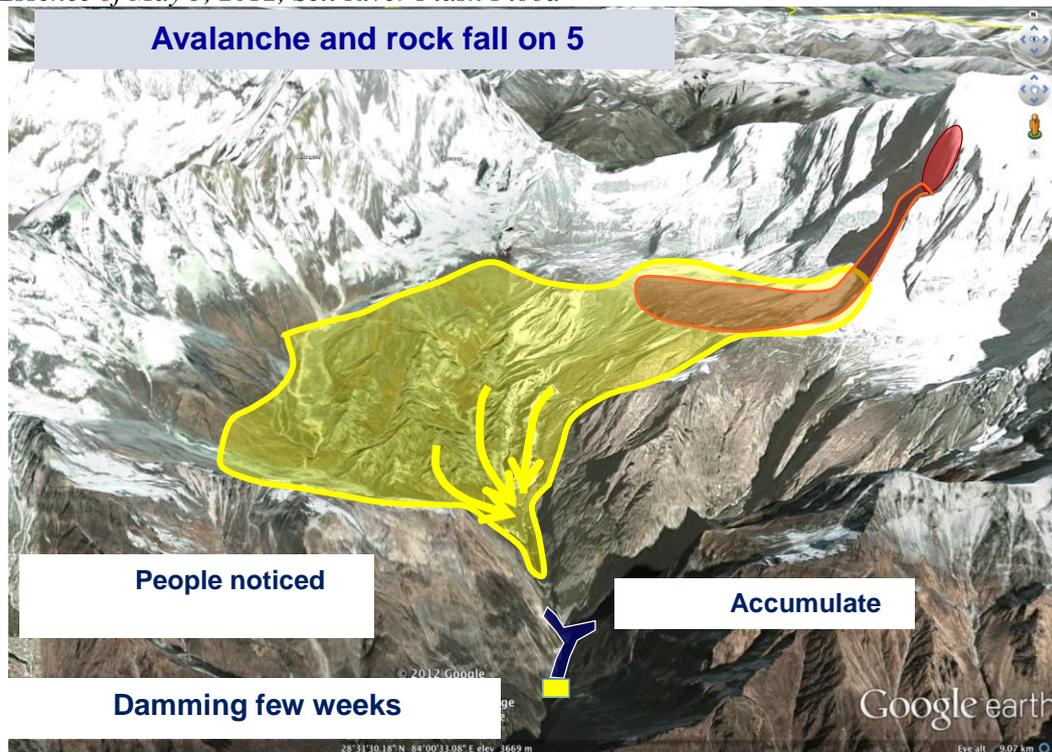
Photo 5

Essence of May 5, 2012, Seti River Flash Flood

have been below the point where the major tributaries within the Sabche Cirque join but above the upstream villages where the diminished (almost zero) flow was observed. This constrains the point of blockage to a short segment of the Seti River. Had the blockage been above the point where the two major tributaries (the north branch and west branch) join in the gorge area, perhaps half (more or less) of the water would have been blocked but much flow would have continued. This first clue tends to rule out the glacier ice and the Annapurna formation as hosts of the reservoir, but it allows the gorge and also could allow any karstic cavernous spaces connected to the gorge that could have been filled due to damming of the gorge [Photo:5].

When the Seti River was blocked, a trickle continued but changed its color from the usual white caused by abundant suspended rock flour. (“Seti” means “white,” so it is the White River) Hence, water draining from the glaciers and the Annapurna formation was blocked, leaving only small amounts of water runoff from points below the glaciers and the Annapurna formation. This again points to a blockage in the gorge area below the Annapurna formation and below where the two major tributaries join.

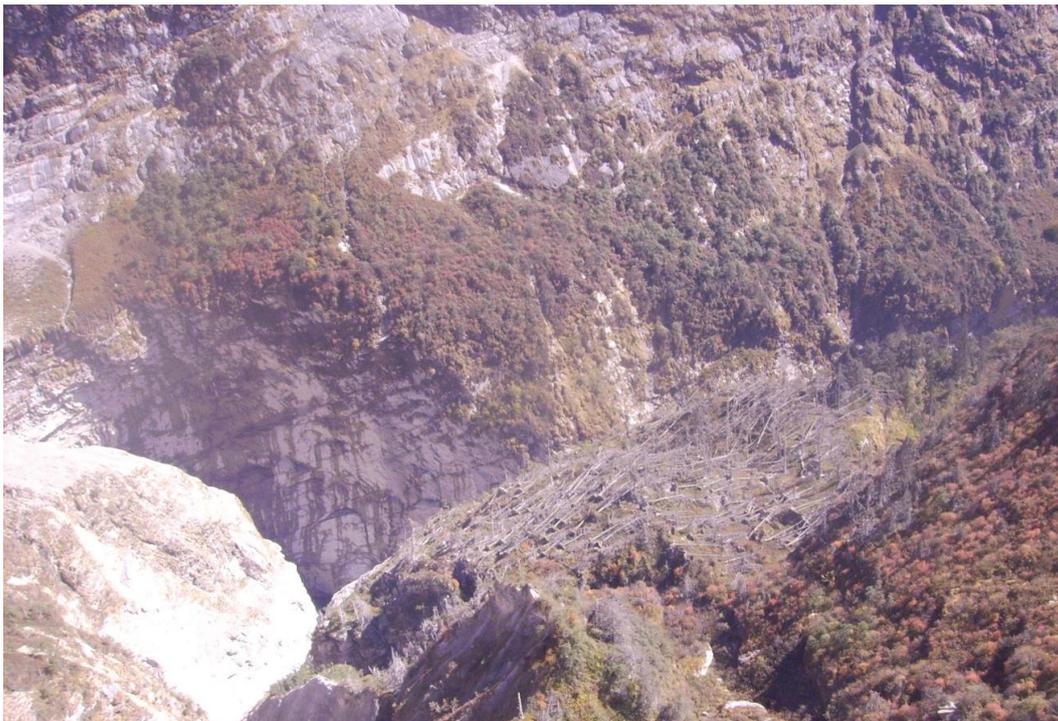
Photo 6

Flattened forest blown down by the avalanche winds. Gorge starts from Upper Seti basin nearly 3000m height from asl

Our observations have indicated that the gorge volume is far greater than we had initially believed, and so it could have contained enough water and sediment volume to have explained the slurry flood disaster. The gorge is both wider in some sections and far deeper (exceeding 500 m) than we had suspected at first [Photo: 6]. The gorge geometry

is such that a contained volume of more than 107 m³ is possible, i.e., enough to explain the 2012 outburst flood volume. Furthermore, there remains some speculation with some limited supporting observations that the gorge geometry may widen at the bottom with karst cave-like structures, which may add to the present estimations of contained volume. Consequently, our earlier assessment that the flood water volume required multiple sources is no longer a requirement. The gorge alone with or without additional water-filled karstic caverns-might be sufficient to explain the flood volume.
