Evaluating the Effectiveness of Sinkhole Mitigation and Its Impact on the Local Community: A Case Study of the Armala Sinkhole, Pokhara, Nepal

Mahendra Bhattarai, Sanjay Baral*, Badri Adhikari

School of Engineering, Faculty of Science and Technology, Pokhara University, Nepal

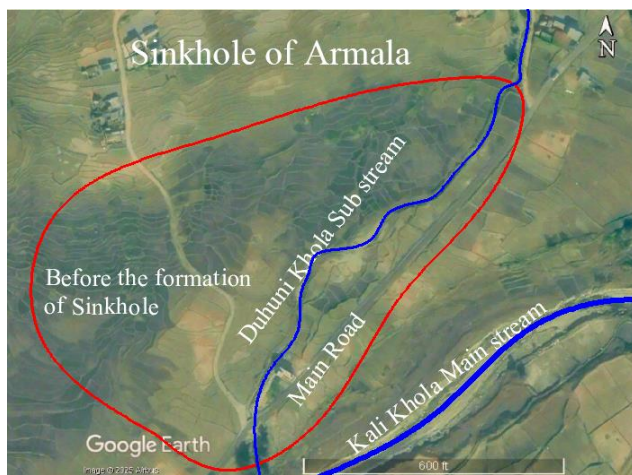
a) 12-2012

Figure 3 shows the Google Earth image of Armal region from December 2012 to May 2025. Figure 3(a) shows Google Earth image of 2012 before the formation of sinkholes, figure 3(b) and figure 3(c) shows the Google Earth image of March 2014 and December 2014 respectively after the formation of sinkholes, and figure 3(d) and figure 3(e) shows the Google Earth image of December 2016 and May 2025 respectively after the formation of sinkholes. Until March 2016 sinkholes are still seen. After the October 2016 sinkholes are demolish and regular terraced farmland, indicating active agricultural use which combined with high rainfall and irrigation, may have contributed to increased water infiltration and subsurface erosion. The area lies to the west of the main road, near the convergence of Duhuni Khola and Kali Khola. The underlying soil in the region is likely calcareous and loose, making it highly susceptible to dissolution and cavity formation over time.
