An Intersection under Stress: Diagnosing Layout and Control Issues - A Case Study at Srijana Chowk, Pokhara

Saroj Dhungana^{1*}

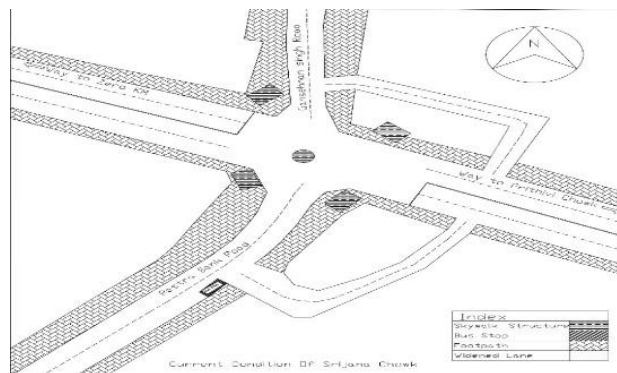
Figure 2. AutoCAD Traced Map of Sijana Chowk

On the northern approach, Ganeshman Singh Road has a roadway width of 8 meters and is flanked by footpaths measuring 5 meters and 6 meters on the respective left and right sides (facing north). In contrast, both the eastern and western approaches are substantially wider, each with an 18-meter carriageway and 5-meter footpaths on either side, allowing for smoother traffic dispersion. Although a bus stop is also present 35 meters east of the intersection, it does not adversely affect flow conditions due to the ample width of the roadway in that section.

A prominent geometric constraint is introduced by the centrally located pillar of the overhead pedestrian skywalk, which is a circular steel truss structure with a diameter of 4.5 meters. This pillar not only occupies valuable space at the heart of the intersection but also restricts sightlines for drivers, particularly those in smaller vehicles. Additionally, each corner of the intersection is occupied by staircases providing access to the skywalk. These stair structures each measure approximately 4.5 meters by 6.3 meters and further encroach into the intersection's operational envelope, particularly during turning movements. The combined effect of the central pillar and corner staircases results in reduced effective turning radii, tighter merging space, and increased interaction conflicts—contributing to operational inefficiencies and driver confusion during signal transitions.

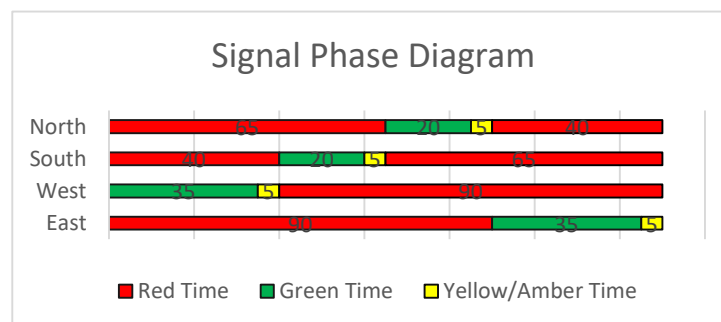
Figure 4. Traffic signal phase diagram

According to traffic police, signal timings are manually configured based on observed traffic conditions each day. The signals operate without automatic coordination and reset whenever there is a power outage, requiring manual reprogramming by on-duty personnel. The green phase follows a fixed order: east → west → south → north.

From the recordings, the eastern and western legs were found to have a green phase of 35 seconds, a yellow phase of 5 seconds, and a red phase of 90 seconds. In contrast, the northern and southern legs had significantly shorter green phases of 20 seconds and longer red phases of 105 seconds, indicating a potential mismatch between signal phasing and observed queue lengths. The uniform yellow/amber time across all legs was 5 seconds.

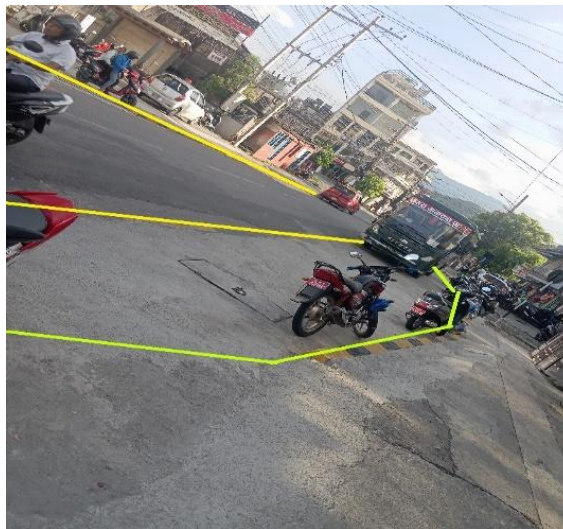
The bus stop located on the southern leg, serving southbound buses, was widely perceived as a major contributor to traffic disruption. Drivers and traffic police reported that public vehicles from at least six different routes converge at this location, leading to one of the two lanes being consistently blocked. Residents highlighted the same issue, noting that buses often stop beyond designated areas and for extended periods, compounding congestion during peak hours. All groups strongly recommended relocating the stop farther downstream and converting it into a recessed bus bay or pocket to separate waiting vehicles from the moving traffic stream. The consensus was that the current arrangement is incompatible with the intersection's operational demands.

Figure 16. Recessed Bus stop at Ratna chowk, Pokhara (Down the southern leg from Srijana Chowk)

The curbside bus stop on the southern leg is a major contributor to lane obstruction and delay. It is recommended to

- The bus stop be relocated approximately 100 meters downstream from the intersection.
- It be converted into a recessed bus bay, preventing blockage of active lanes.

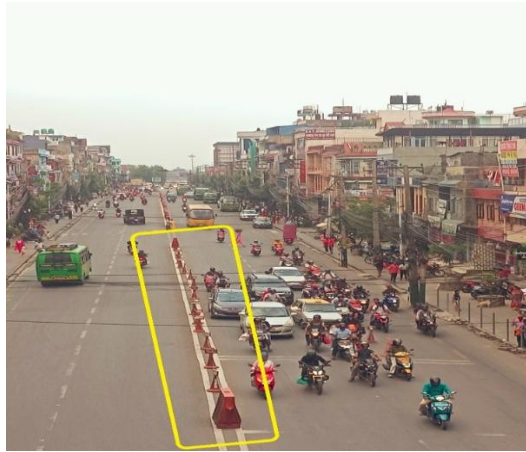
Figure 17. Plastic Cones Median Regulating Traffic in Eastern Leg

- “No Horn” signage should be installed immediately on all approaches.
- New lane markings must be applied on every leg of the intersection to clearly demarcate stop lines, turning paths, and through lanes.
- Plastic cone medians should be introduced on the west, north, and south legs to guide vehicles, similar to the existing median system on the east leg.
