# Types and processes of slope movements along East–West Highway, Surai Khola area, Mid-Western Nepal Sub-Himalaya

\*Naresh Kazi Tamrakar<sup>1</sup> and Shuichiro Yokota<sup>2</sup>

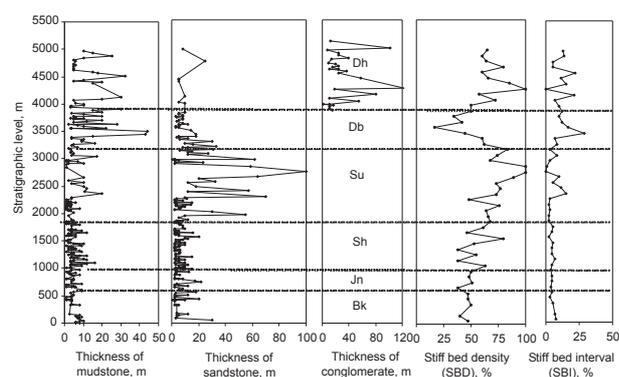
Fig. 2 Thickness of mudstone, sandstone and conglomerate, stiff bed density (SBD) and stiff bed interval (SBI) against stratigraphic level. Dotted lines represent boundaries of lithologic units (based on the litholog after Dhital et al. 1995)

Thickness variation of stiff and weak rocks gives rise to various pattern of interbedding (Fig. 2). Mudstone bed-thickness, that is 5 m in the BF, CKF and SKF, becomes 30 m in the DF and the DKF. Sandstone beds have lower thickness (2–5 and 5–10 m) in the BF, CKF, DF and DKF than in the SKF (10–20 to 100 m). Conglomerates have thickness ranging from 5 to 120 m.

Stiff bed density (SBD) and stiff bed interval (SBI) were calculated per 100 m of intervals (Fig.

4). SBD is the total thickness of stiff beds per 100 meters. SBI is an average thickness of soft bed per 100 m. The lower SBI indicates increase in number of stiff beds. SBD is high (~ 75%) in SKF and the middle part of DKF. SBD is low (7 to 50%) in the DF and is intermediate in other formations. SBI is 1–7.6% in BF, CKF and SKF showing that stiff beds are frequently intercalated therein. SBI is relatively high in DF and DKF.

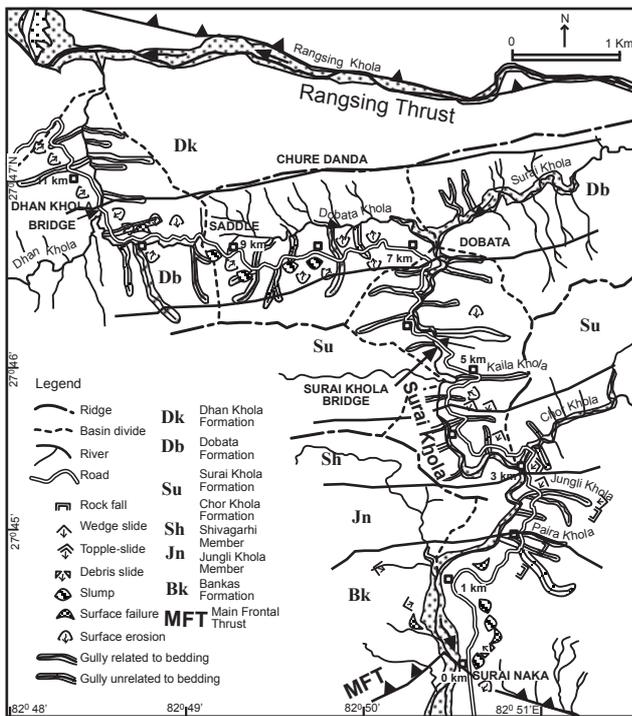
Fig. 3 An inventory map of slope movements along the Surai Khola and the East–West Highway, Mid-Western Nepal

Spatial distribution of slope movements which vary in their type and magnitude are shown in Fig. 3. Rock fall, wedge slide, slump, debris flow, slope failure and gully erosion have been recognized. Most of them distribute on natural slopes, but slope failure commonly occurs on excavated slopes.

Large-scale rock falls were recognized at 1.56 km and 2 km from Surai Naka (Fig. 3). In the former, a slope is composed of sandstone and mudstone with differential weathering and plunge 60° N. Two major potential wedges (320° to 334°) were measured. The wedge that faced 174° became potential when underlying mudstone bed was eroded. Therefore, this rock fall occurred by failure of wedges.

Some major debris flows are located at Surai Naka 3.5 and 1.56 km, in the Paira, Jungli, and the Kaila Kholas (Fig. 3). Older debris flow deposits were also recognized from gullies across the highway. Tributaries in the northern face of the Chure Danda carry abundant debris to the Rangsing Khola. Friable sandstone and loosely consolidated conglomerate are the chief source materials for debris flows.

Gullies often follow mass and structural discontinuities. Gullies related to bedding plane are distributed in Surai Naka–Kaila Khola and in Dobata–Dhan Khola Bridge (Fig. 3). The magnitude of gullies depends on thickness and plunge of beds, contrast in stiffness of strata, SBD and SBI.

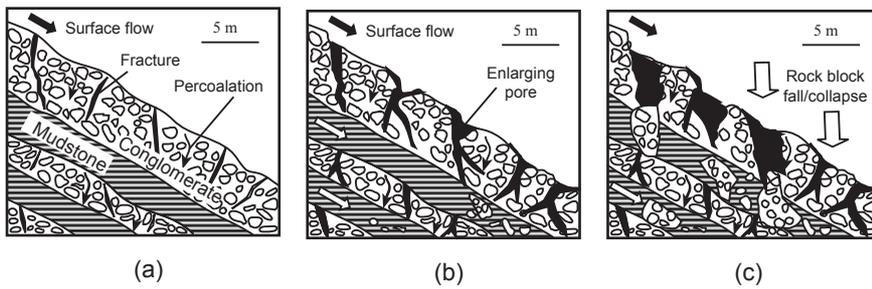
Fig. 4 Schematic diagram showing processes of rock fall: (a) Surficial flow and percolation of water, (b) Solution of cementing material, formation of vugs in conglomerate, and erosion of underlying soft rock (mudstone), and (c) Rock block fall by gravity, and collapse of beds due to removal of underlying support of mudstones

Rock fall often occurs by collapsing of rock blocks due to removal of underlying support of soft beds. Such rock fall has a low magnitude of displacement (1 to 10 m), but has frequent impact on the highway. Collapse of rock blocks occurs widely in areas of BF, CKF and DKF due to gully erosion. In conglomerate and mudstone sequences of DKF, mechanism of collapse involves (1) gully erosion of mudstone, (2) dissolution of cements in conglomerate and enlargement of vugs, and (3) collapse of conglomerate blocks (Fig. 4).
