CASE REPORT

AN UNUSUAL CAUSE OF INTRAOPERATIVE HIGH AIRWAY PRESSURE AND VENTILATOR FAILURE: MESSAGE TO BE LEARNED

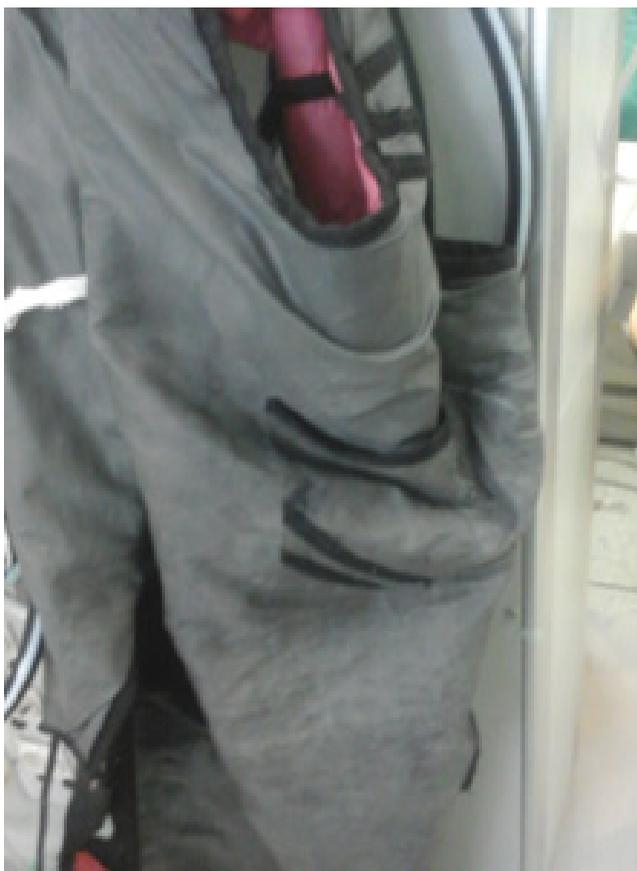
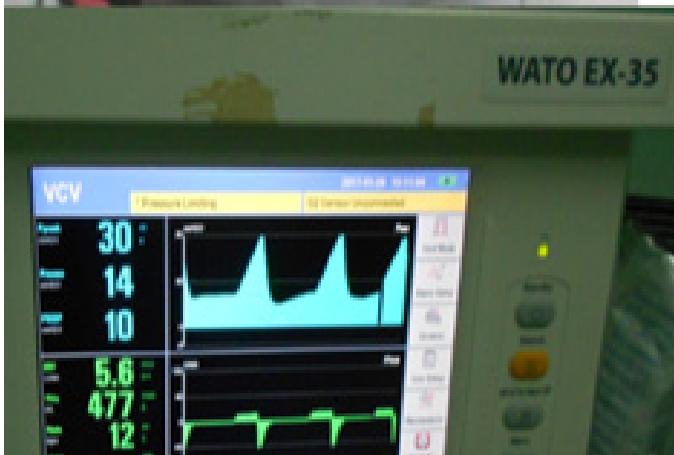
back of the machine which was obstructing the anesthetic gas scavenging system hence blocking the outflow of the machine causing back pressure.

Figure 1: Lead apron covering exhaust valve causing increase of peak airway pressure.

The patient was brought to the operating room and regulator monitors were attached. Patient was anesthetised and manually ventilated until nasal intubation with size 6.5mm flexometallic tube was done and switched to ventilator after confirmation of correct tube placement. The ventilator worked normally but after 7-8 breaths the peak pressure started to rise and alarm of sustained airway pressure activated and finally the ventilator stopped. Manual ventilation by same machine was done without any problem. Tubes, circuits, valves were checked and was found to have no problem. Patient was connected to ventilator and ventilated mechanically again but the same problem arose. The patient, tubes, circuits and machine including sodalime container were checked once again but no problem was found. Same fate was encountered again when the ventilator was used. We thought of changing the ventilator but suddenly our eye fell on a lead apron hanging on the back of the machine (Figure 1). Once the lead apron was removed from the machine the ventilator worked properly (Figure 2). It was found that someone had hanged a lead apron on the

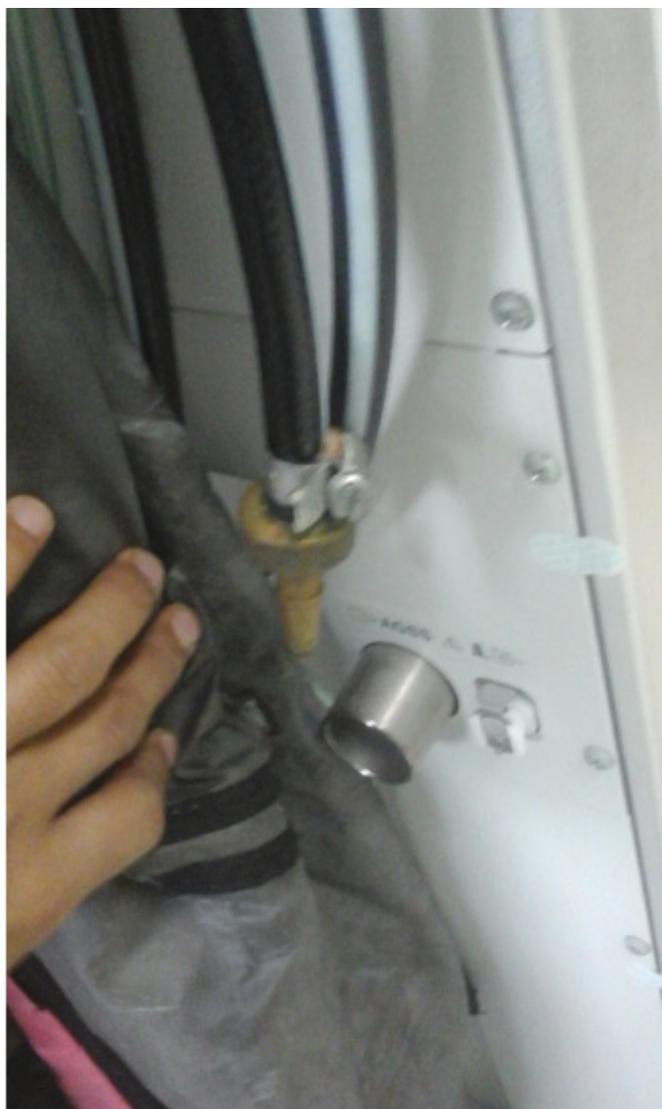
Figure 2: Exhaust Valve after removal of Lead apron.
